**Service Contract No. EDO/01/2017
ENVIRONMENTAL TEAM FOR
Development of Anderson Road Quarry Site –
Road Improvement Works**

**DEVELOPMENT OF
ANDERSON ROAD QUARRY SITE -
ROAD IMPROVEMENT WORKS**

TRANSPLANTATION COMPLETION REPORT

Transplantation Completion Report for Contract No. NE/2017/03 Development of Anderson Road Quarry Site – Road Improvement Works and Pedestrian Connectivity Facilities Works Phase 2A

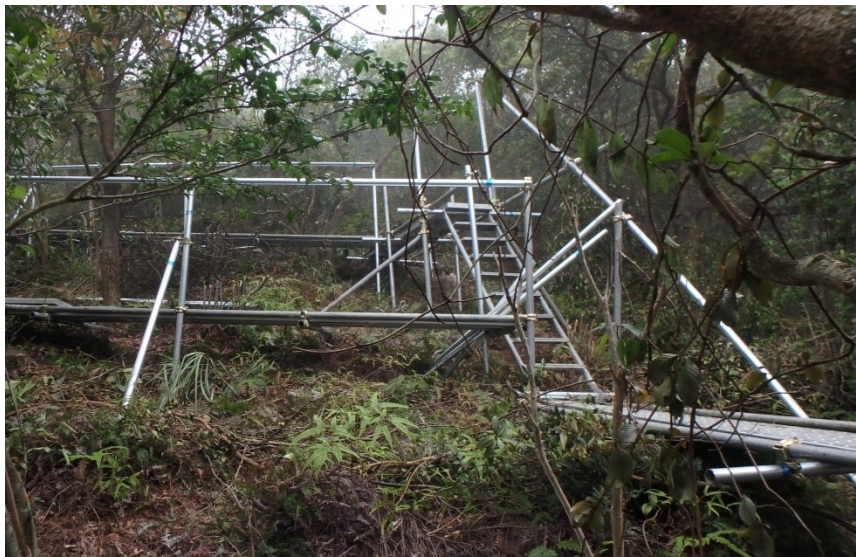
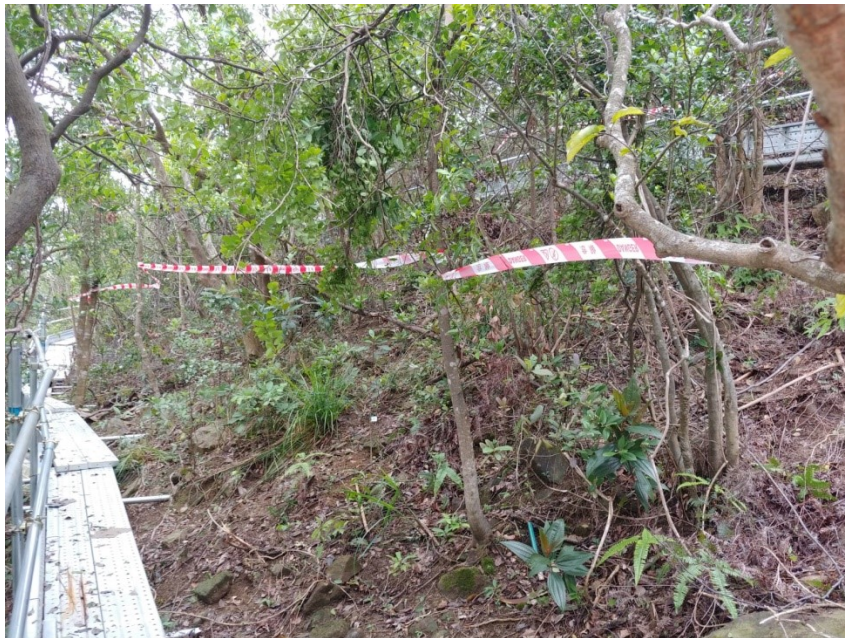
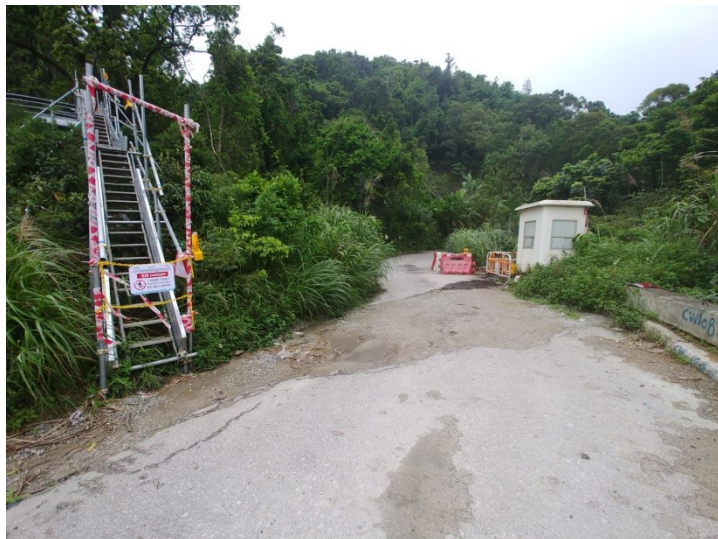
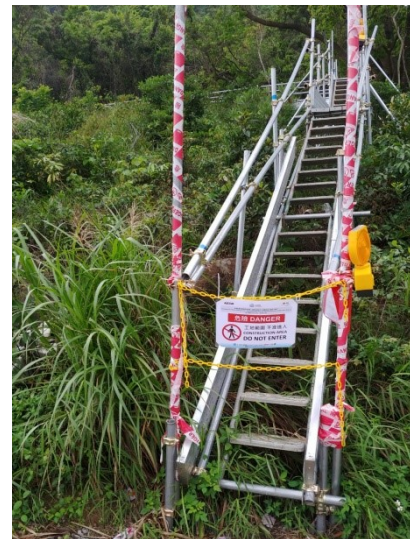
Designed receptor site (RSB as per the transplantation proposal) has received minimum vegetation clearance for building temporary access for the 3-year post-transplantation monitoring and maintenance programme (**Plate 1**). There will be no construction activities at RSB, of which the access is exclusively built for post-transplantation monitoring and maintenance works. Nonetheless, RBS was enclosed with warning tapes. Warning sign was placed at the only entrance against unintentional entry of site staff.

Since RSB is within Project NE/2016/01 which has its security guards and system for the project area. This serves certain protection against potential illegal loggers from entering the area (**Plate 1**).

Plate 1. Vegetation clearance was kept at minimum for building temporary access to the transplantation receptor site.

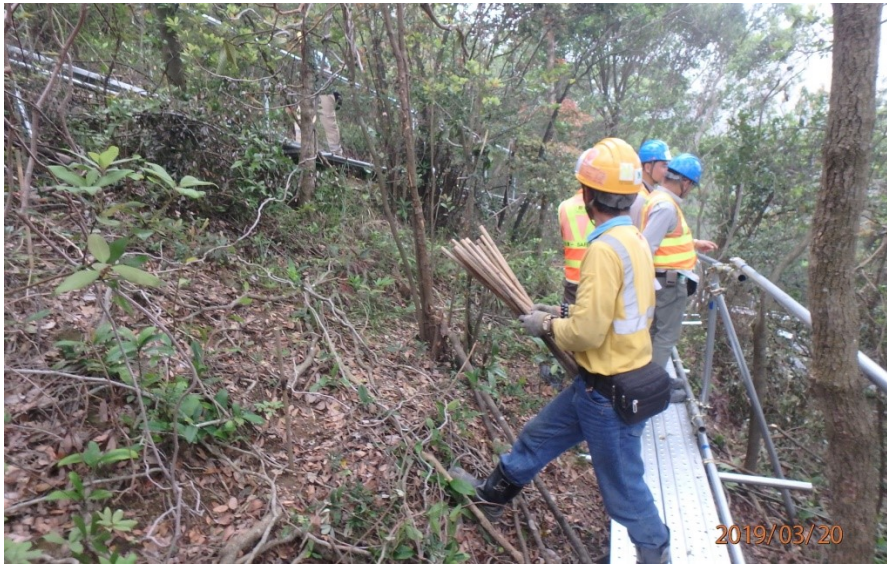
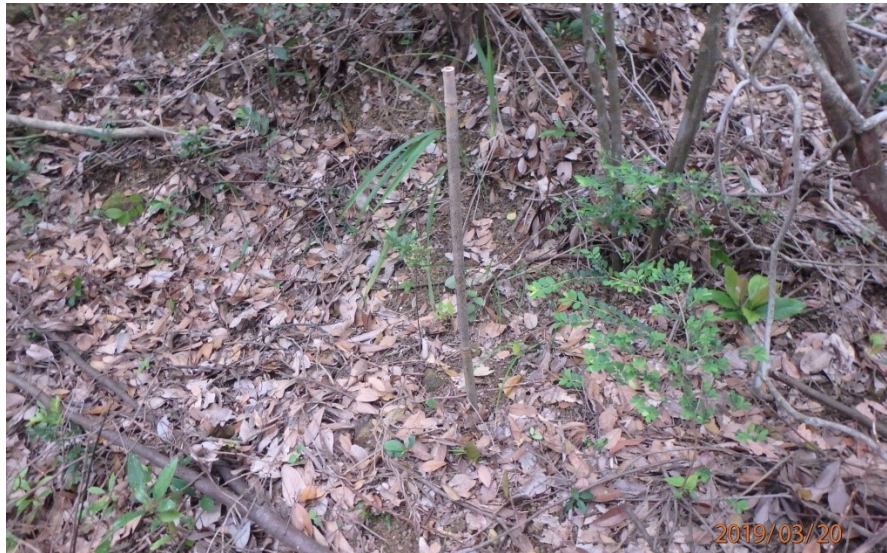
Locations of each planting pit were agreed by the Plant Specialist and the Supervisor of the Contract with adequate spacing for future growth of seedlings. Each pit was marked by a bamboo stick (**Plate 2**). No plant species of conservation importance were detected at the planting area of seedlings.

Plate 2. Each planting pit agreed by the Plant Specialist and the Supervisor of the Contract was marked by a bamboo stick prior to transplantation.

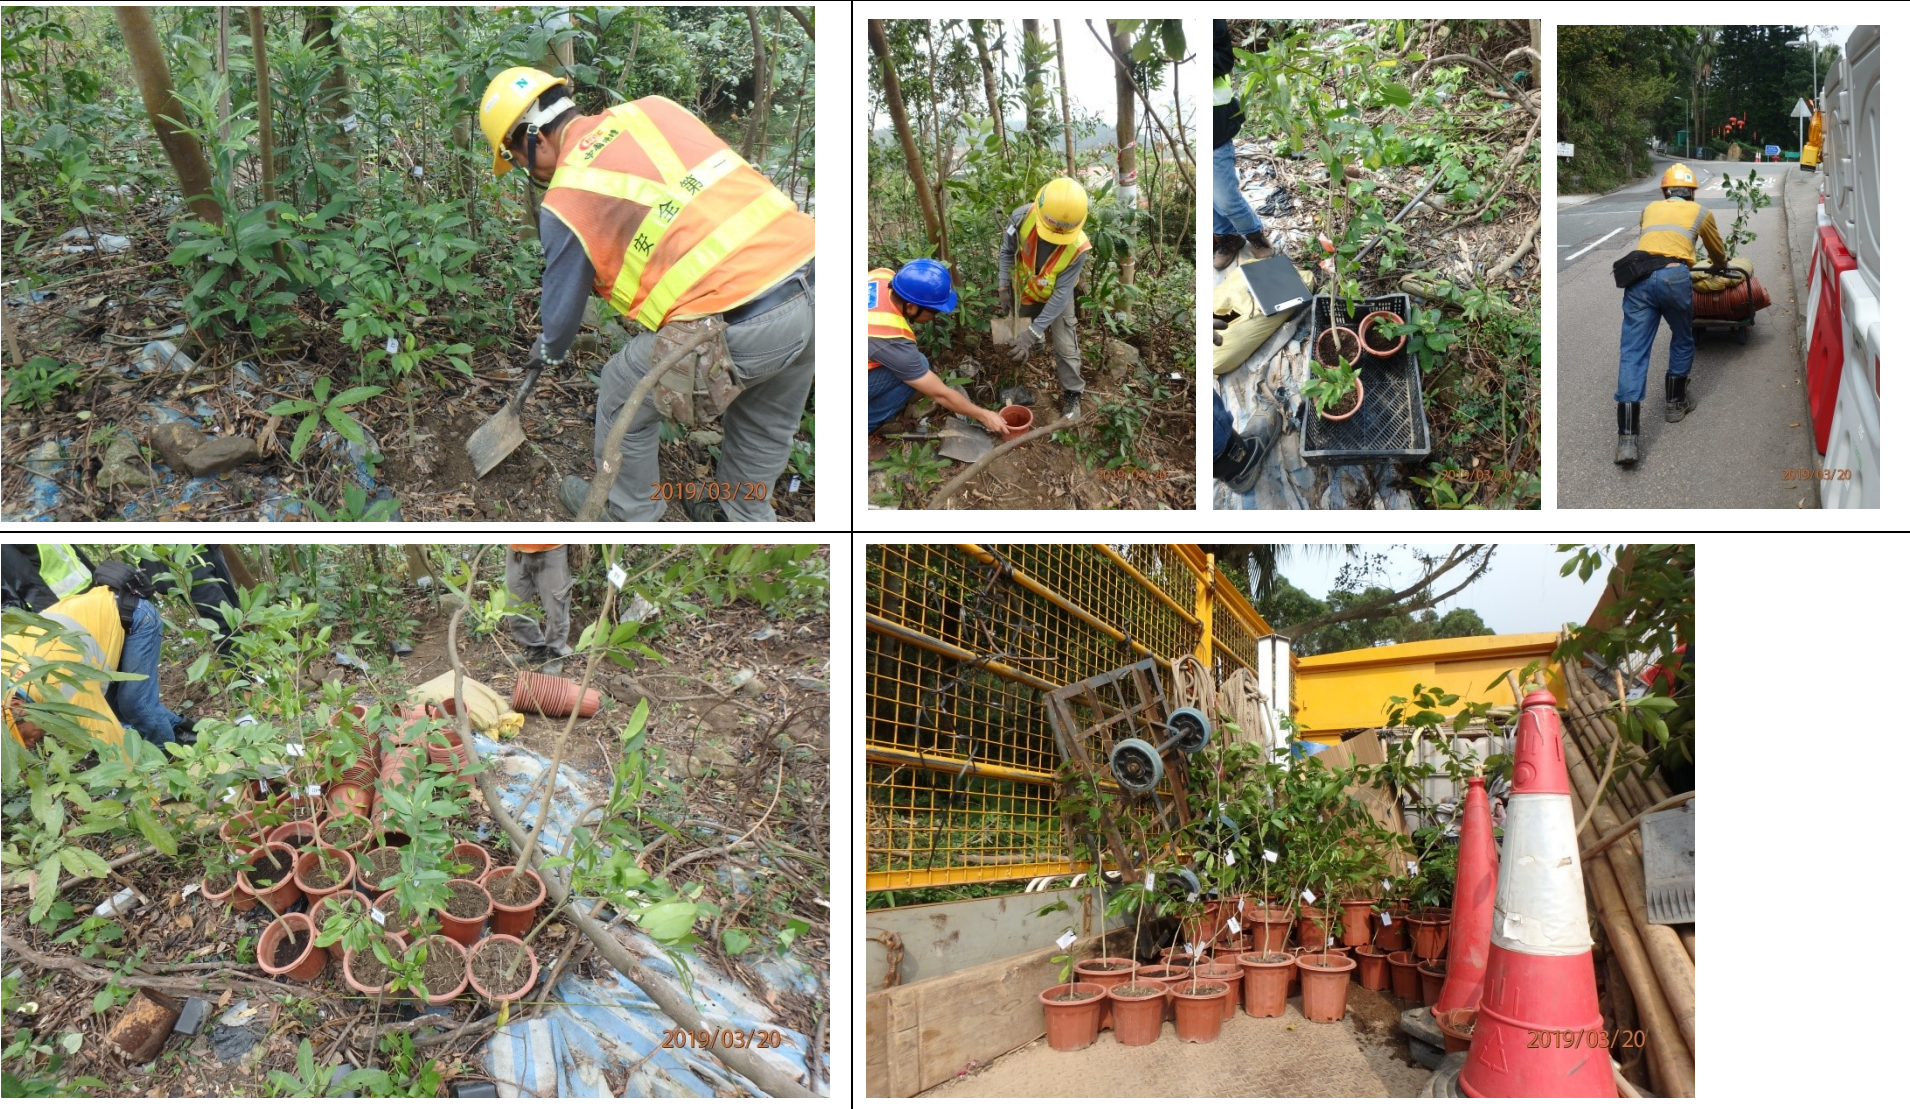
By following the transplantation proposal, all target seedlings were dug up with caution by hand-held shovel by Landscape Specialist Contractor, individually placed upright in pots, counted, irrigated and delivered to the receptor site (**Plate 3**). Meanwhile, planting pits were ready right before transplantation at each marked location. They were optimized at two to three times the width; and same depth of the rootball at the surface wherever practical. All seedlings were transplanted in the pits within two hours of lifting.

Plate 3. All 55 seedlings were dug up with caution by hand-held shovel by Landscape Specialist Contractor, individually placed upright in pots and delivered to the receptor site.

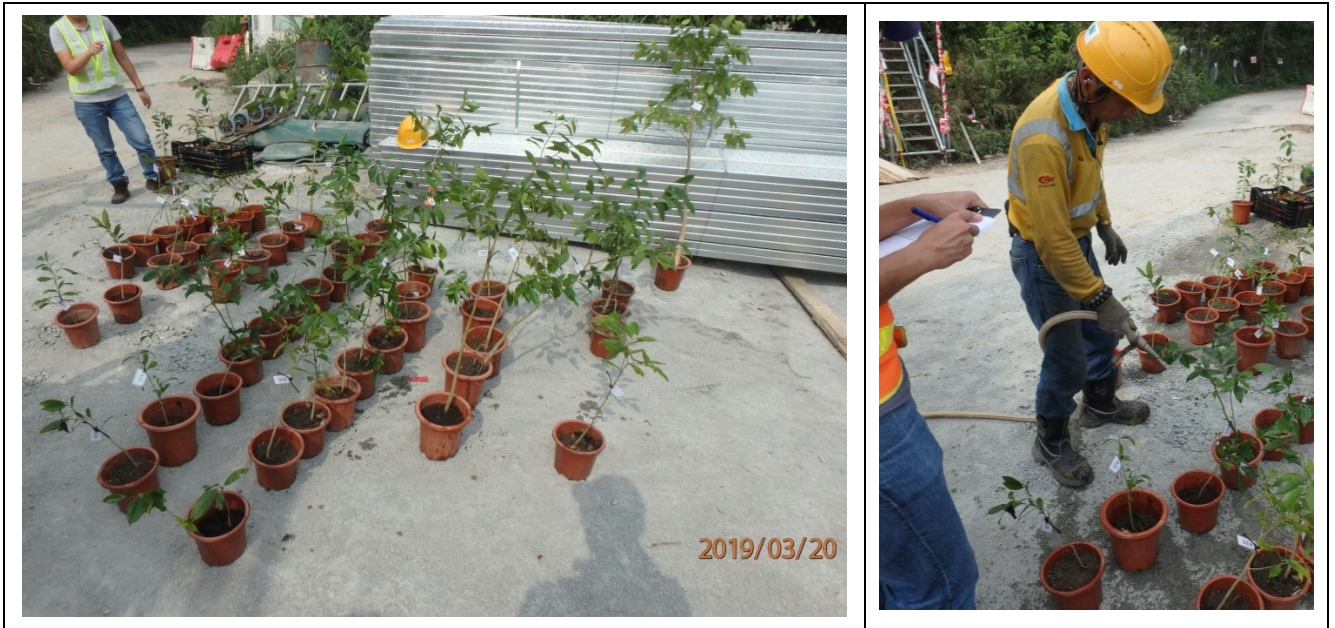
Plate 3 cont'd. All 55 seedlings were counted and irrigated before transplanting to the receptor site.

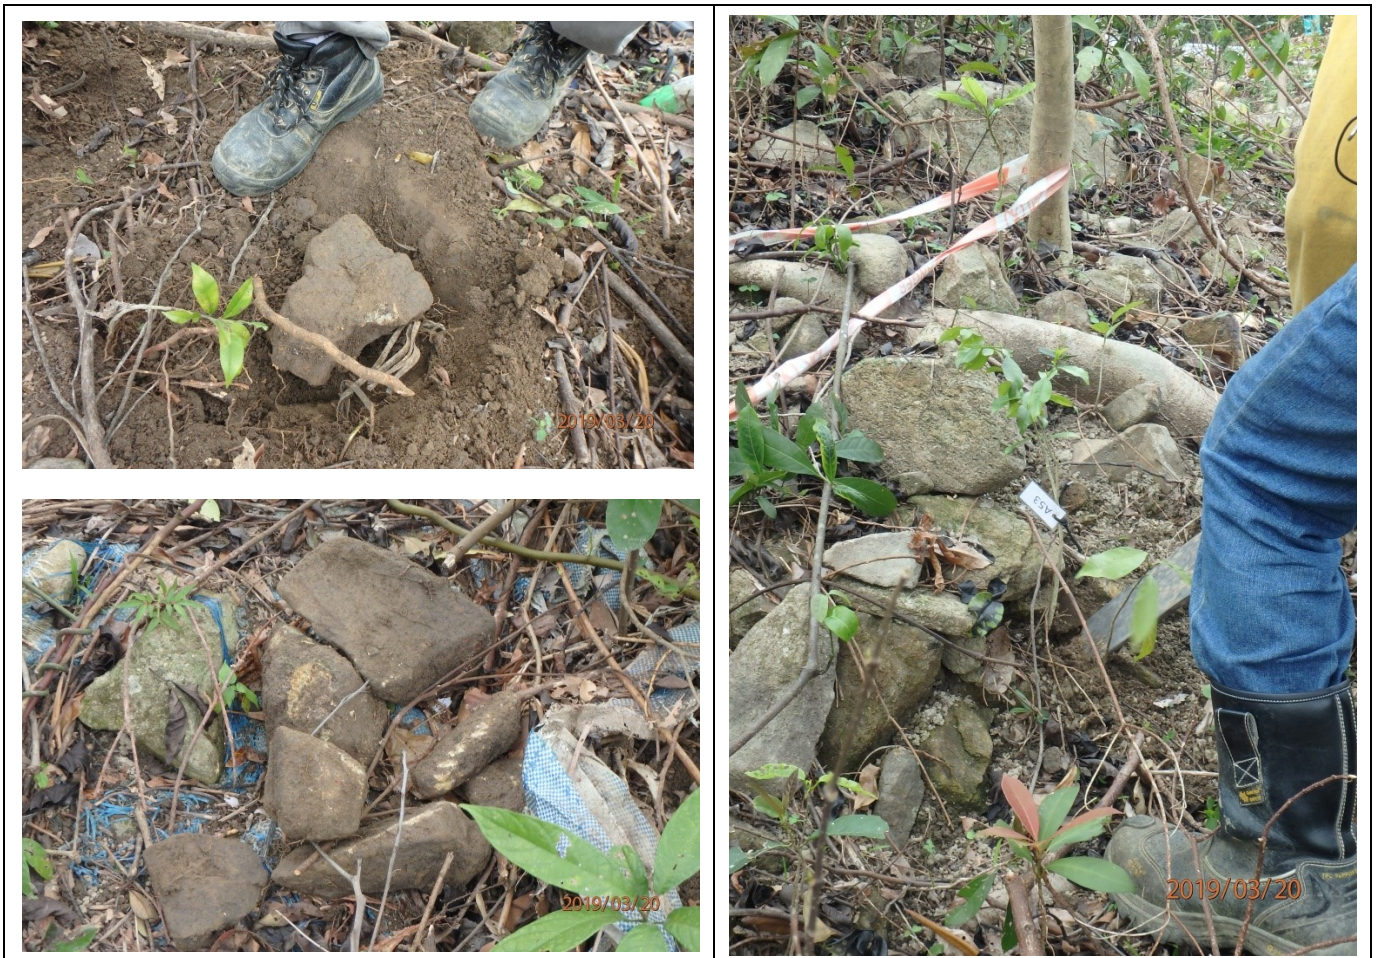
We revealed the original growing site of target seedlings is full of boulders after clearance of dense ground vegetation has been carried out. Rocks/ boulders exposed under a few centimetres of top soil around root zones for some seedlings (**Plate 4**). Some other seedlings were even growing among rock crevices.

Plate 4. Original growing site of target seedlings is full of boulders as revealed by digging up the top soil (left). Some seedlings were even growing among rock crevices (right).
