**Service Contract No. EDO/01/2017
ENVIRONMENTAL TEAM FOR
Development of Anderson Road Quarry Site –
Road Improvement Works**

**TRANSPLANTATION PROPOSAL –
UPDATED JUSTIFICATION FOR TRANSPLANTING 2 NOS. *AQUILARIA SINENSIS* TREES**

Field Justification by Plant Specialist of the Environmental Team Regarding the Infeasibility of Transplanting the Two Mature *Aquilaria sinensis* Trees R-T02142 and R-T02157.

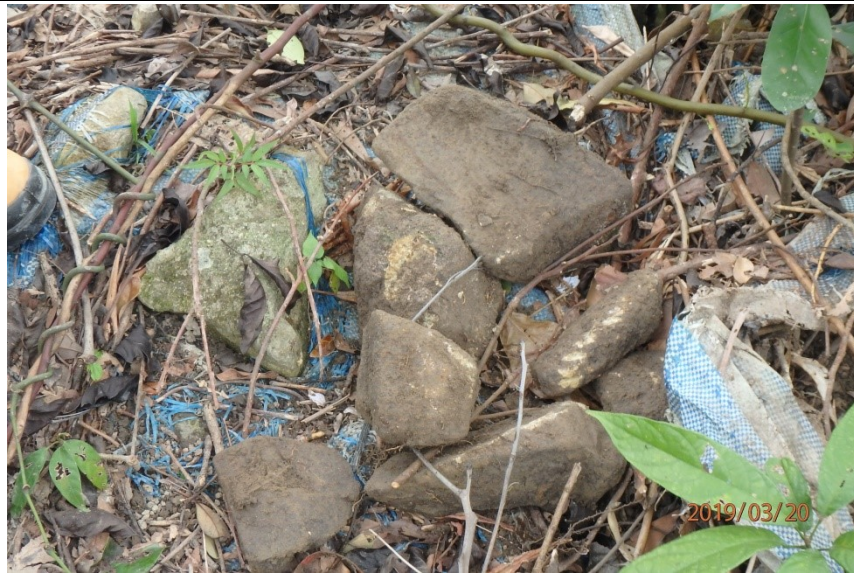
Plate 1

During a joint site visit with representatives from HK Landscape, AECOM and Lam Env. Service Ltd. on 20 March 2019, we revealed the site is full of boulders after clearance of dense ground vegetation has been carried out. Landscape Specialist Contractor has carefully dug up the top soil around core root zone, rocks/ boulders exposed in depth of a few centimetres (**Plate 1**). Due to this condition, it is impracticable to create a reasonable root ball size. Attempt has been made to remove some rocks/boulders, however, this would lead to excessive damage of the core root zone even root pruning is successful.

Boulders exposed under top soil at the site

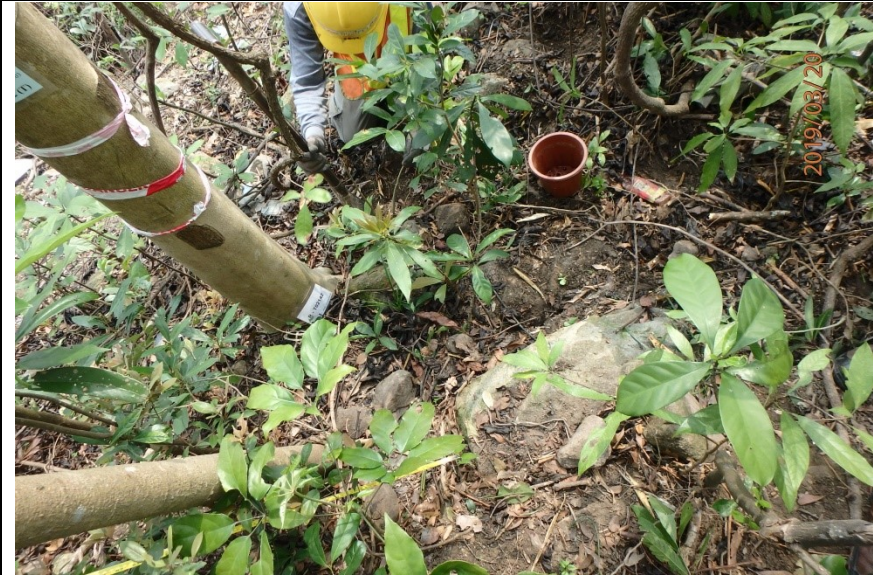
Boulders observed at core root zone of R-T02142-(T)

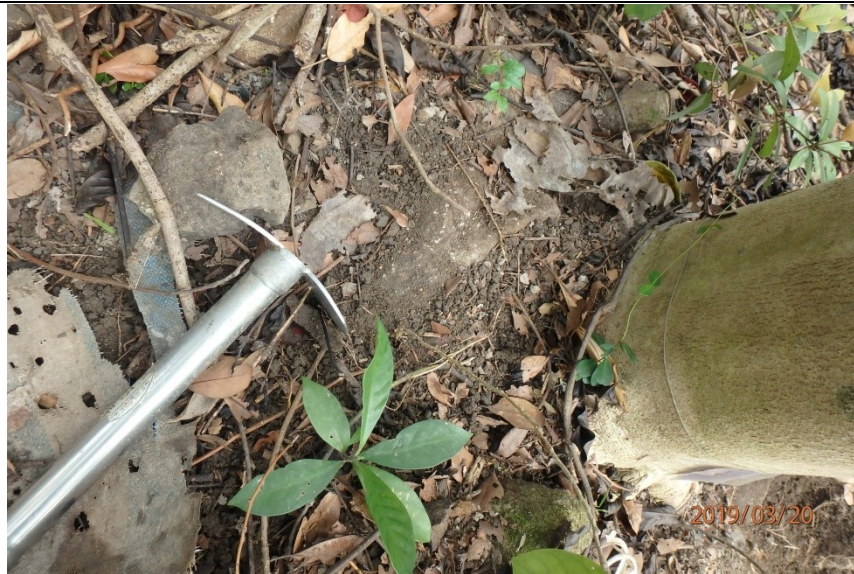
Underground rock observed near root collar of R-T02142-(T)

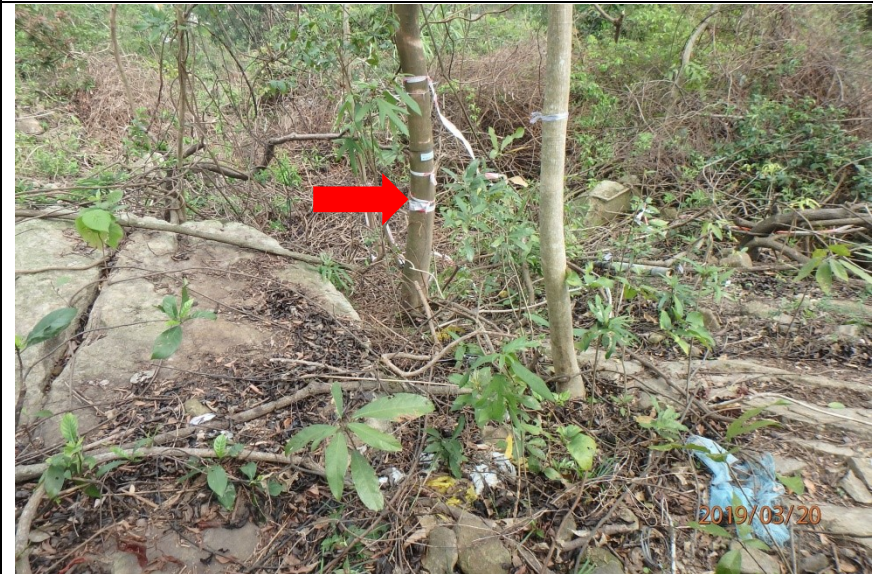
R-T02157 is growing between two large rocks

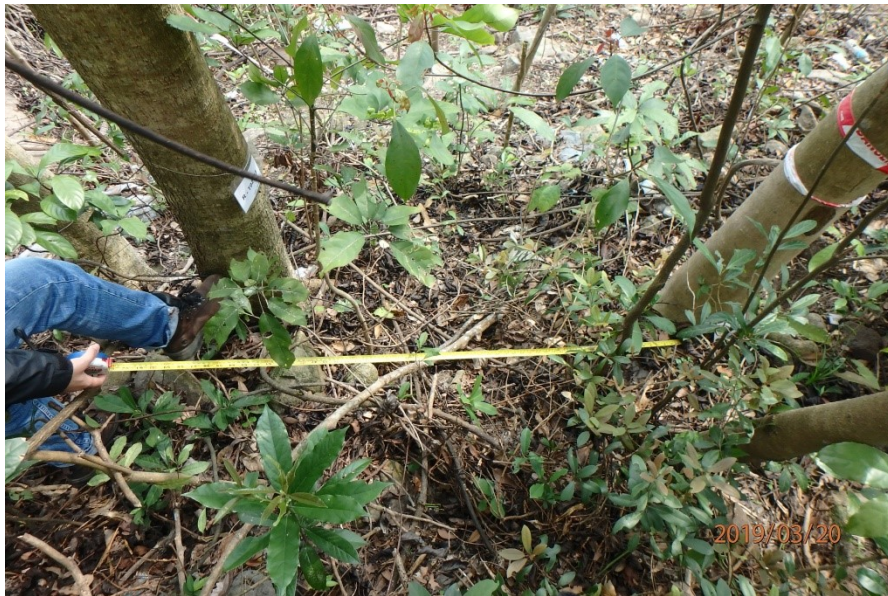
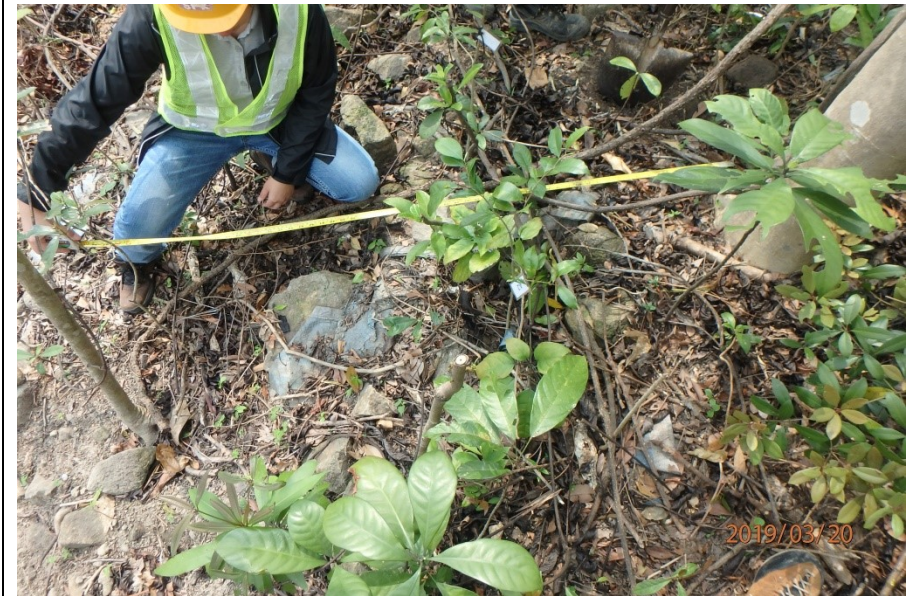
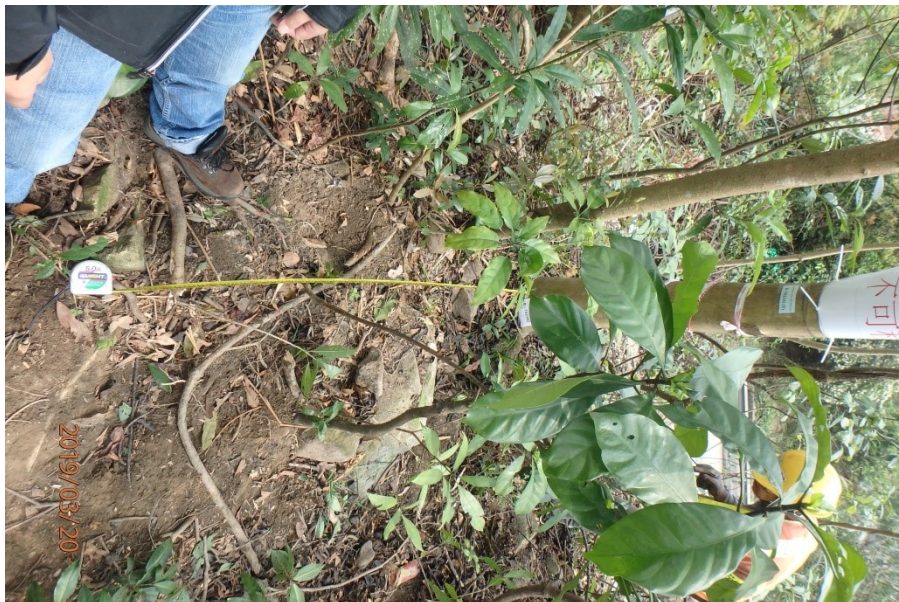
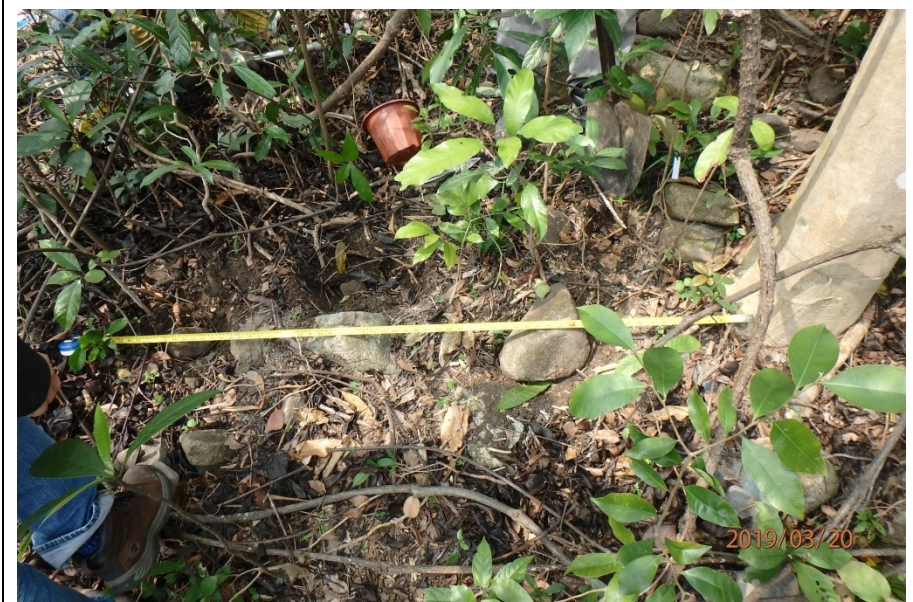
Plate 2.

Vegetation clearance also revealed that there is a significant level difference at four directions of the core root zone, making a highly uneven rootball for a mature tree to be transplanted at an up straight position (**Plate 2 & 3**). R-T02157 is even growing in crevices between two large rocks (**Plate 3**).

Boulders and difference in ground level observed at 4 directions within core root zone of R-T02142-(T).

Subsequently, R-T02142-(T) and R-T02157 would have to be removed due to direct conflict with currently proposed construction works.

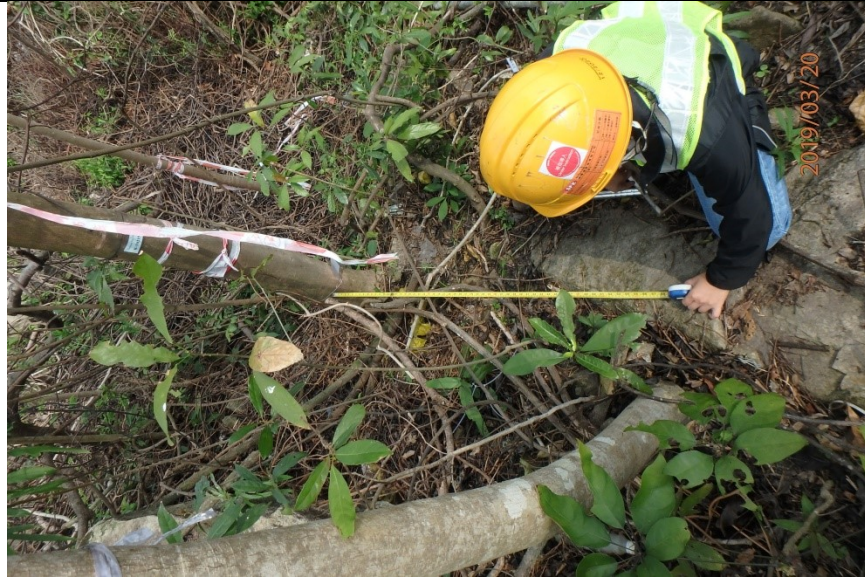
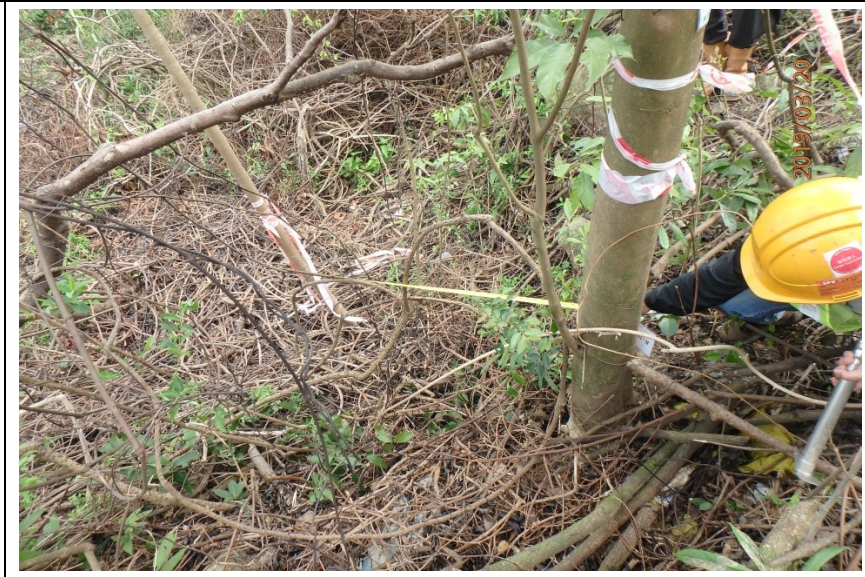
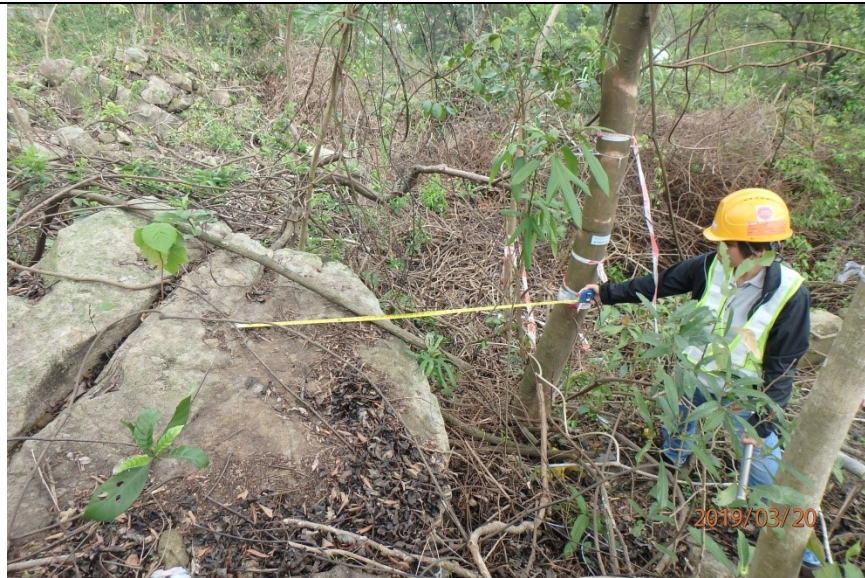
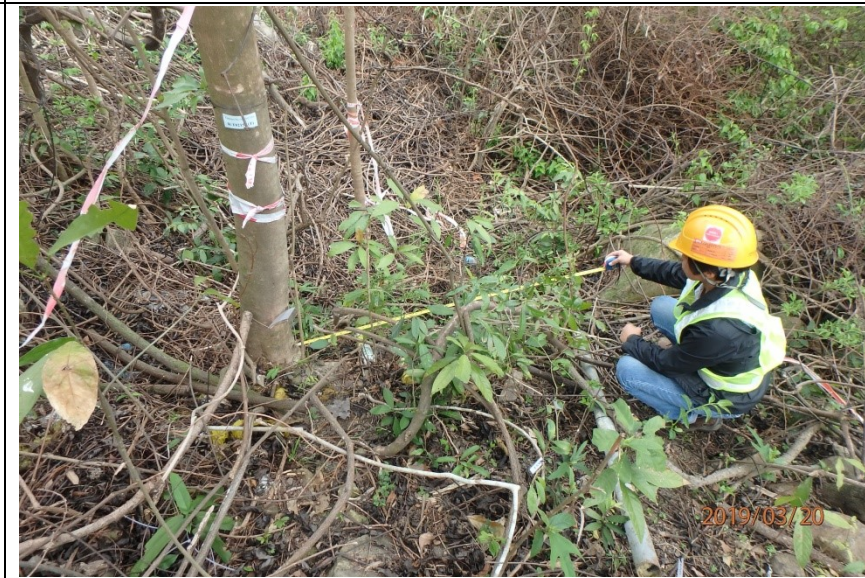
Plate 3.

Boulders and difference in ground level observed at 4 directions within core root zone of R-T02157.
