**ENVIRONMENTAL TEAM FOR
DEVELOPMENT OF
ANDERSON ROAD QUARRY SITE -
ROAD IMPROVEMENT WORKS**

UNDER ENVIRONMENTAL PERMIT NO. EP-513/2016

MONTHLY ENVIRONMENTAL MONITORING & AUDIT REPORT

FEBRUARY 2022

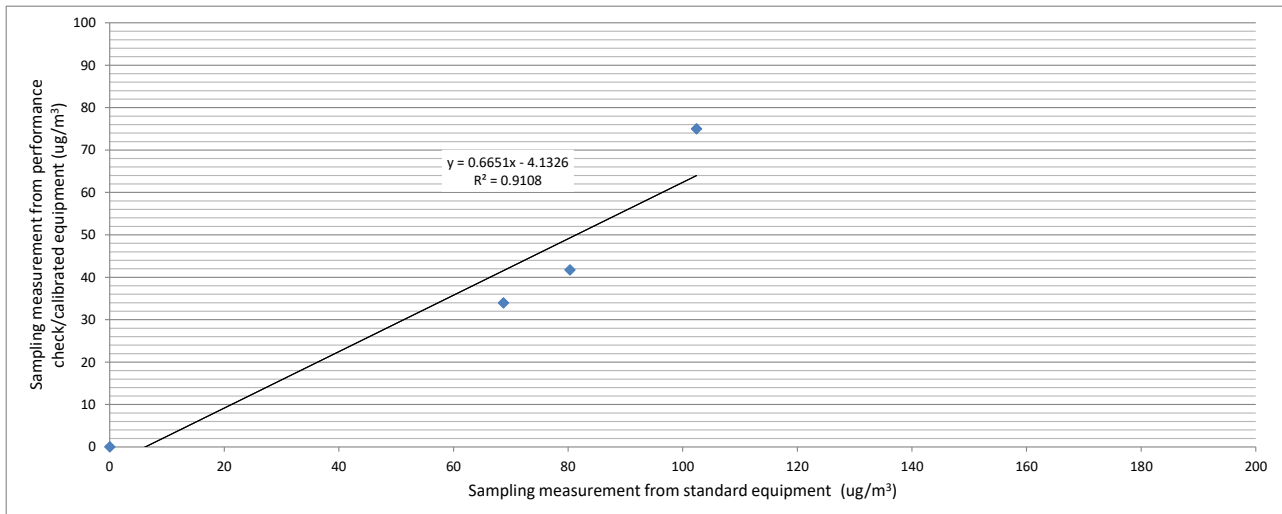
Linear Regression of Y on X

Slope (K- factor) : 1.4000
Correlation Coefficient : 0.9544
Validity of Performance Check / Calibration Record : 22/3/2022

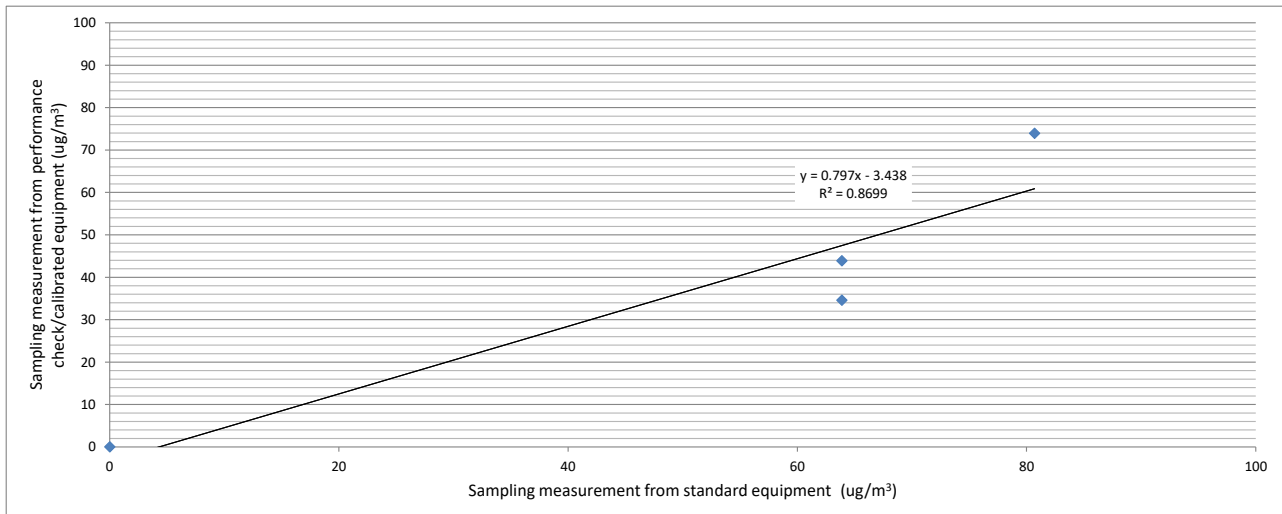
Linear Regression of Y on X

Slope (K- factor) : 1.1000
 Correlation Coefficient : 0.9327
 Validity of Performance Check / Calibration Record : 18/6/2022

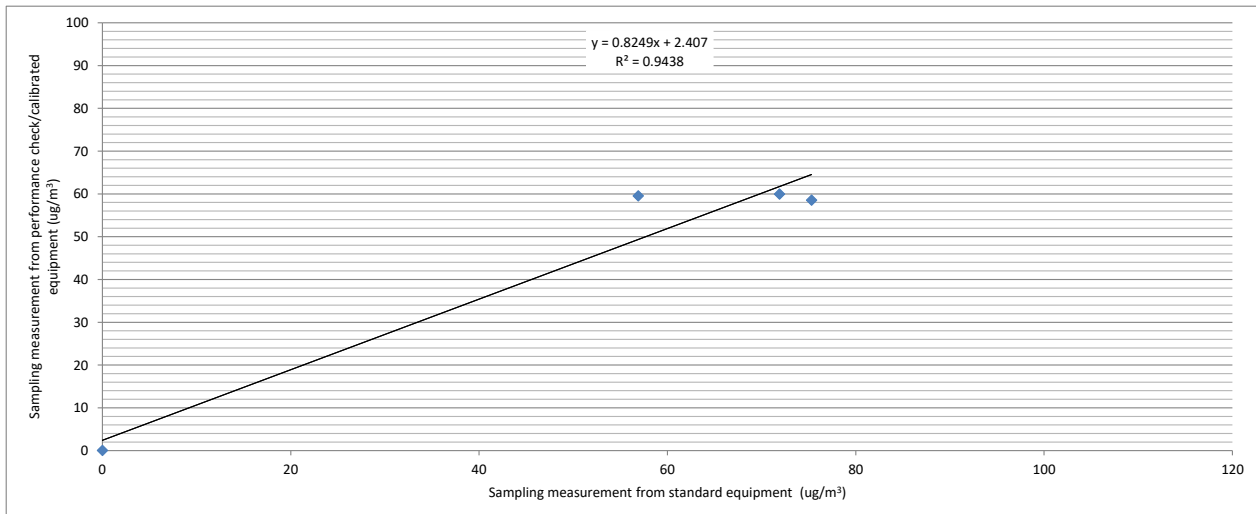
Linear Regression of Y on X

Slope (K- factor) : 1.2000
Correlation Coefficient : 0.9715
Validity of Performance Check / Calibration Record : 10/5/2022

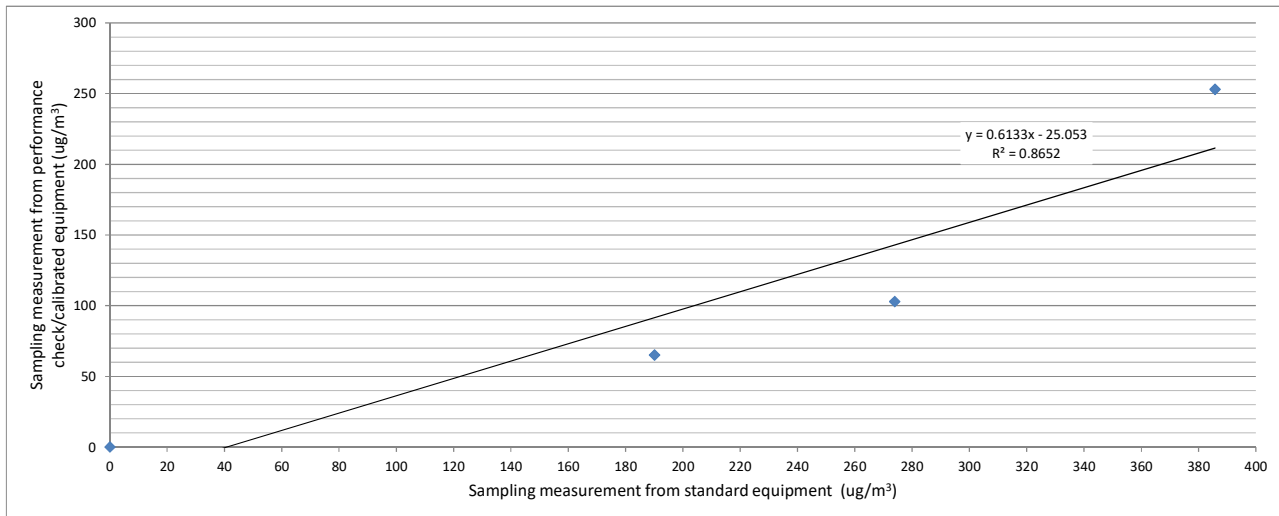
Linear Regression of Y on X

Slope (K- factor) : 1.5000
Correlation Coefficient : 0.9302
Validity of Performance Check / Calibration Record : 20/4/2022

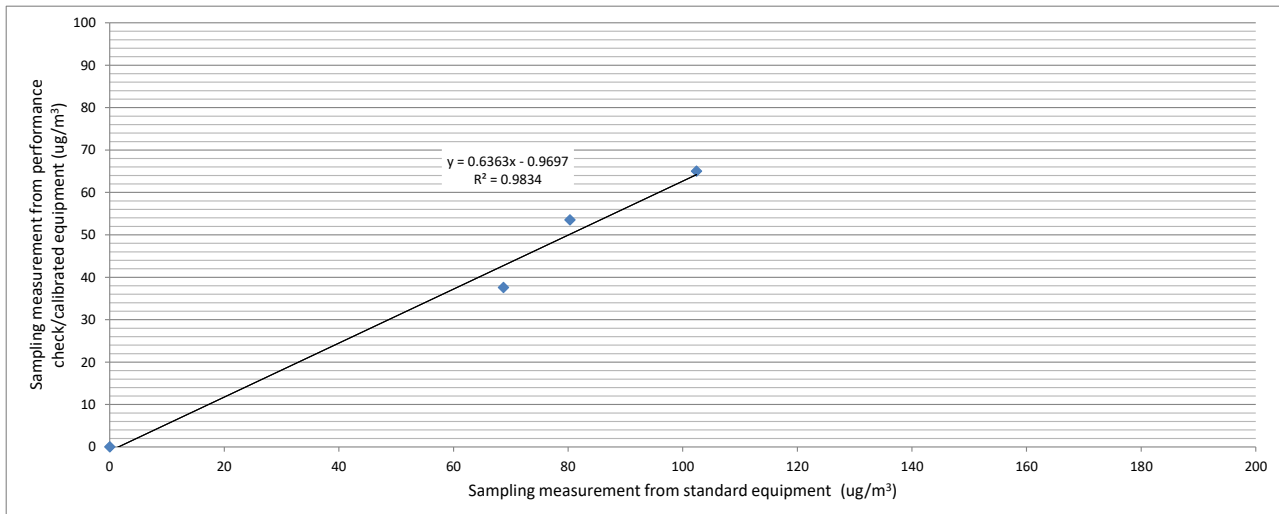
Linear Regression of Y on X

Slope (K- factor) : 1.6000
Correlation Coefficient : 0.9917
Validity of Performance Check / Calibration Record : 22/3/2022

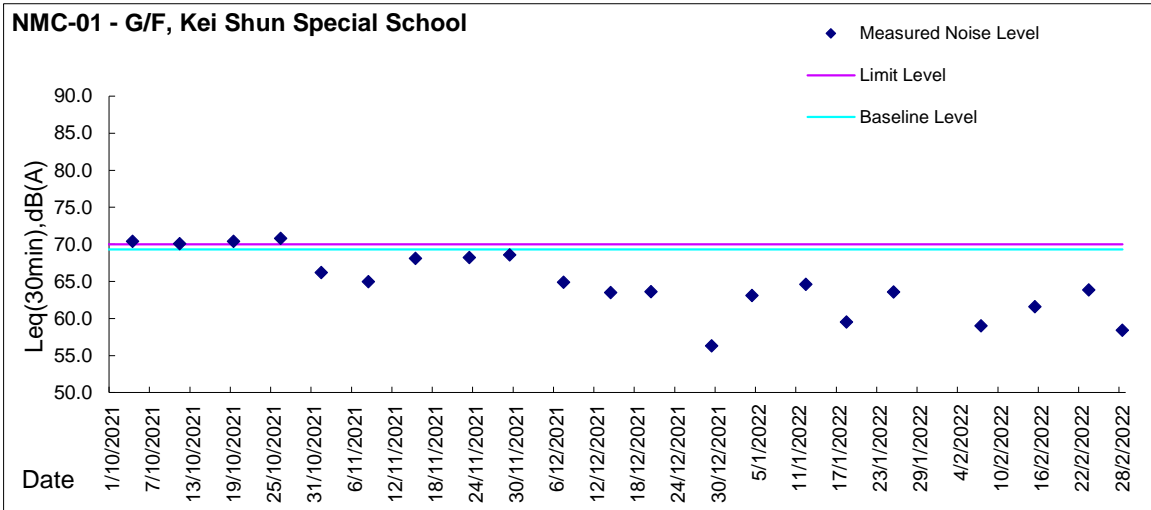
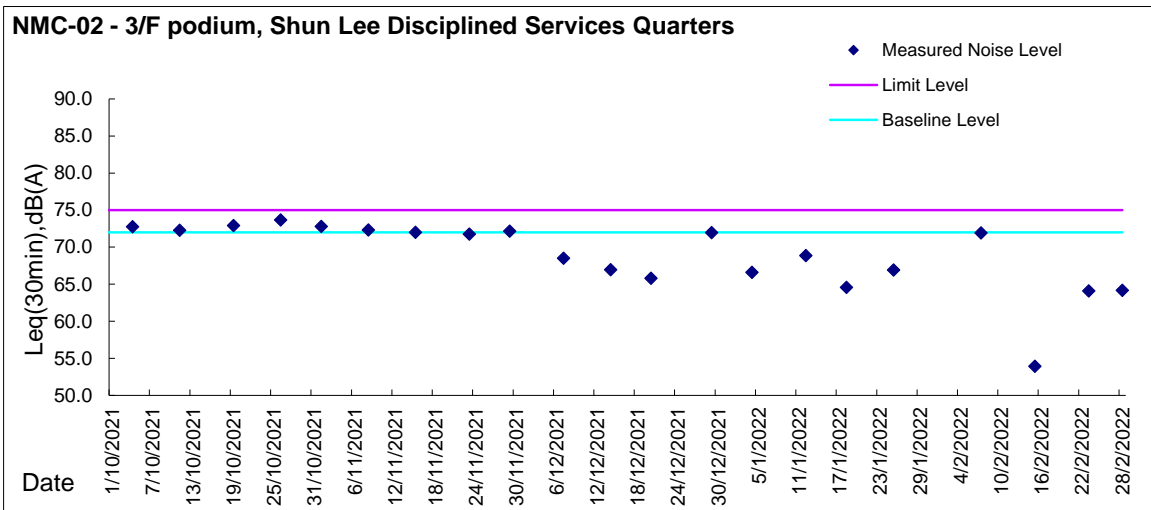
Graphic Presentation of Noise Monitoring Result
Day Time (0700 - 1900hrs on normal weekdays)

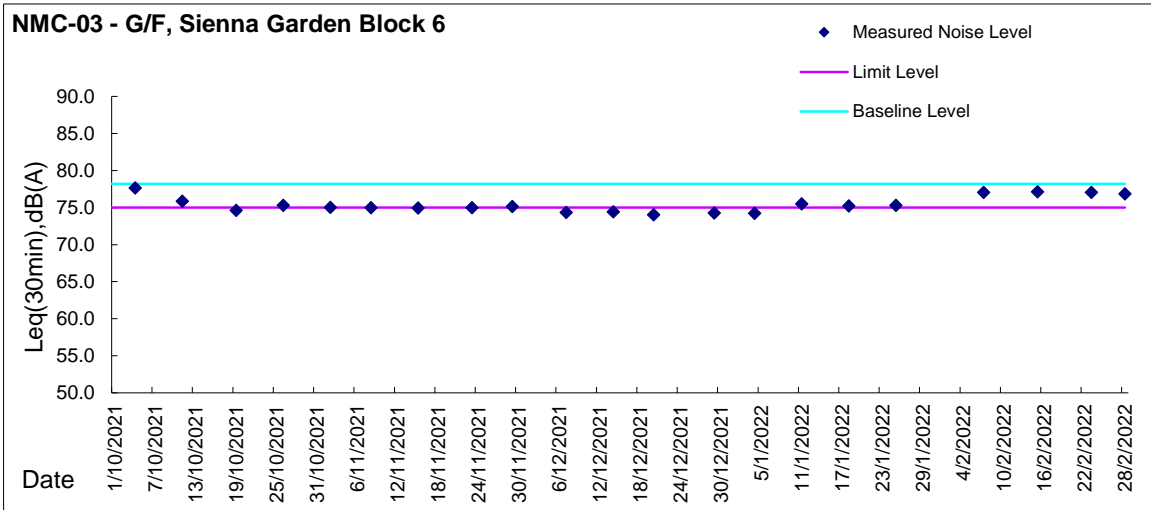
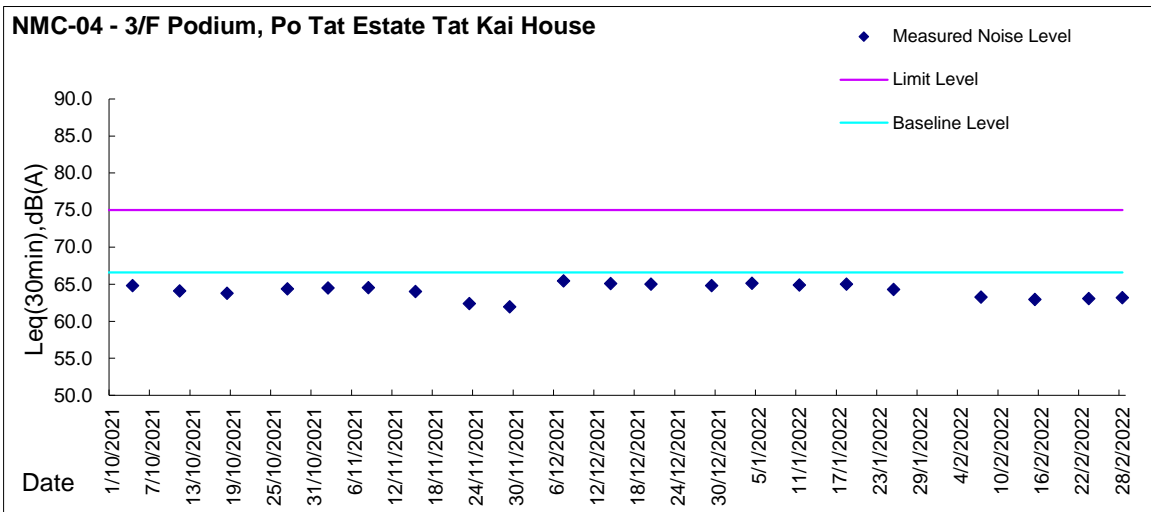
Graphic Presentation of Noise Monitoring Result
Day Time (0700 - 1900hrs on normal weekdays)

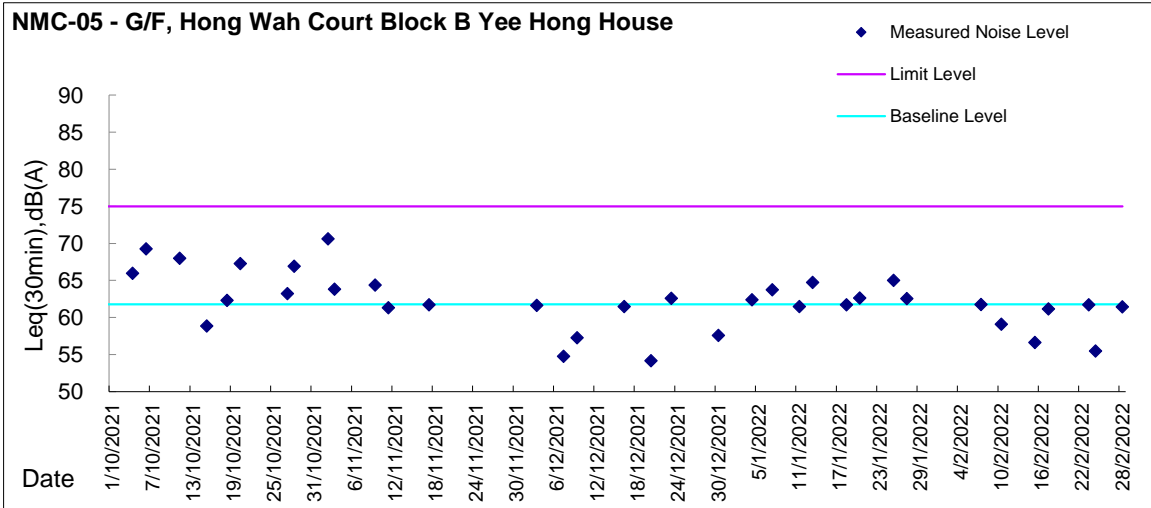
Graphic Presentation of Noise Monitoring Result

Day Time (0700 - 1900hrs on normal weekdays)

NMC-05 - G/F, Hong Wah Court Block B Yee Hong House
