**ENVIRONMENTAL TEAM FOR  
DEVELOPMENT OF  
ANDERSON ROAD QUARRY SITE -  
ROAD IMPROVEMENT WORKS**

**MONTHLY ENVIRONMENTAL MONITORING & AUDIT REPORT**

**FEBRUARY 2023**

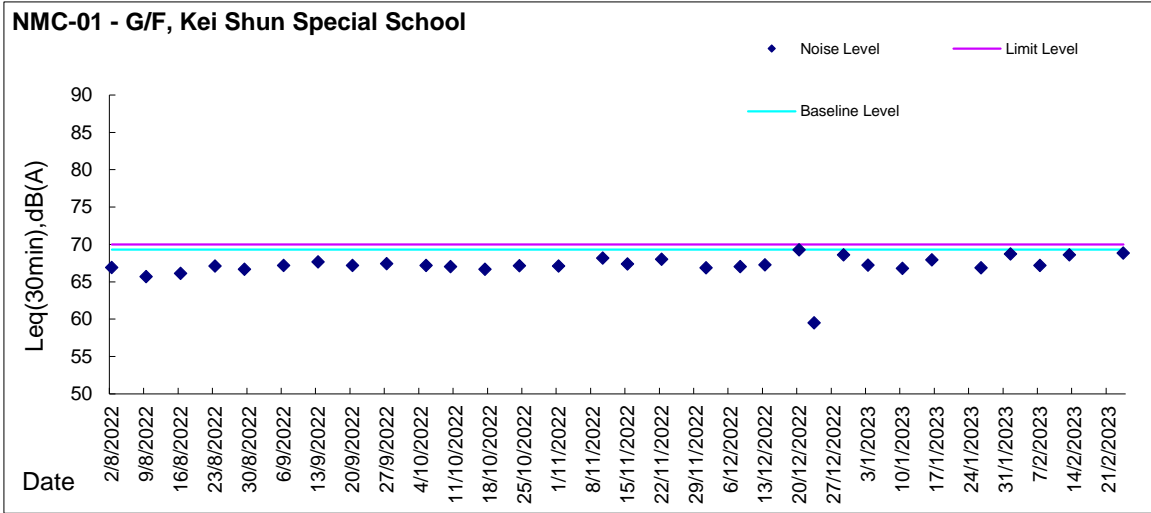
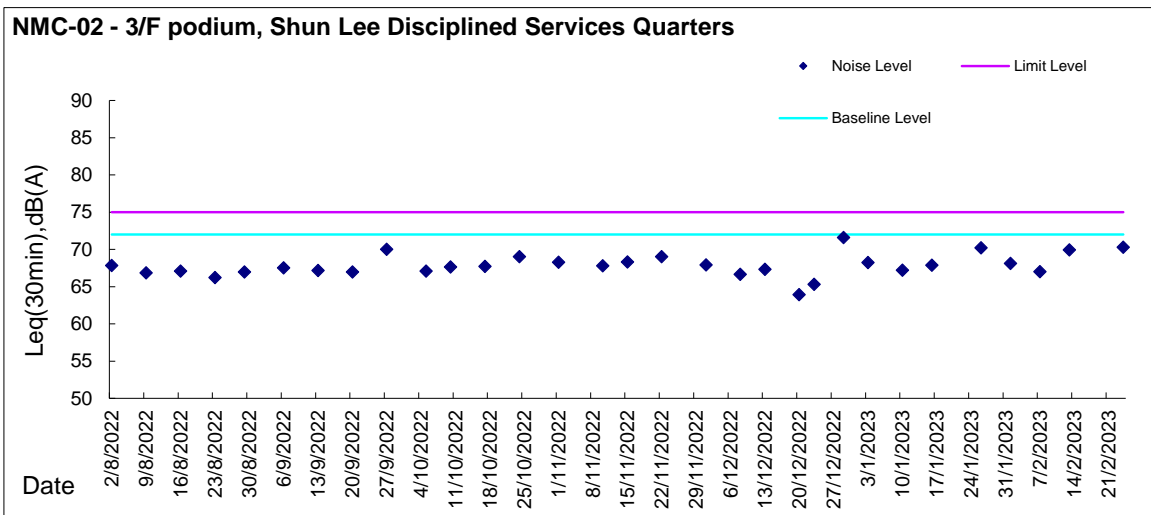
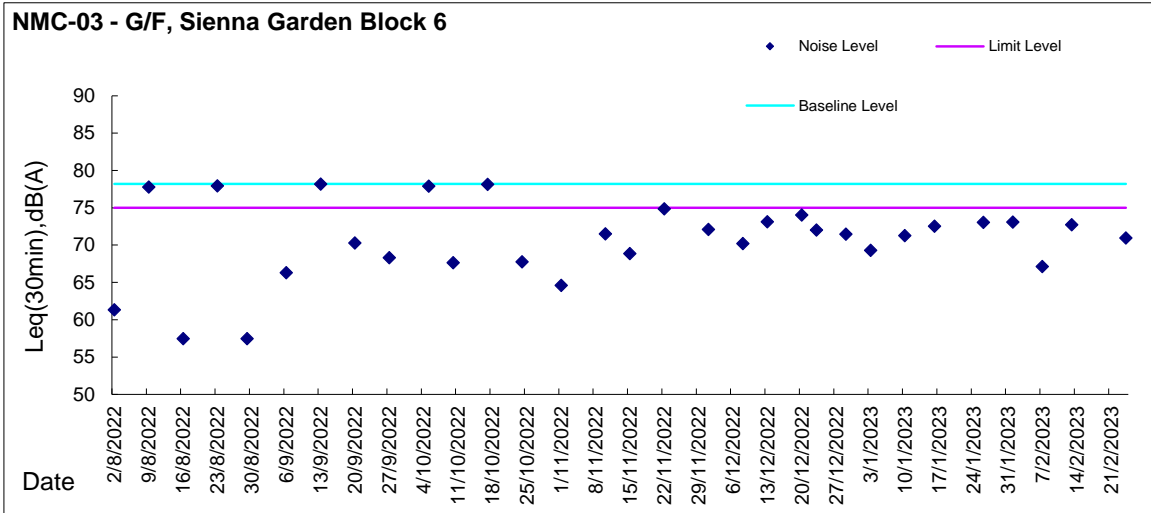
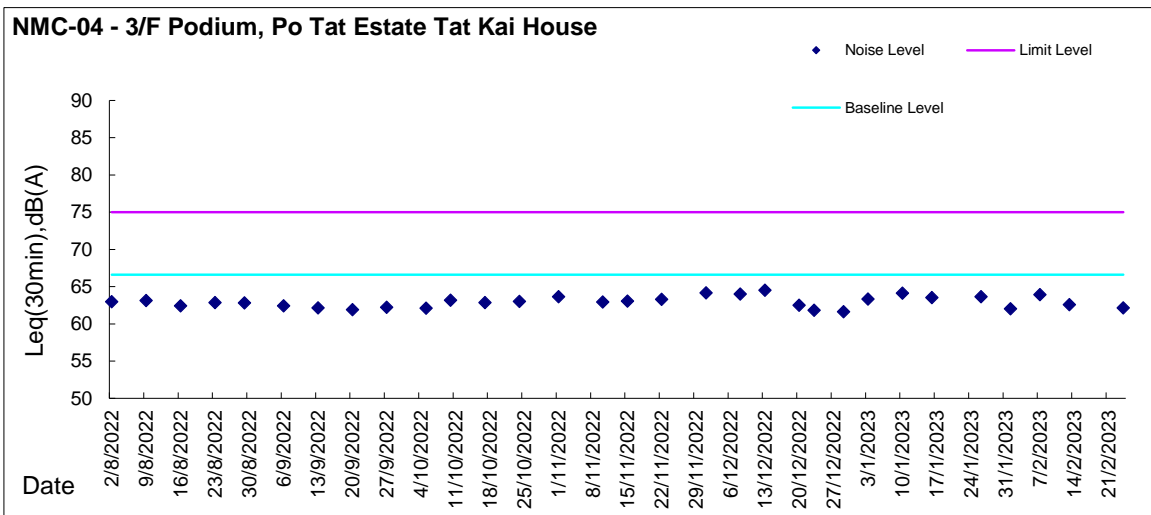
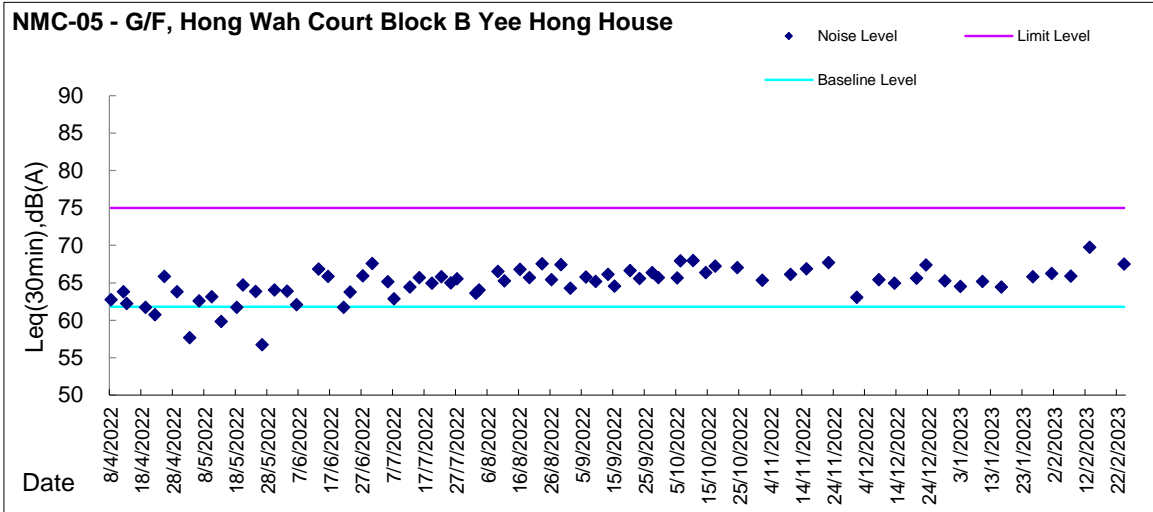
**Graphic Presentation of Noise Monitoring Result**  
**Day Time (0700 - 1900hrs on normal weekdays)**

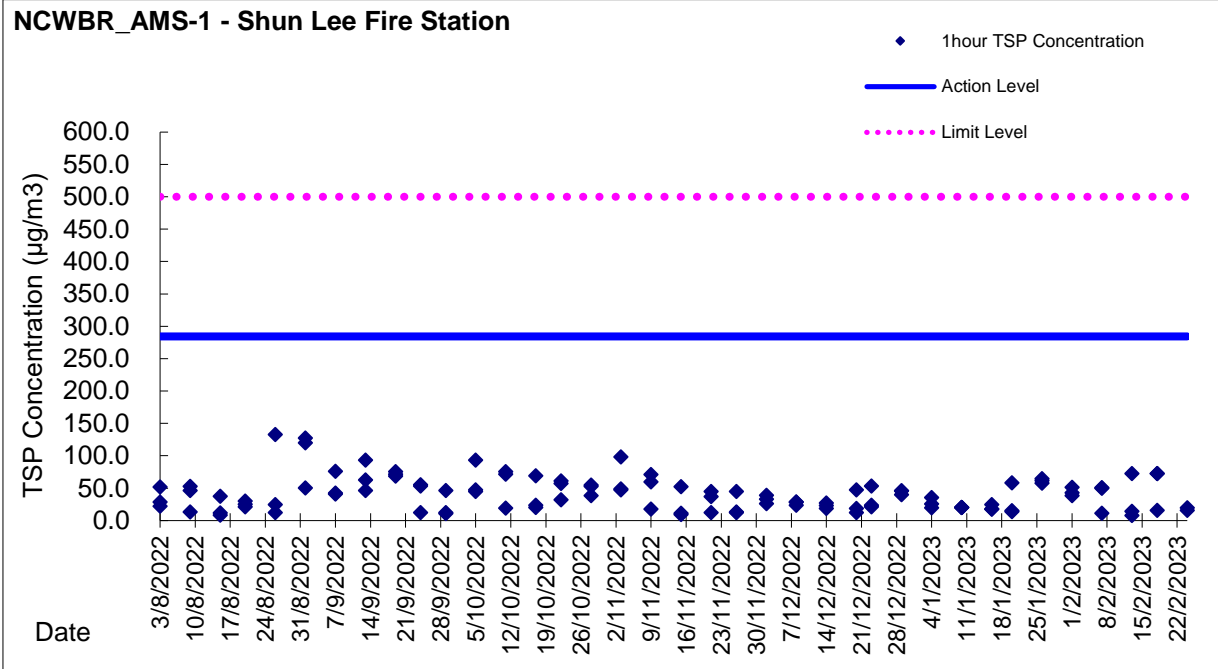
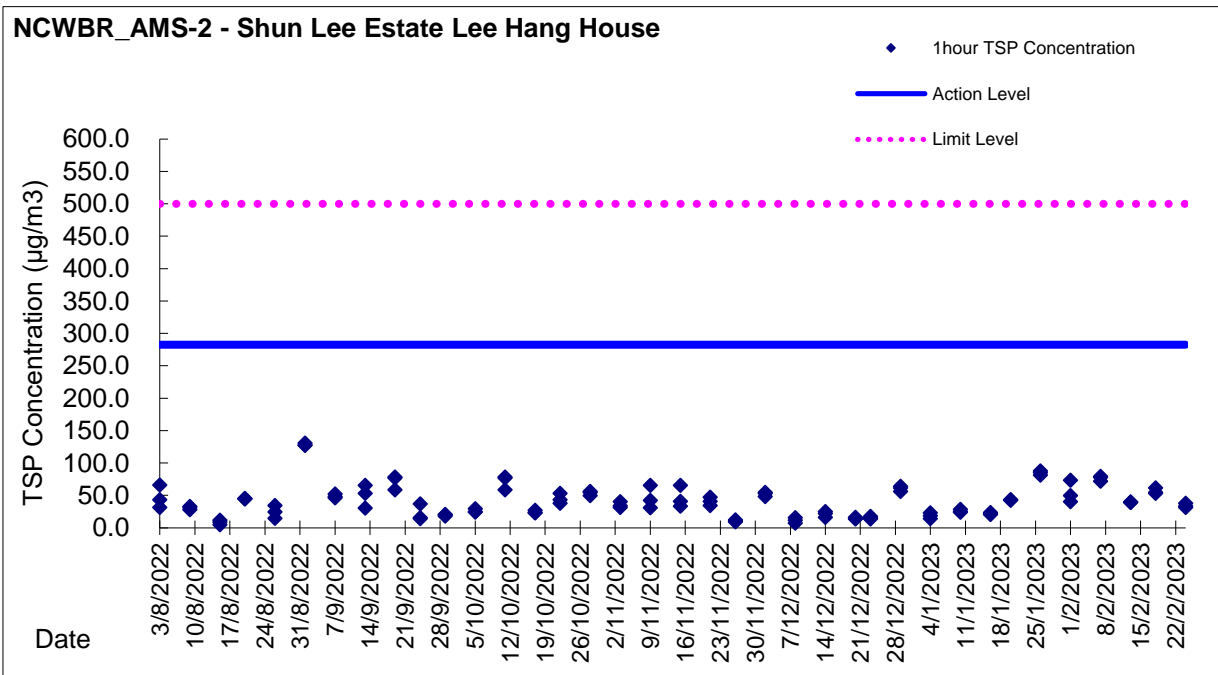
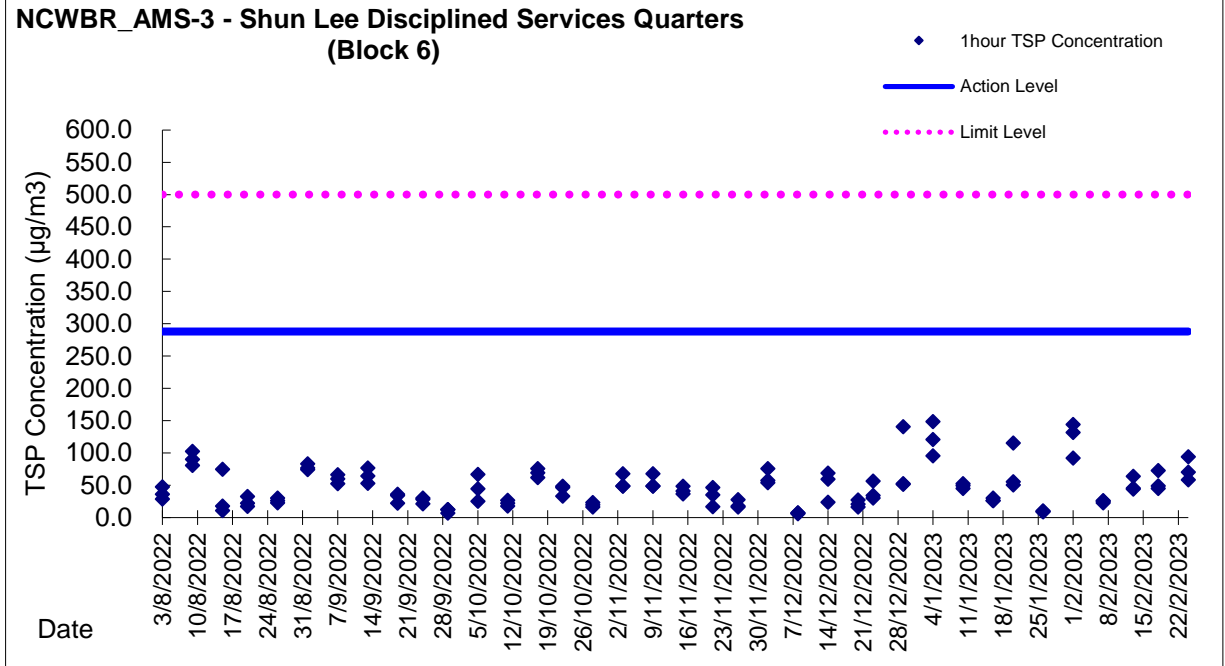
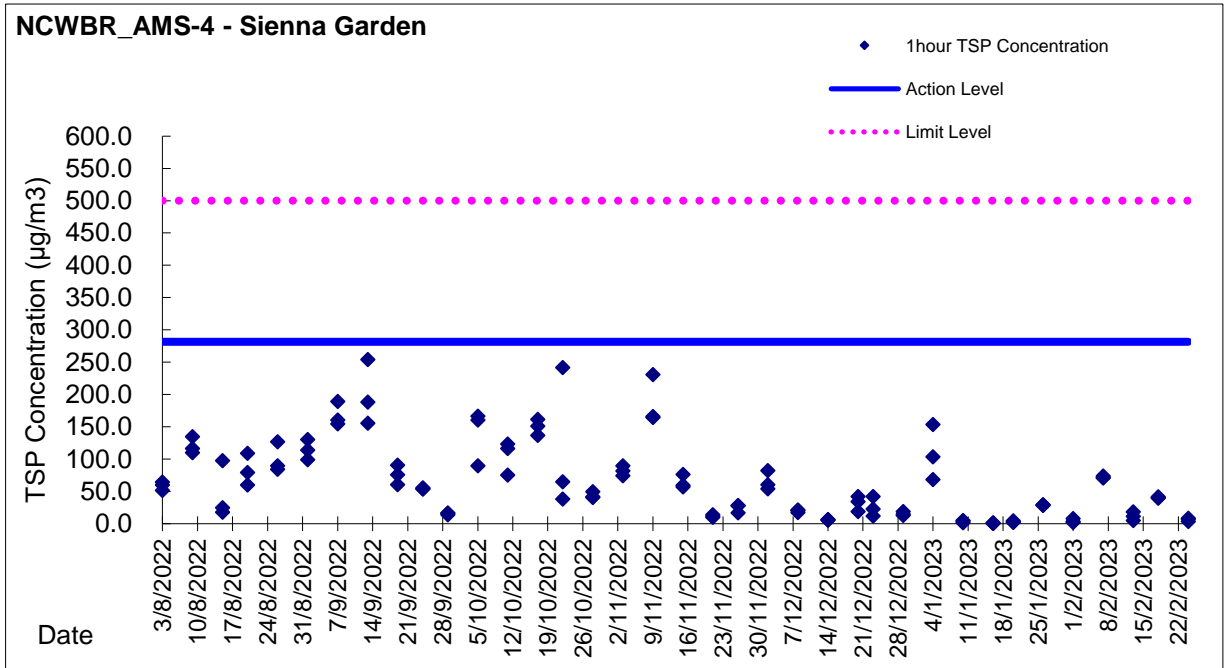
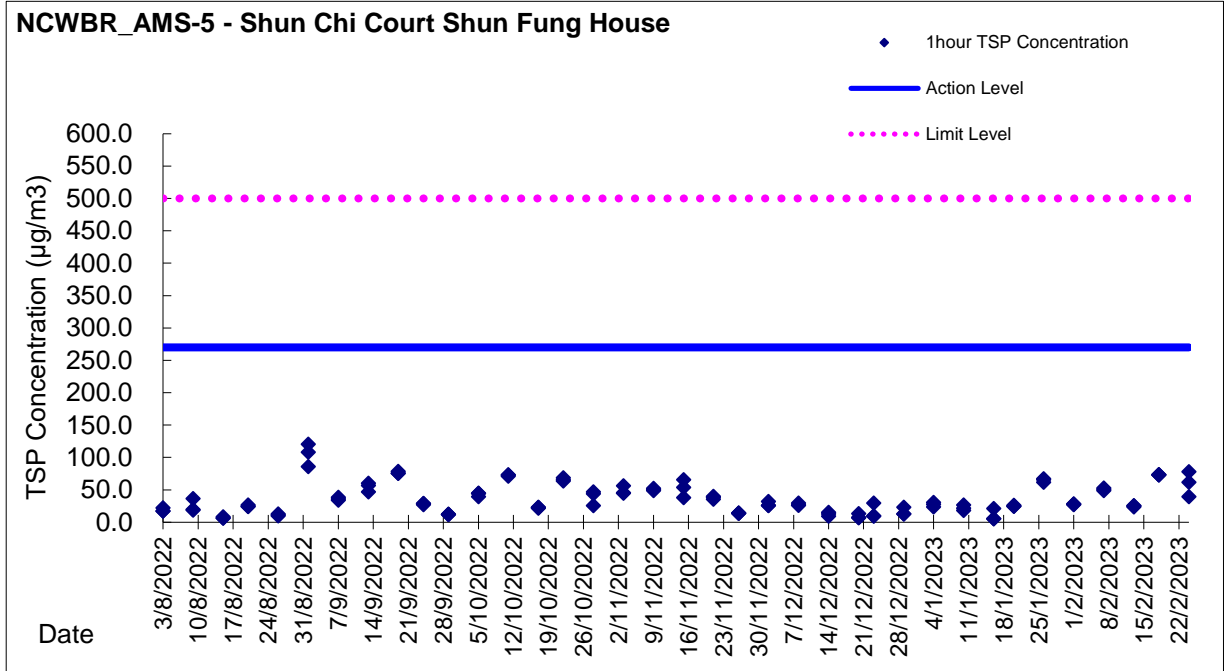
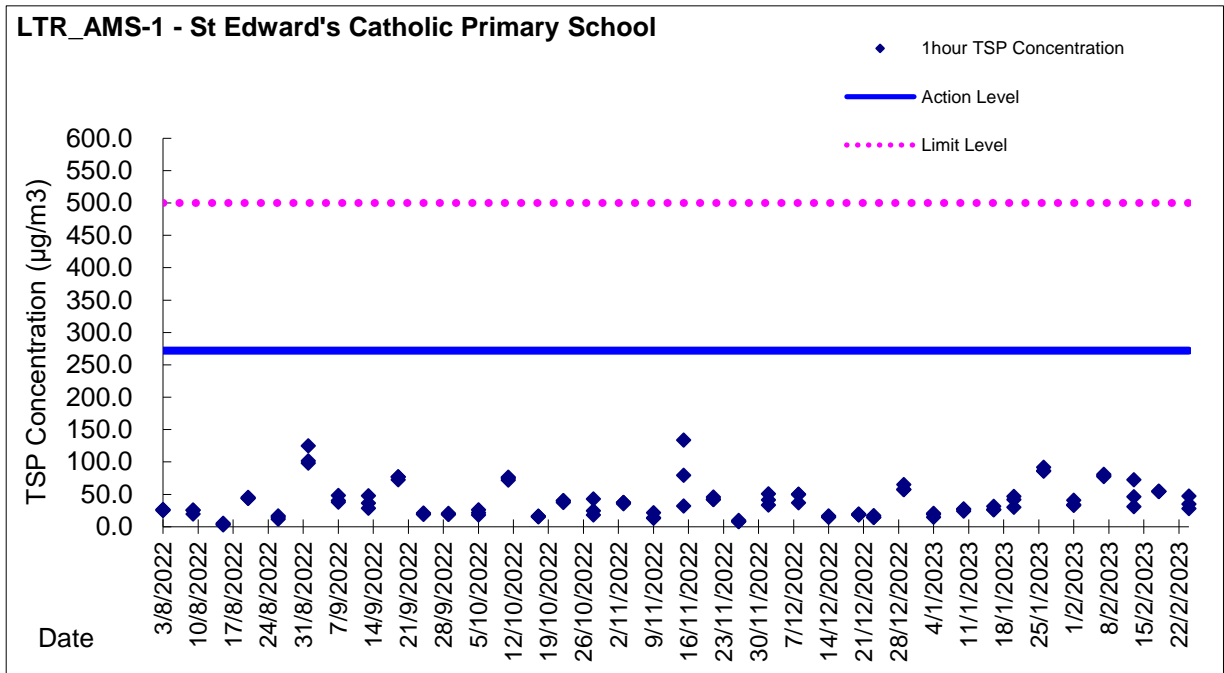
Graphic Presentation of TSP Result

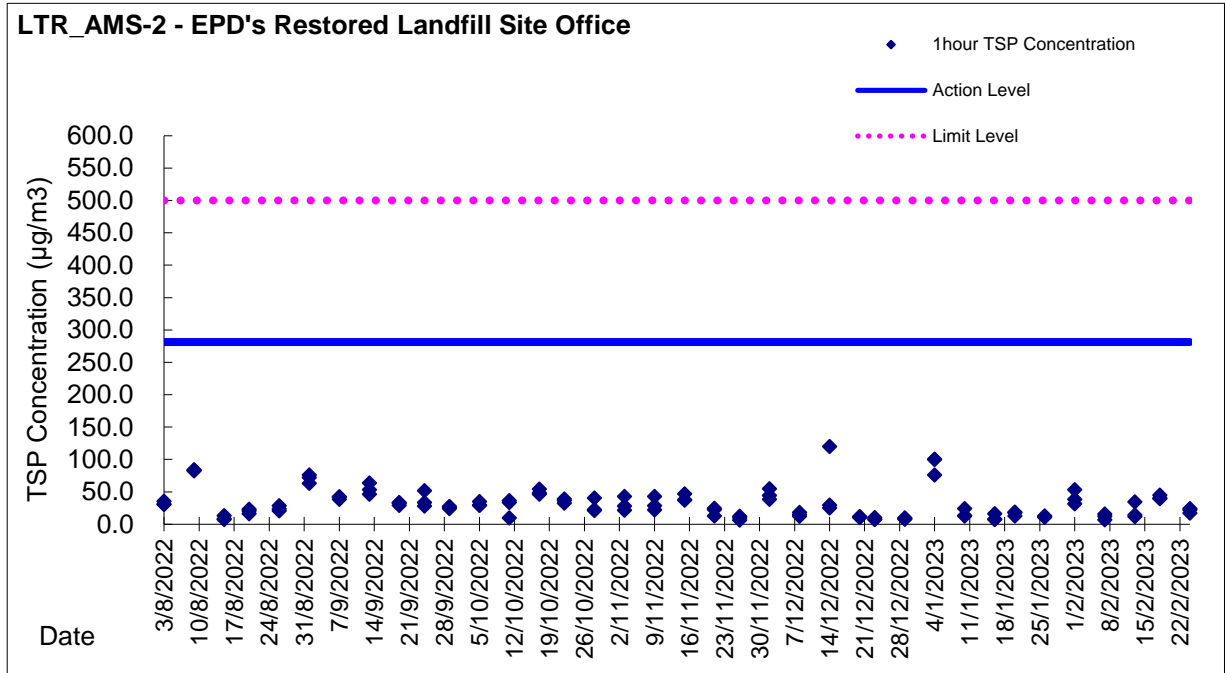
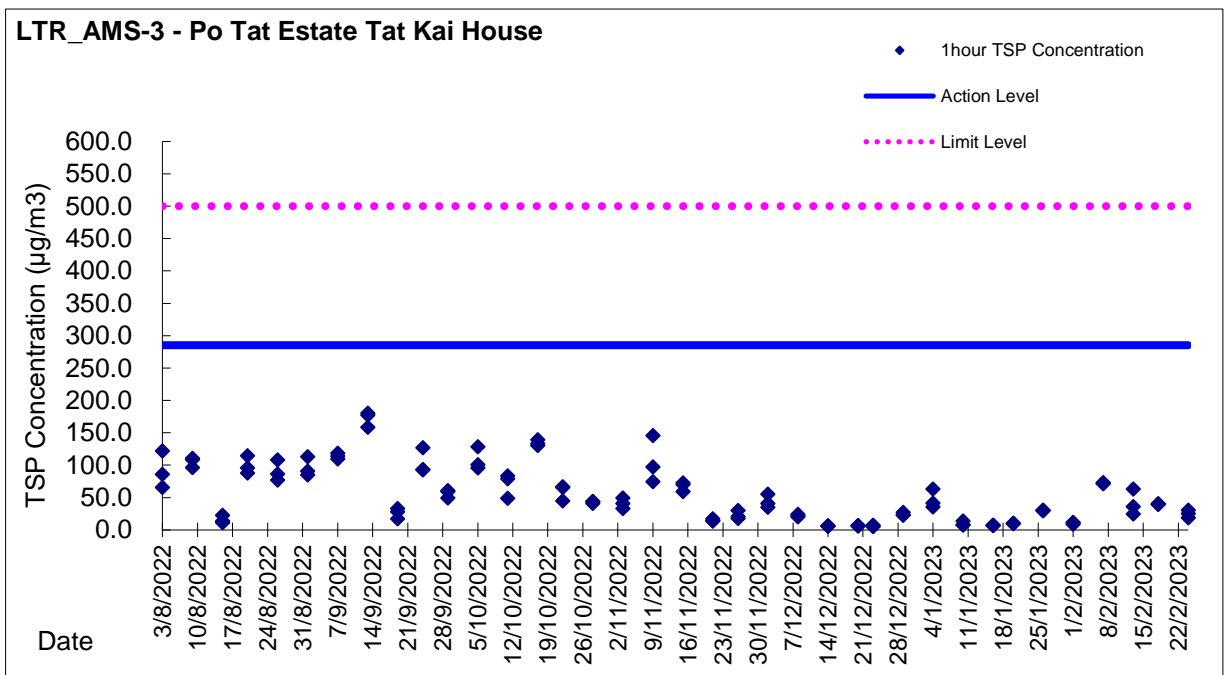
Graphic Presentation of TSP Result
