Service Contract No: EDO/01/2017
Environmental Team for
Development of Anderson Road Quarry Site
Road Improvement Works
Monthly EM&A Report (June 2020)

**ENVIRONMENTAL TEAM FOR
DEVELOPMENT OF
ANDERSON ROAD QUARRY SITE -
ROAD IMPROVEMENT WORKS**

MONTHLY ENVIRONMENTAL MONITORING & AUDIT REPORT

JUNE 2020

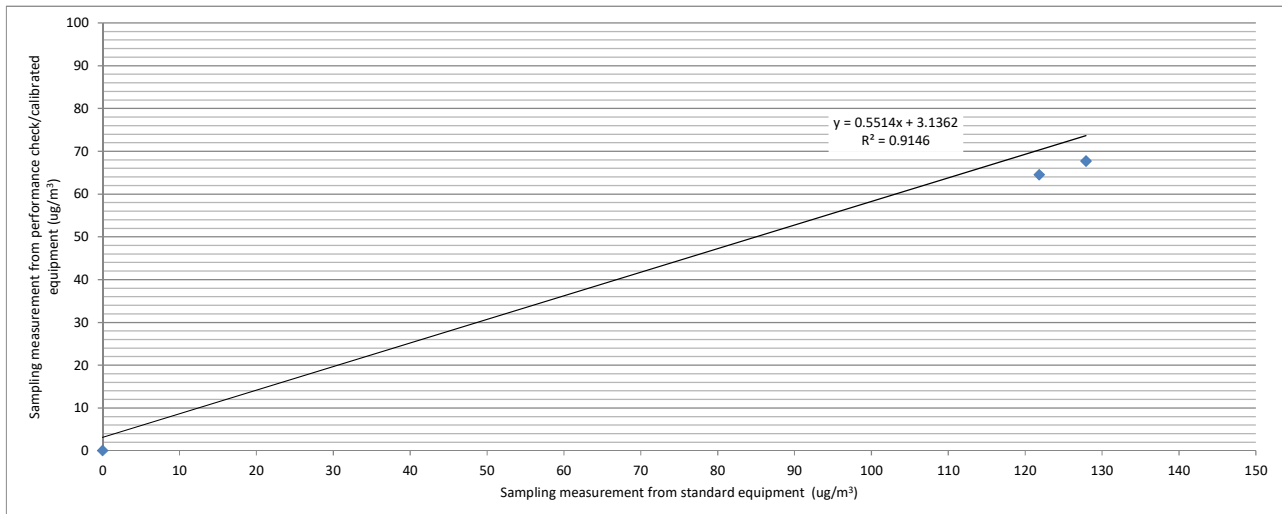
Linear Regression of Y on X

Slope (K- factor) : 1.7000
Correlation Coefficient : 0.9563
Validity of Performance Check / Calibration Record : 5/11/2020

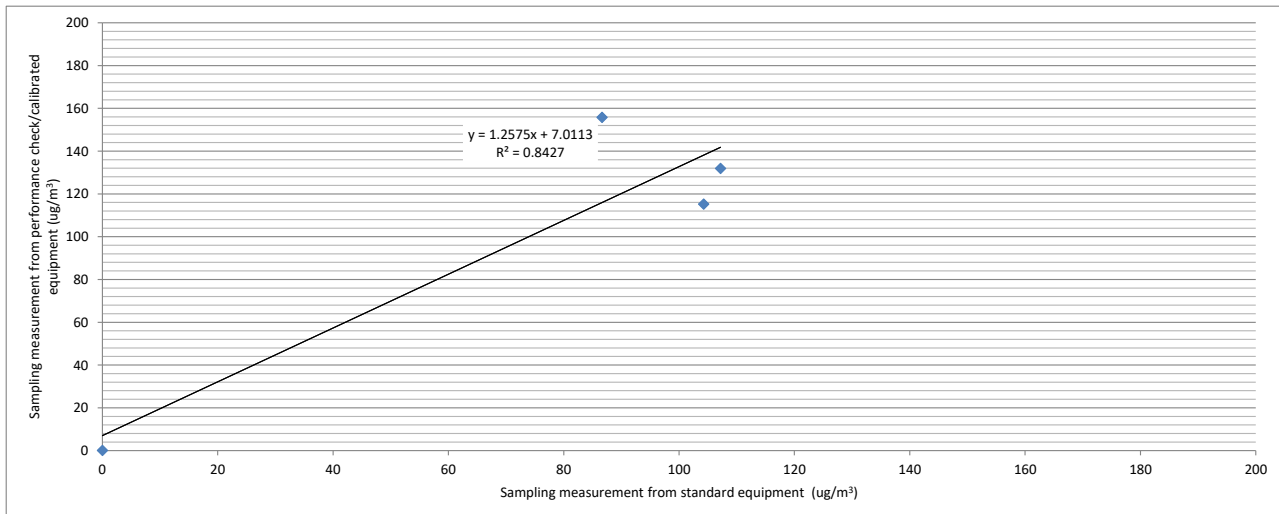
Linear Regression of Y on X

Slope (K- factor) : 0.7000
Correlation Coefficient : 0.9180
Validity of Performance Check / Calibration Record : 2/1/2021

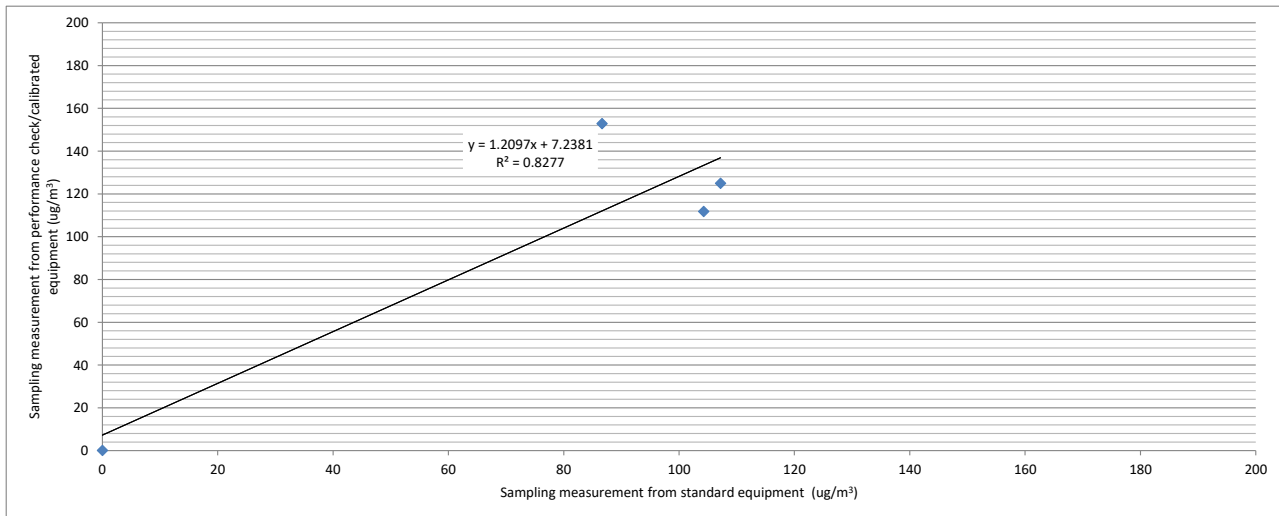
Linear Regression of Y on X

Slope (K- factor) : 0.7000
Correlation Coefficient : 0.9098
Validity of Performance Check / Calibration Record : 2/1/2021

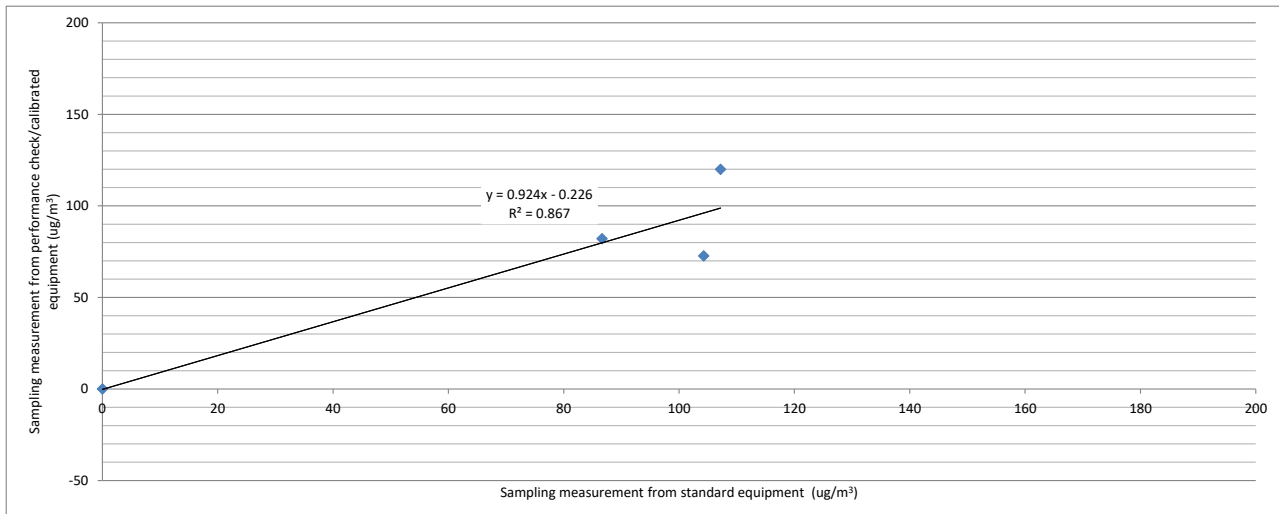
Linear Regression of Y on X

Slope (K- factor) : 1.0000
 Correlation Coefficient : 0.9311
 Validity of Performance Check / Calibration Record : 2/1/2021

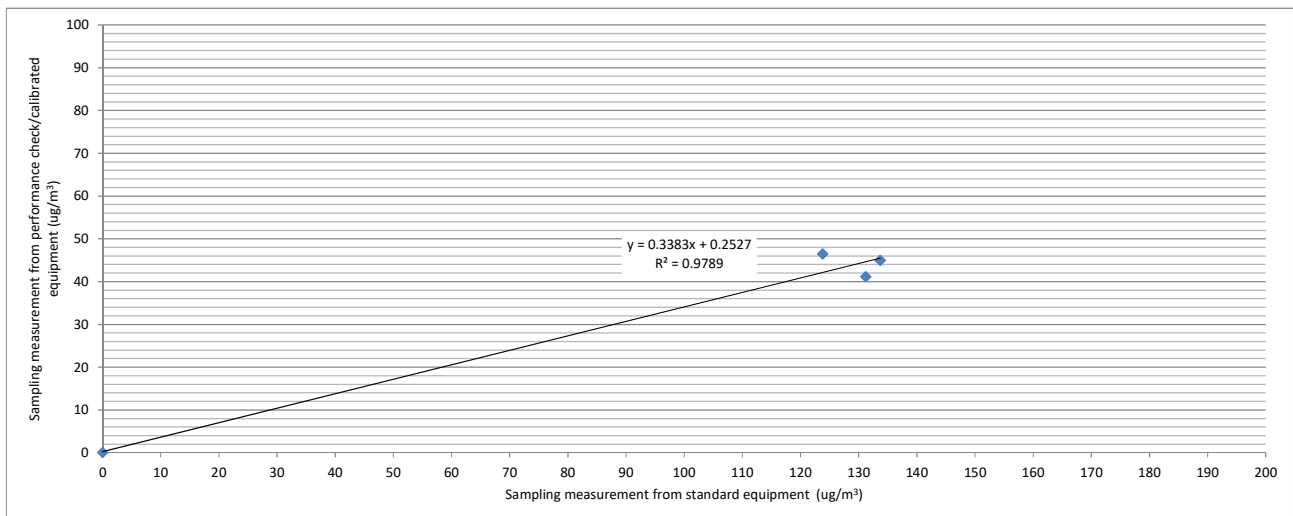
Linear Regression of Y on X

Slope (K- factor) : 2.9000
 Correlation Coefficient : 0.9894
 Validity of Performance Check / Calibration Record : 6/12/2020

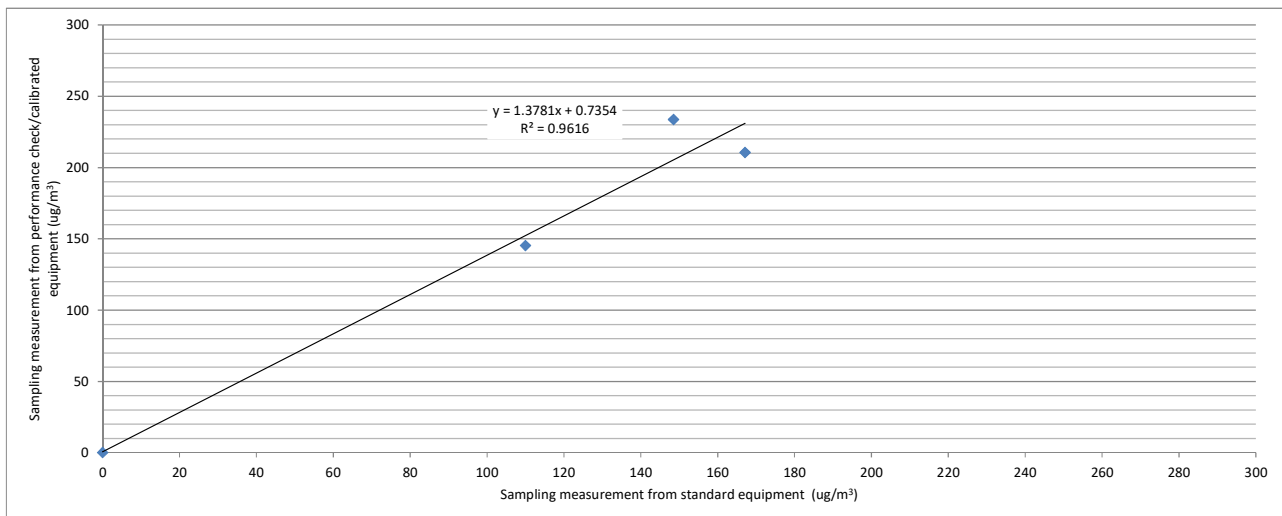
Linear Regression of Y on X

Slope (K- factor) : 0.7000
 Correlation Coefficient : 0.9806
 Validity of Performance Check / Calibration Record : 29/9/2020

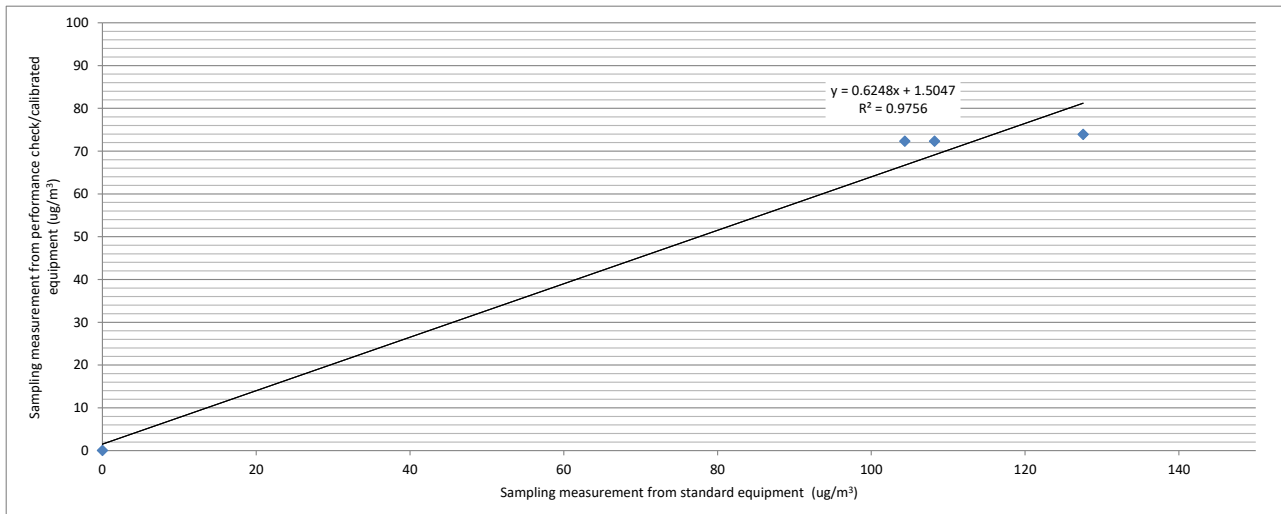
Linear Regression of Y on X

Slope (K- factor) : 1.6000
 Correlation Coefficient : 0.9877
 Validity of Performance Check / Calibration Record : 17/3/2021

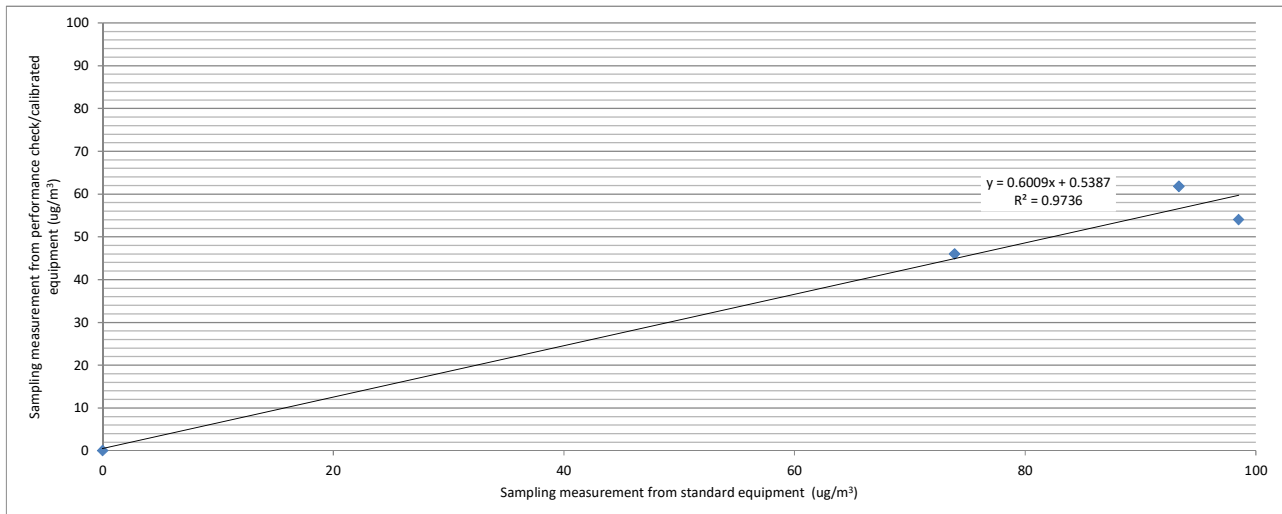
Correlation Coefficient : 0.9867

Validity of Performance Check / Calibration Record : 27/4/2021

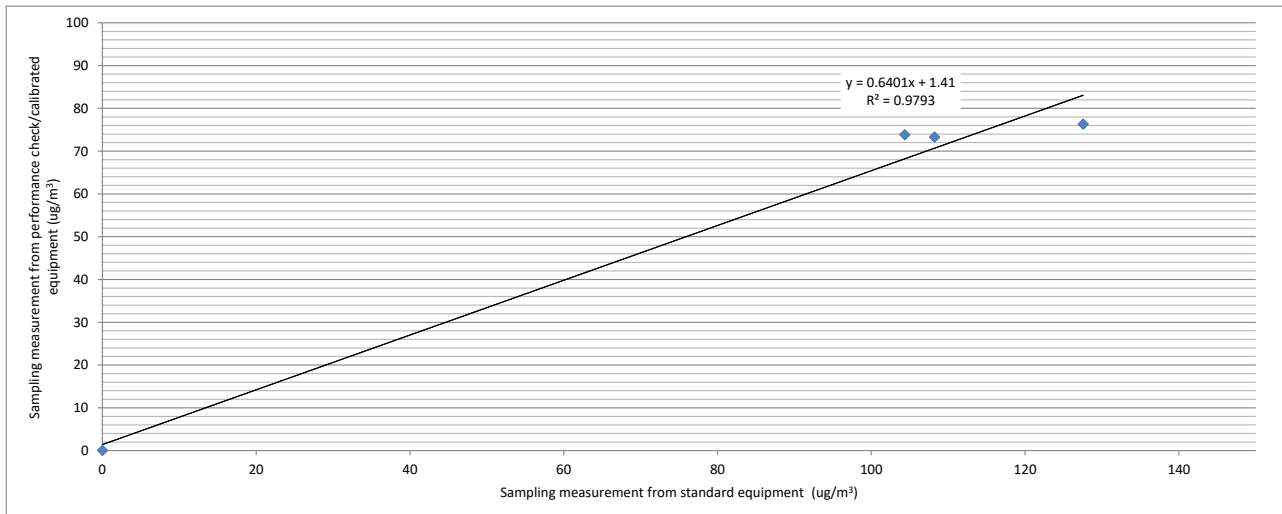
Linear Regression of Y on X

Slope (K- factor) : 1.6000
Correlation Coefficient : 0.9896
Validity of Performance Check / Calibration Record : 17/3/2021

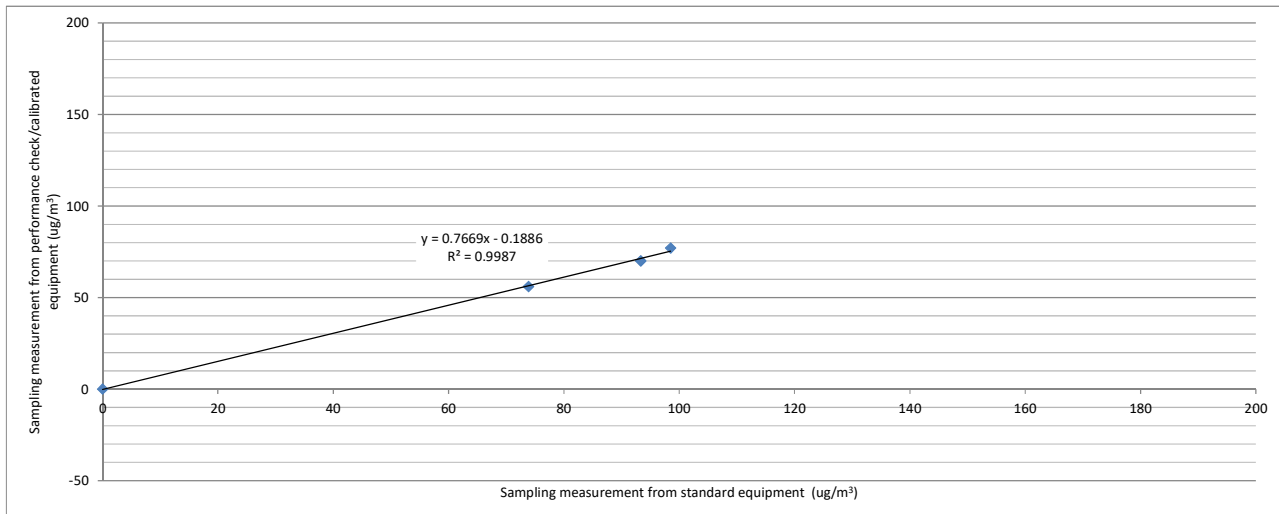
Linear Regression of Y on X

Slope (K- factor) : 1.4000
Correlation Coefficient : 0.9993
Validity of Performance Check / Calibration Record : 2/5/2021

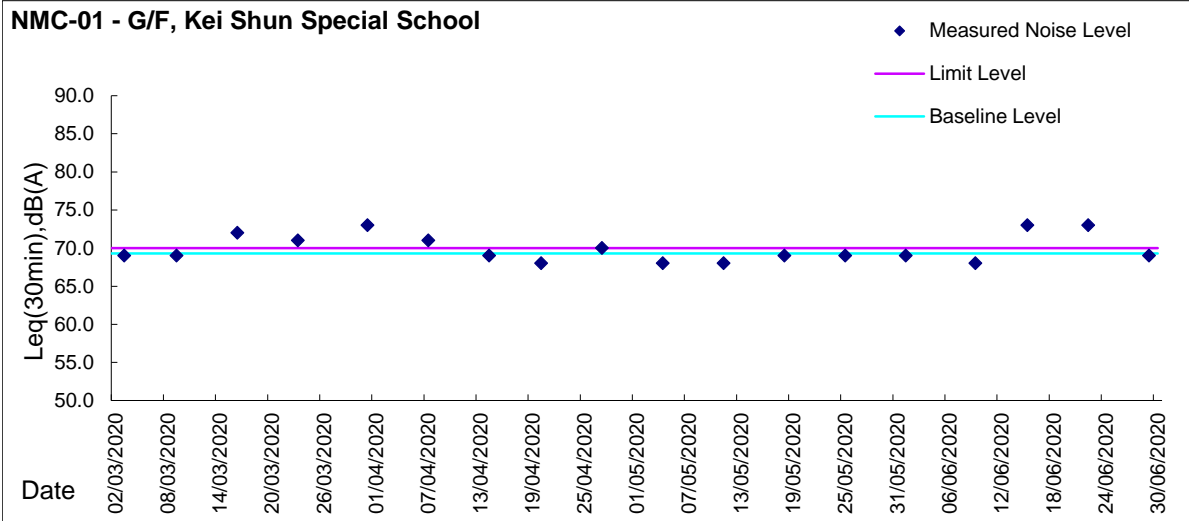
NMC-01 - G/F, Kei Shun Special School

Day Time (0700 - 1900hrs on normal weekdays)
