**SERVICE CONTRACT NO: EDO/01/2017**

**ENVIRONMENTAL TEAM FOR  
DEVELOPMENT OF  
ANDERSON ROAD QUARRY SITE -  
ROAD IMPROVEMENT WORKS**

**MONTHLY ENVIRONMENTAL MONITORING & AUDIT REPORT**

**JULY 2022**

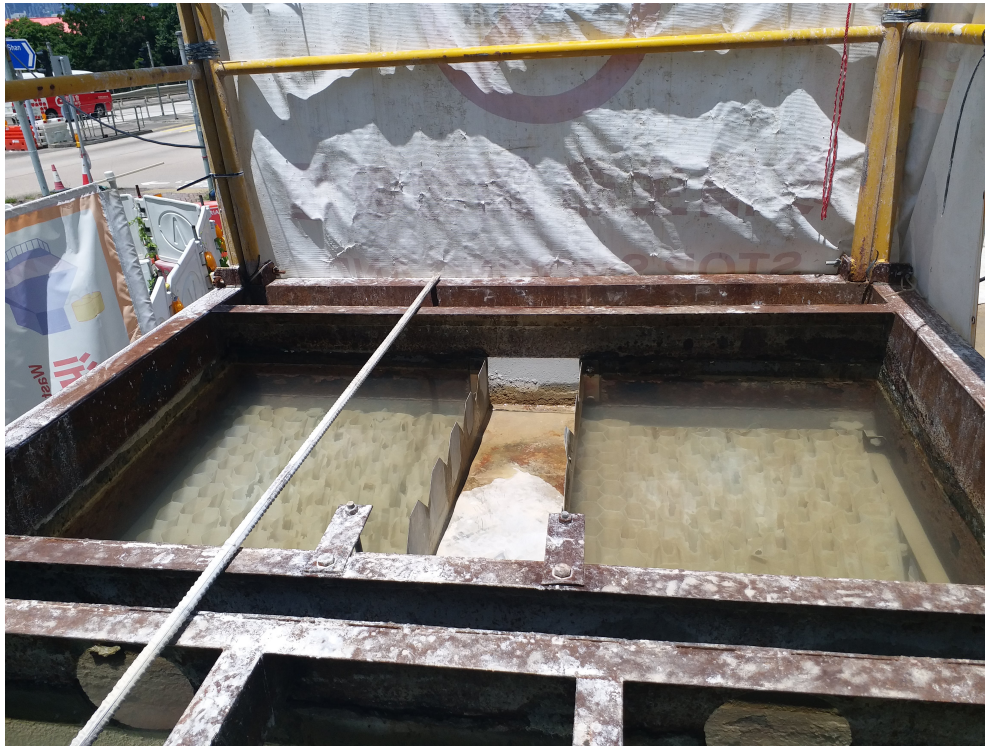
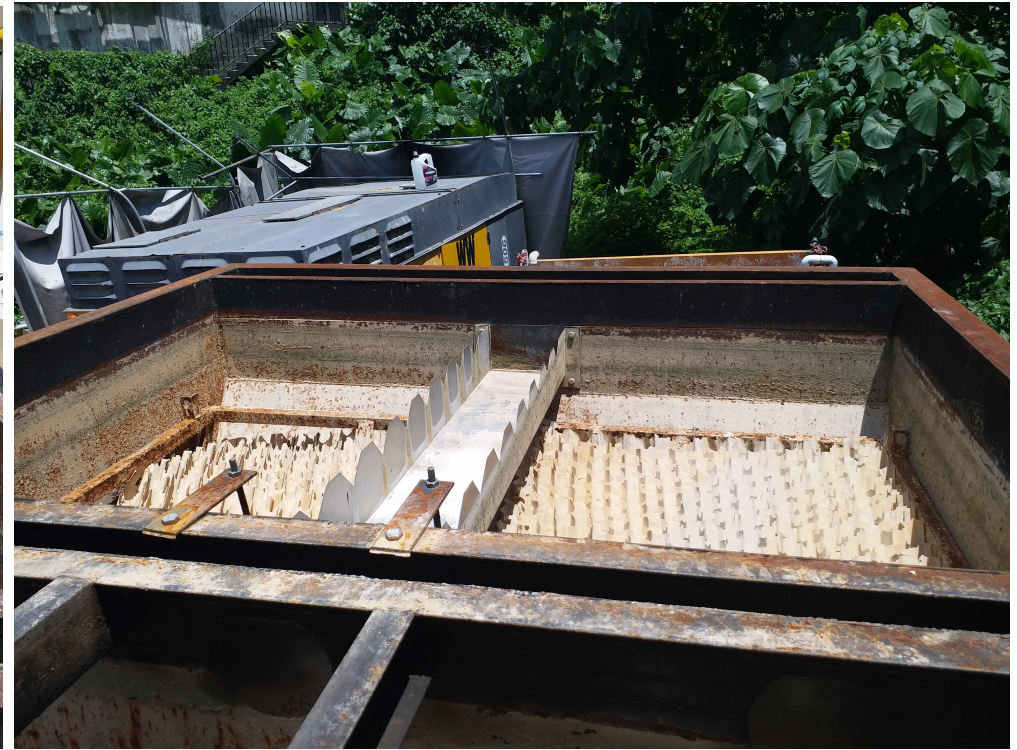
**The condition of the RIW2 wastewater treatment facilities near Monitoring Station F on 11 July 2022, 11:30am**
