Service Contract No: EDO/01/2017
Environmental Team for
Development of Anderson Road Quarry Site
Road Improvement Works
Monthly EM&A Report (November 2018)

**ENVIRONMENTAL TEAM FOR
DEVELOPMENT OF
ANDERSON ROAD QUARRY SITE -
ROAD IMPROVEMENT WORKS**

UNDER ENVIRONMENTAL PERMIT NO. EP-513/2016

MONTHLY ENVIRONMENTAL MONITORING & AUDIT REPORT

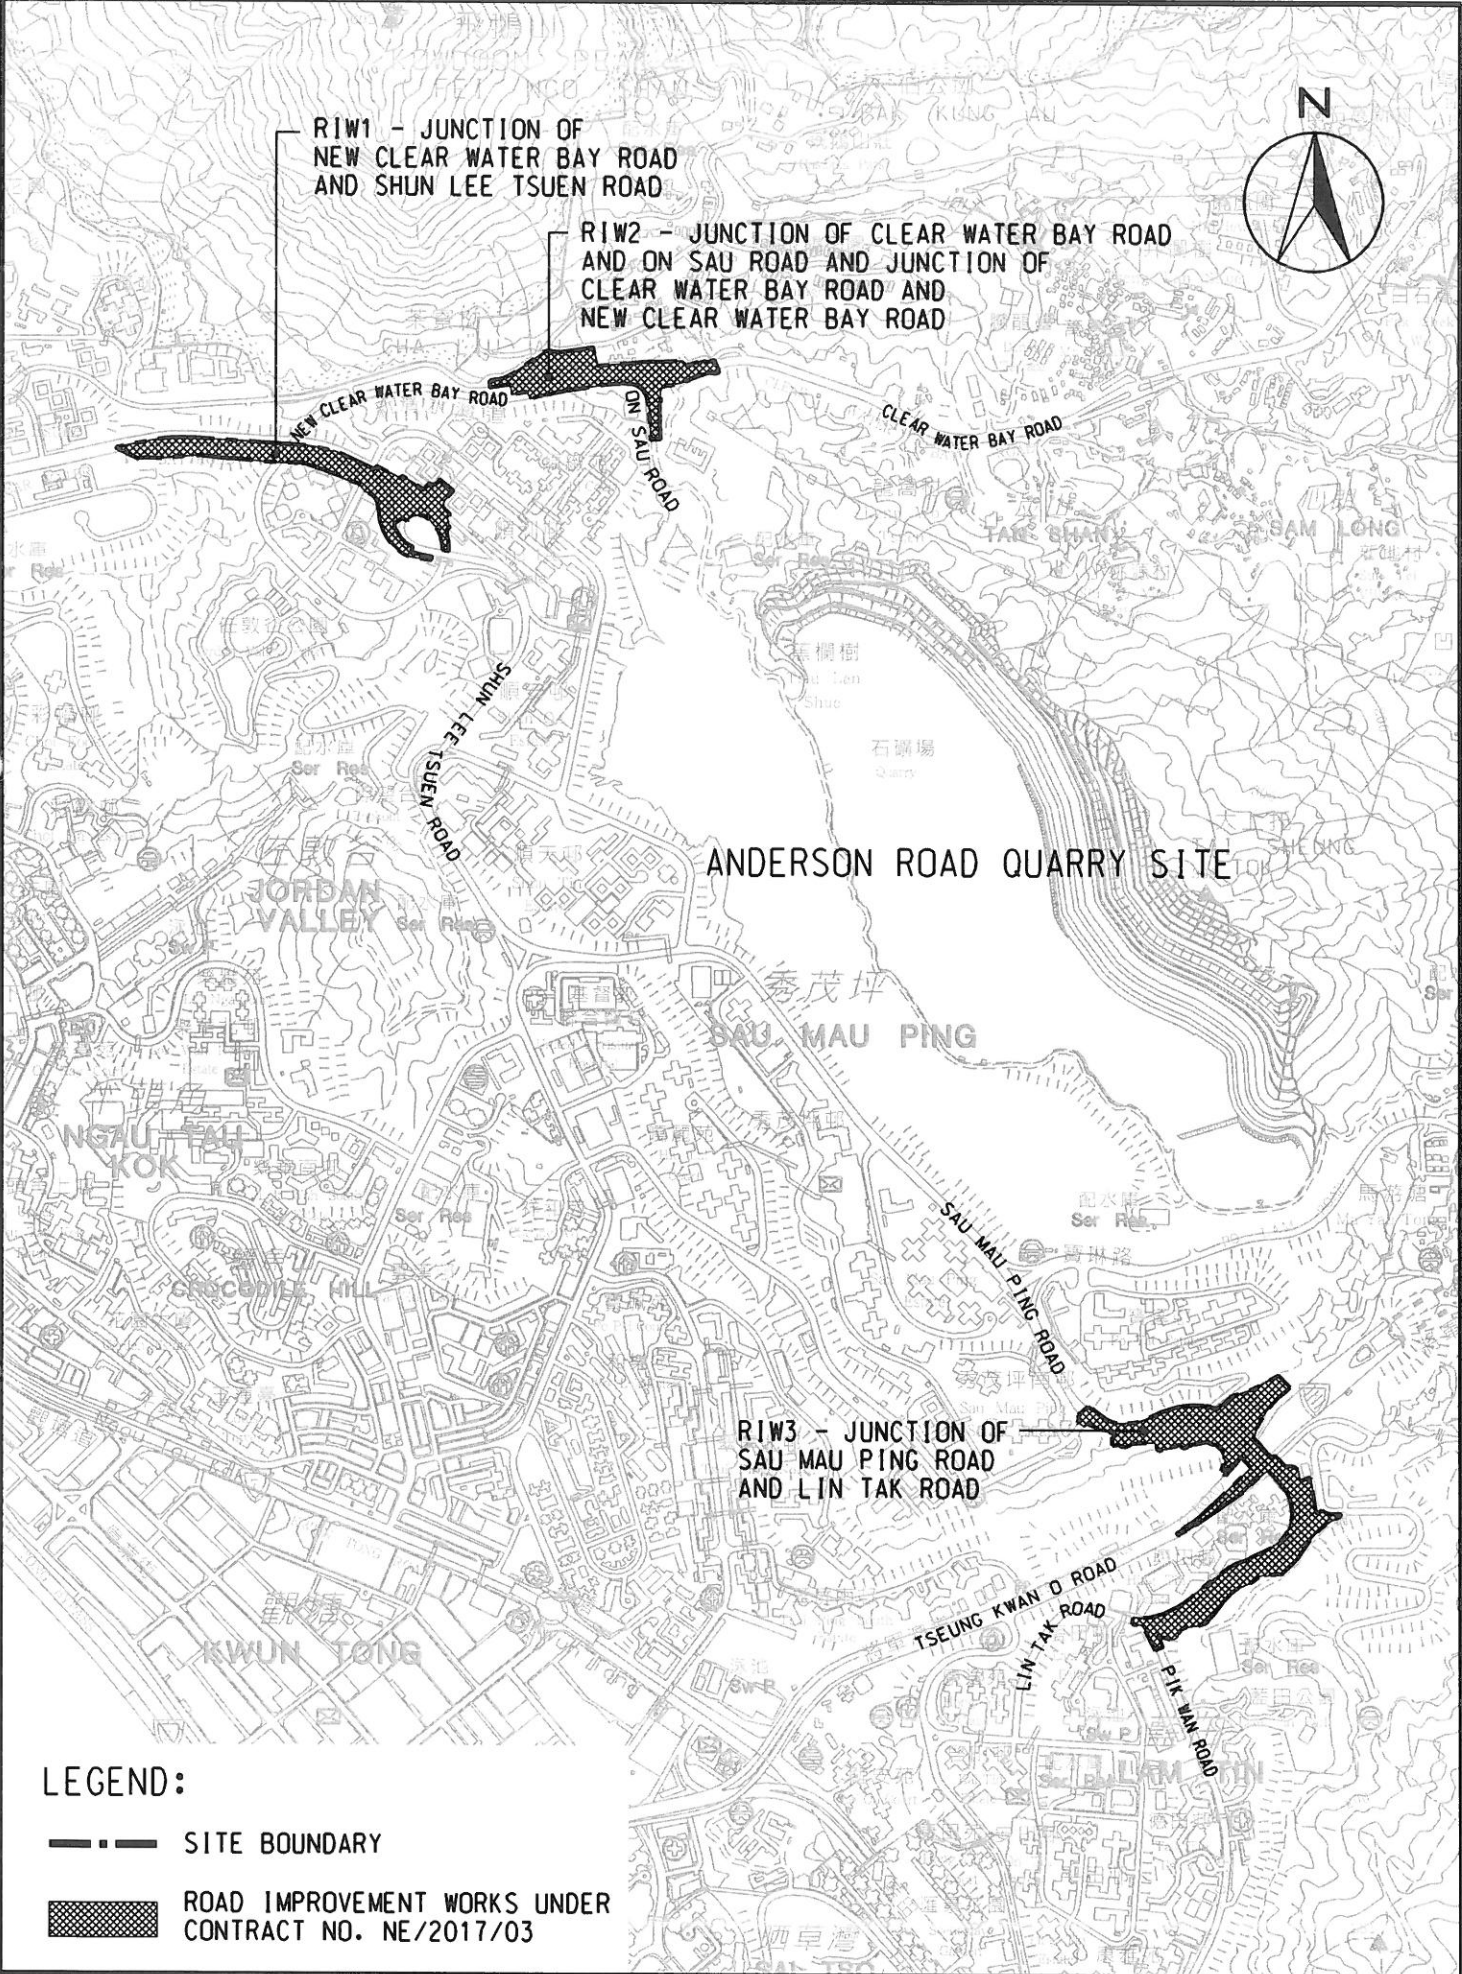
Figure 2.1

Project Layout

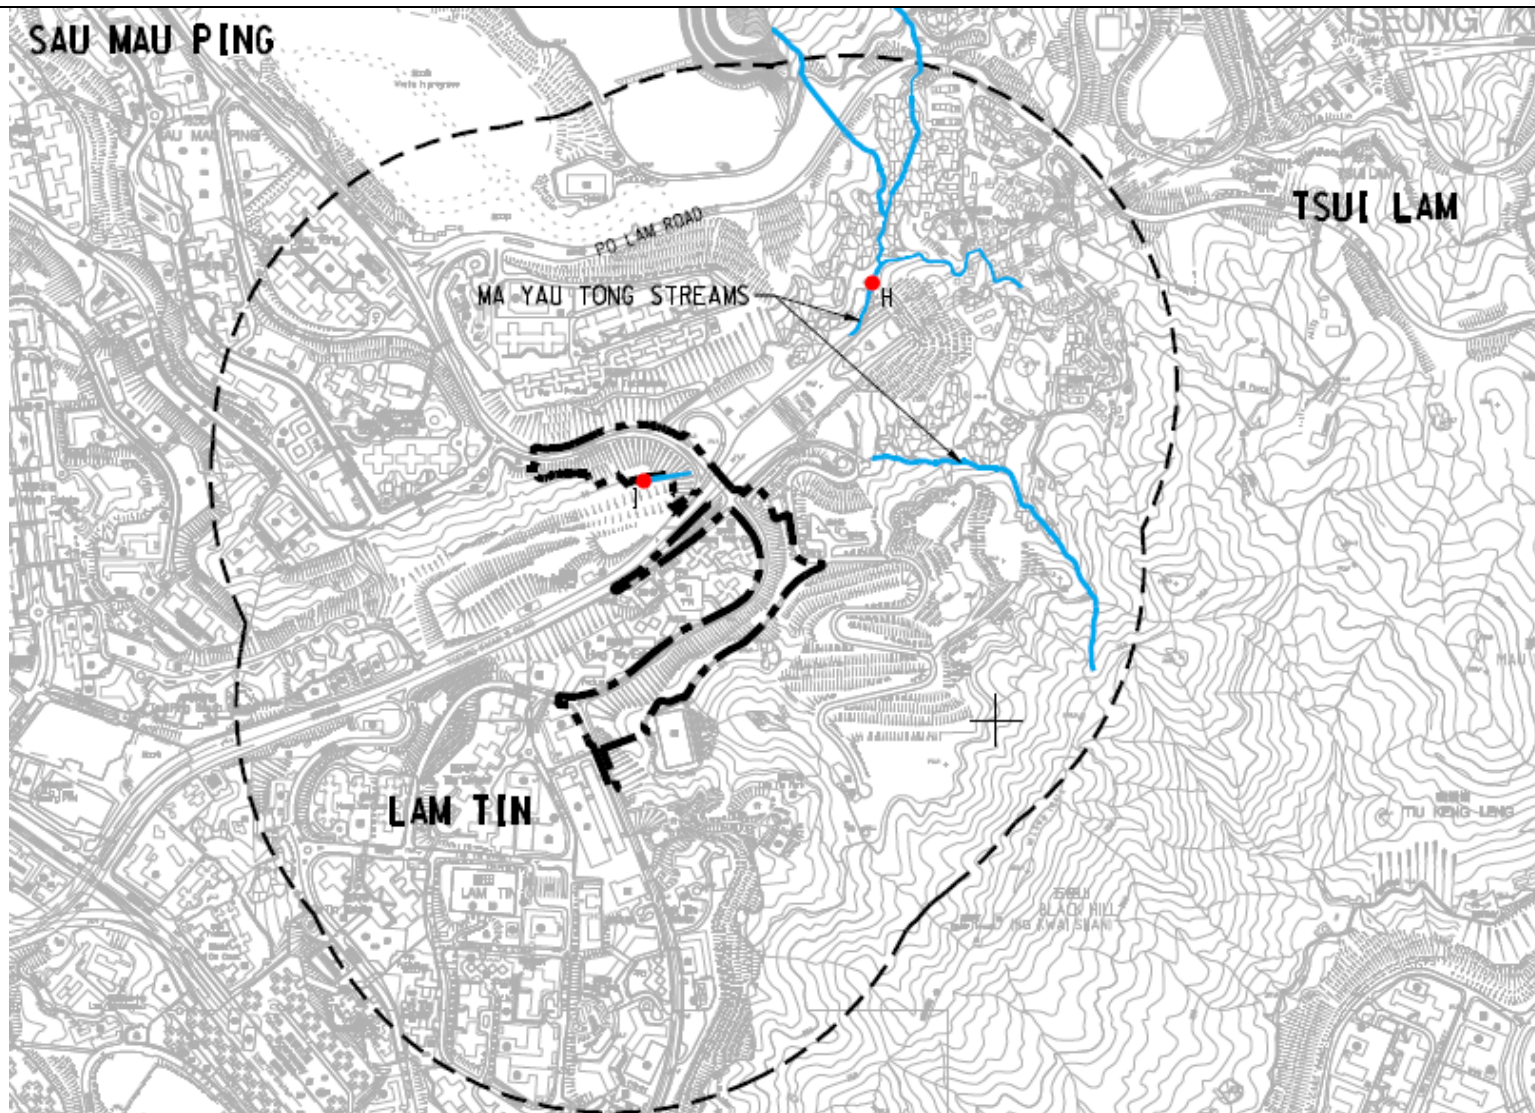
Figure 4.1 to Figure 4.6

Locations of Monitoring Stations

| Inland Water | Stations | Description |
| Ma Yau Tong Stream | H | Upstream Control Station |
| | I | Downstream Impact Station |

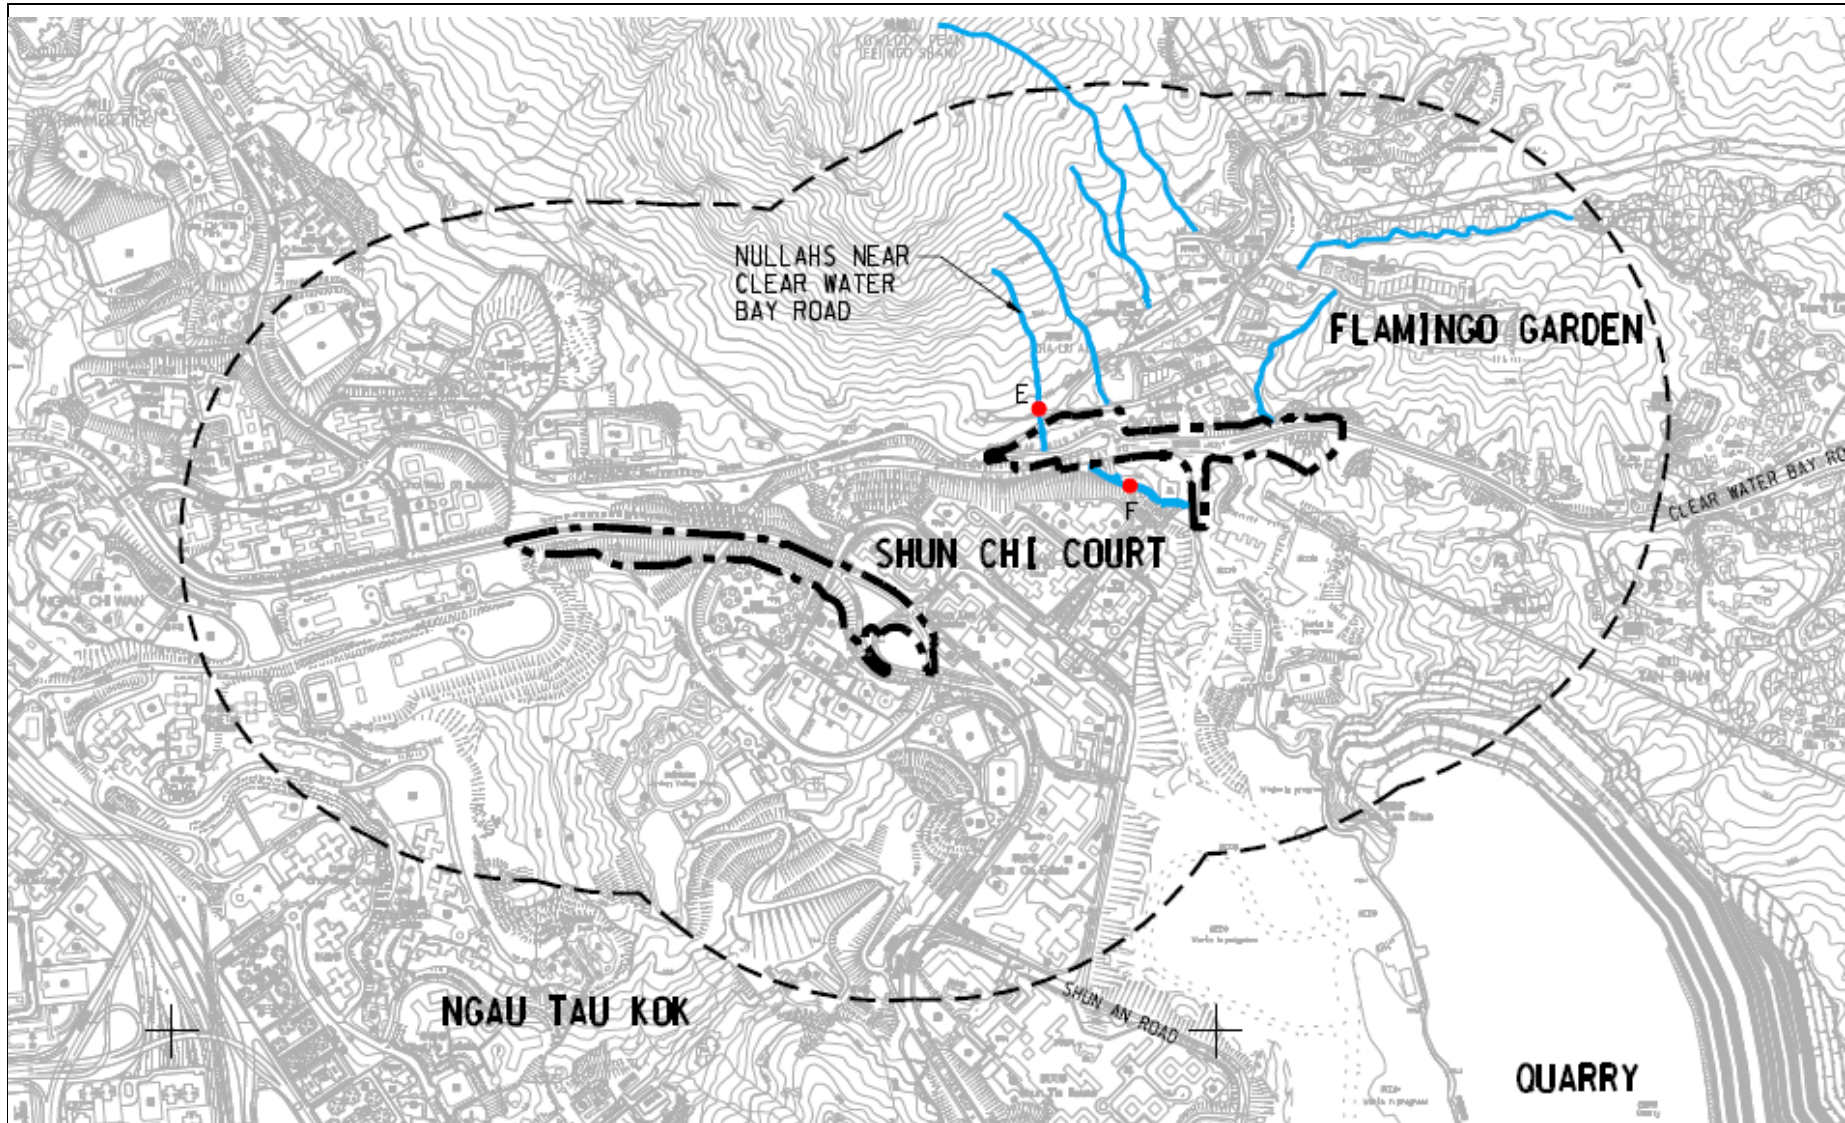
Figure 4.6
Location of Water Quality Monitoring Station
(for Road Improvement Work 3)

| Inland Water | Stations | Description |
| Channelized nullah across the Project site | E | Upstream Control Station |
| | F | Downstream Impact Station |

It is recommended that upstream monitoring station (monitoring station E and H) would be taken as control reference for exceedance investigation only. Action and limit level would not be establish using the baseline data.

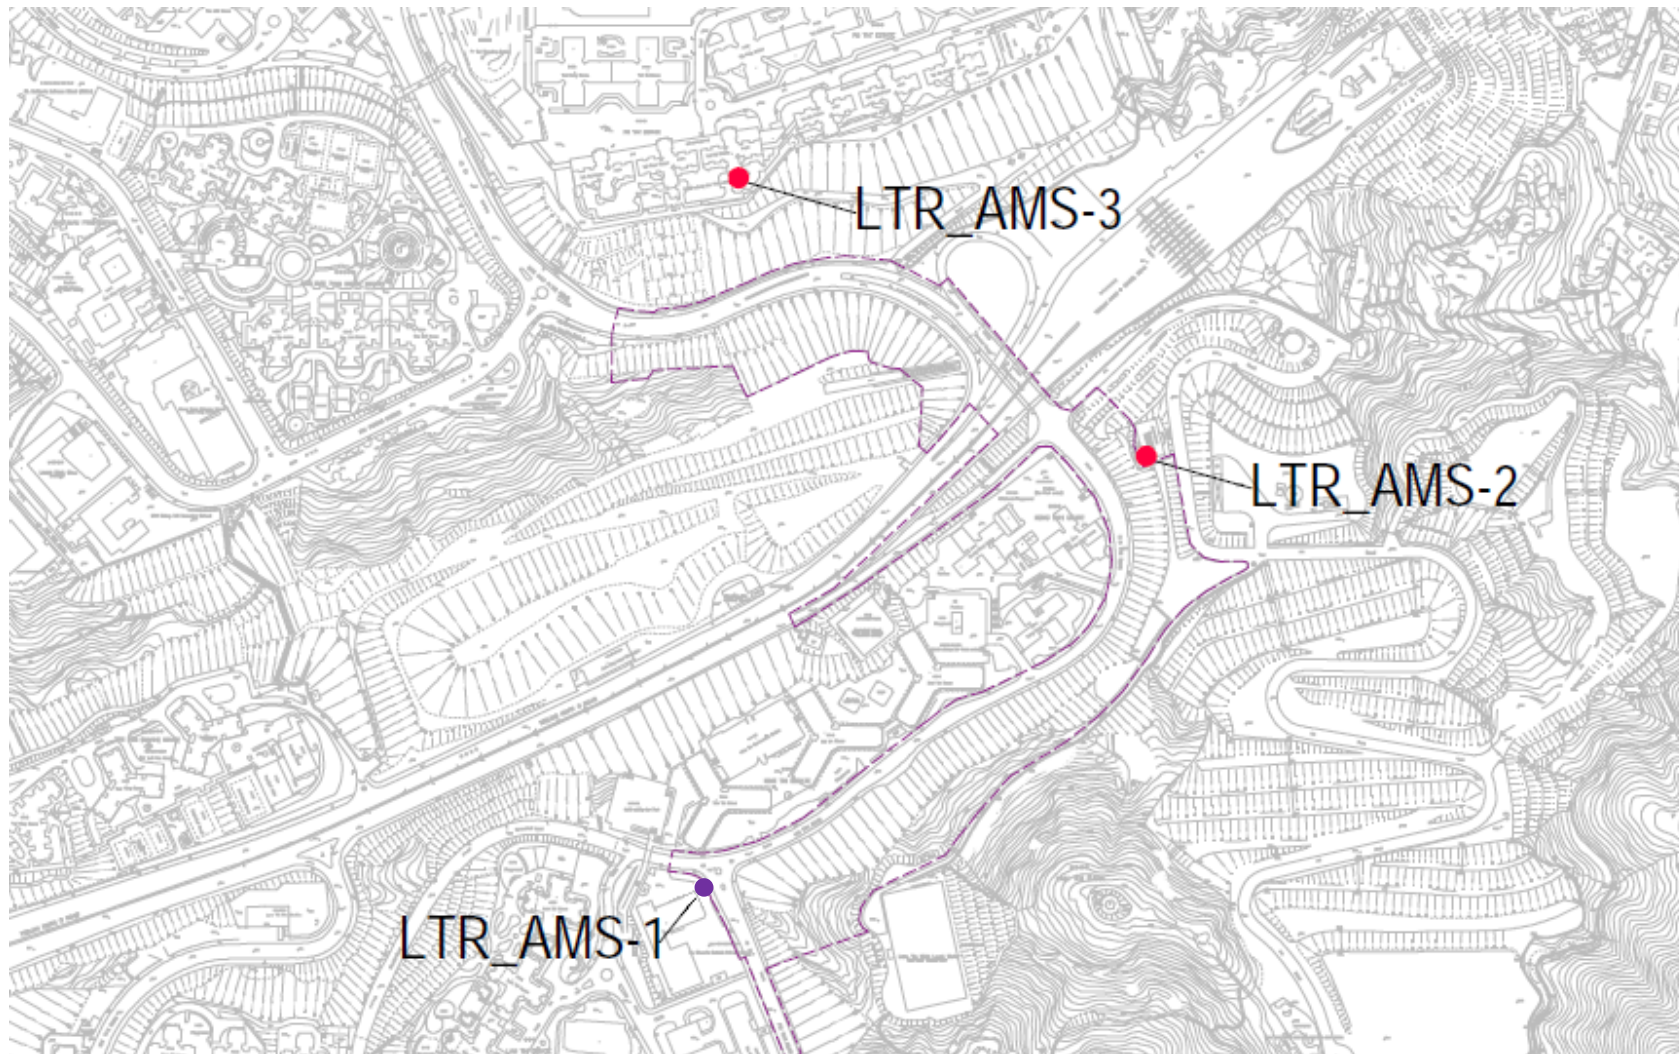
Figure 4.5
Location of Water Quality Monitoring Station
(for Road Improvement Work 1 & 2)

| Monitoring Station ID | EIA ID | Location |
| LTR_AMS-3 | APTE-14 | Po Tat Estate Tat Kai House |

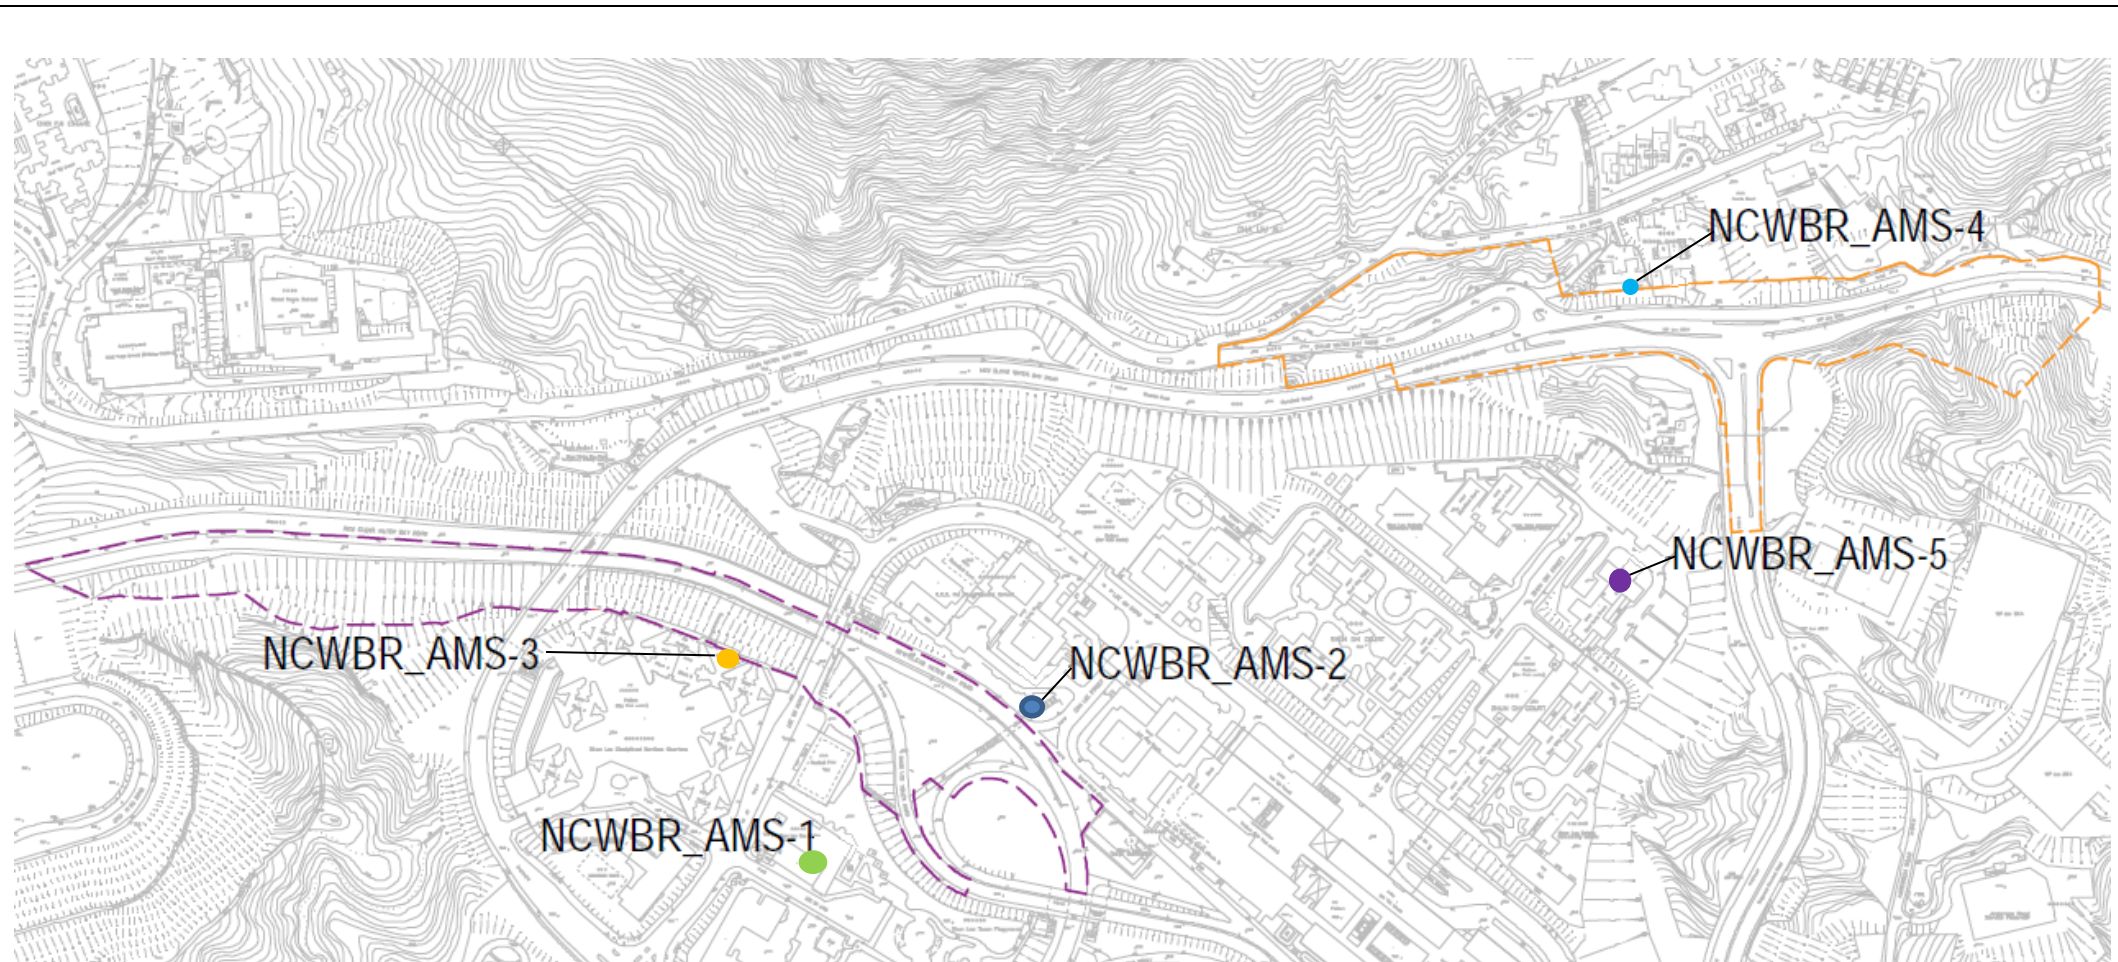
Figure 4.4
Location of Air Quality Monitoring Station
(for Road Improvement Work 3)

| Monitoring Station ID | EIA ID | Location |
| NCWBR_AMS-5 | ASCC-05 | Shun Chi Court Shun Fung House |

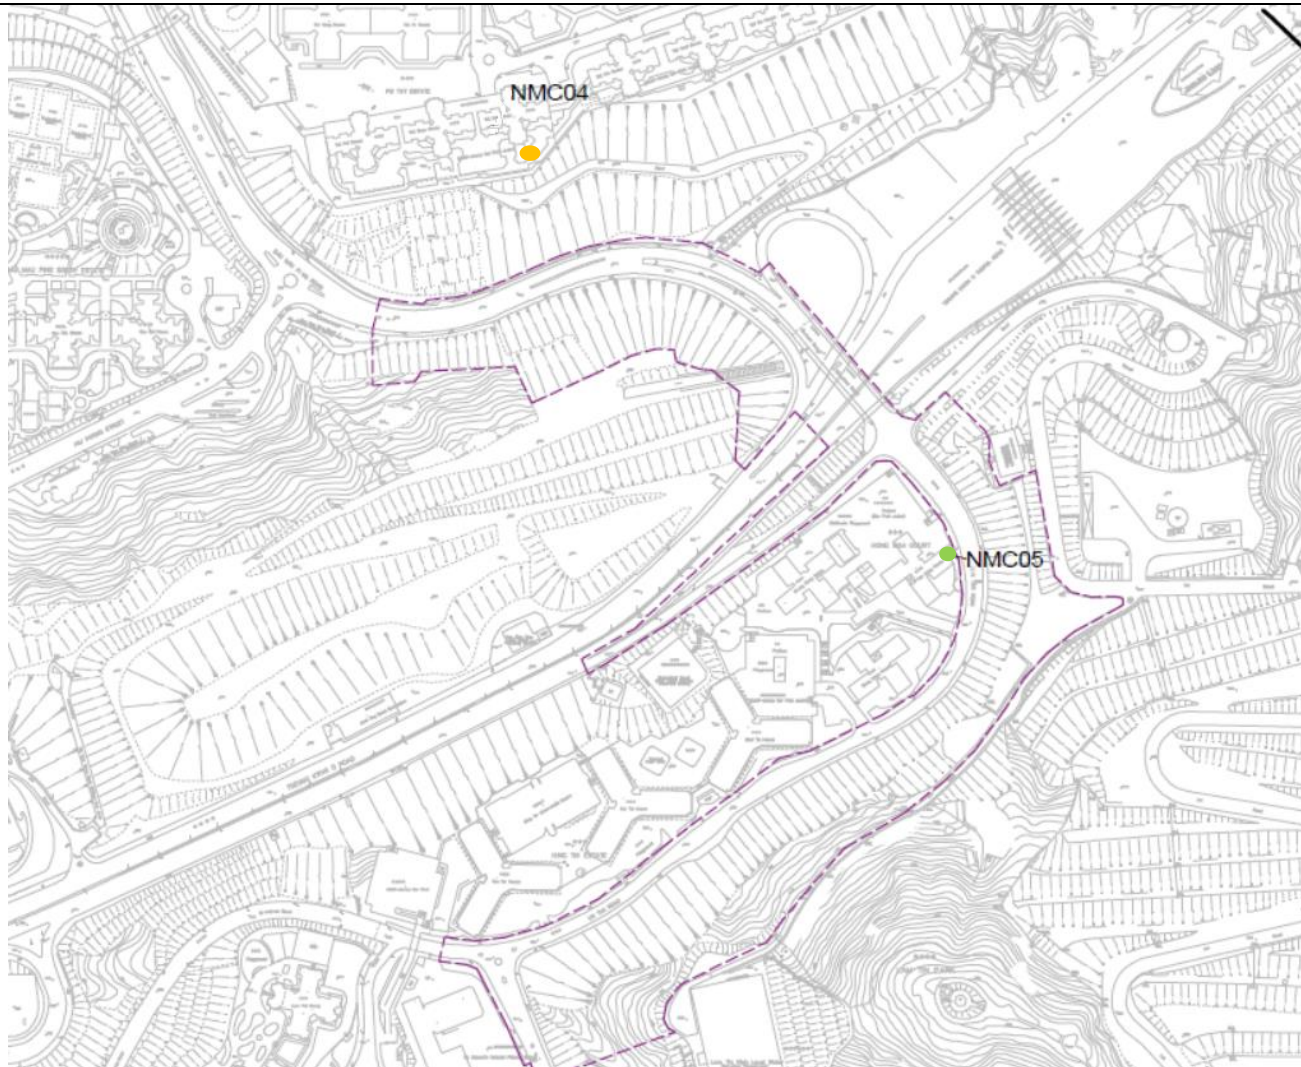
Figure 4.3
Location of Air Quality Monitoring Station
(for Road Improvement Work 1 & 2)

| Monitoring Location ID | Description |
| NMC04 | Po Tat Estate Tat Kai House |
| NMC05 | Hong Wah Court Block B Yee Hong House |

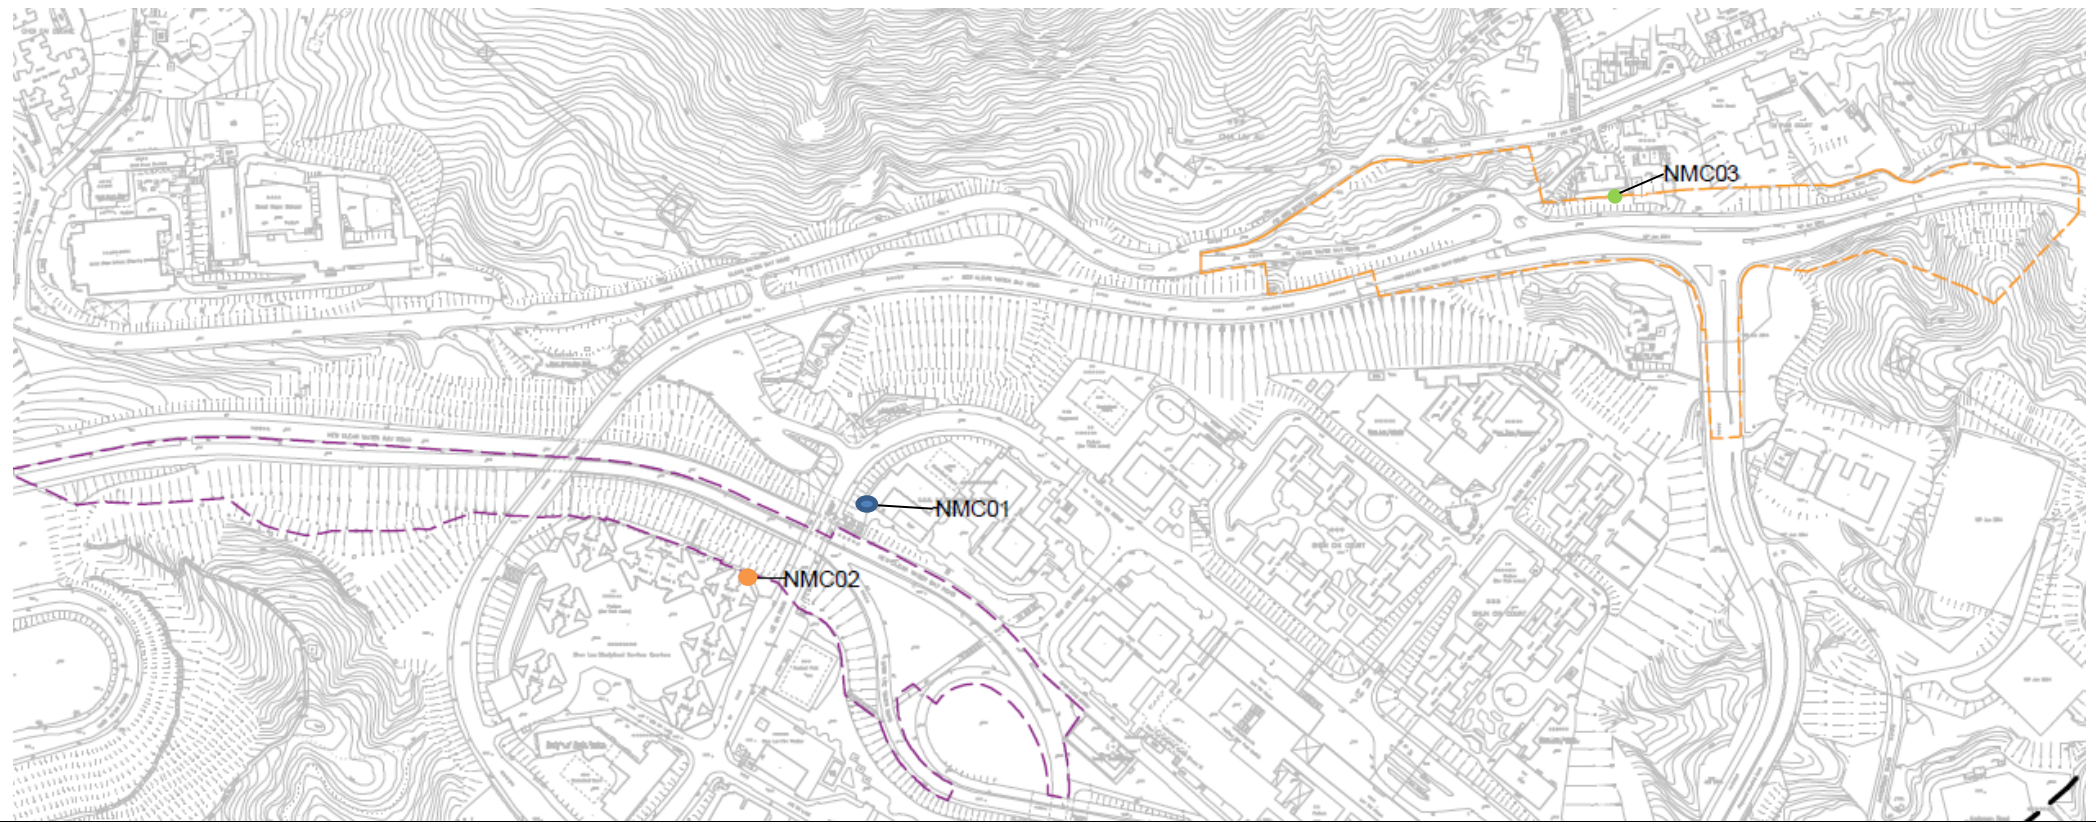
Figure 4.2
 Location of Noise Monitoring Station
 (Construction Phase)
 (for Road Improvement Work 3)

| Monitoring Location ID | Description |

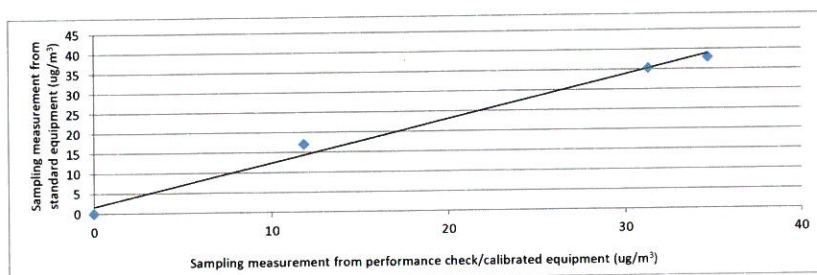
Linear Regression of Y on X

Slope (K- factor) : 1.1000
 Correlation Coefficient : 0.9942
 Validity of Performance Check / Calibration Record : 13/5/2019

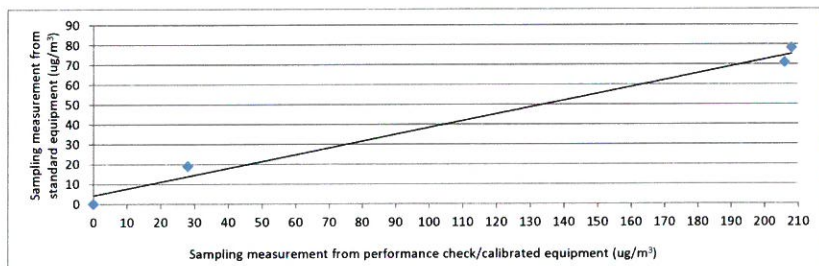
Linear Regression of Y on X

Slope (K- factor) : 0.3400
 Correlation Coefficient : 0.9925
 Validity of Performance Check / Calibration Record : 11/5/2019

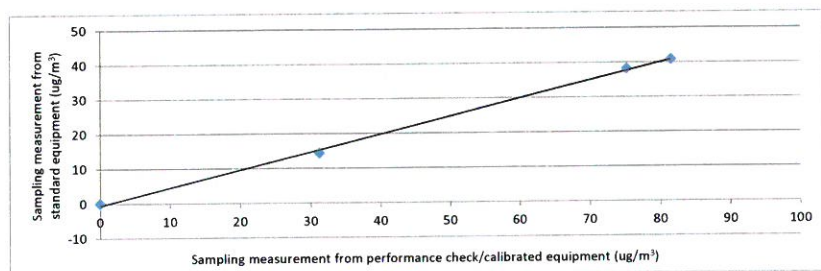
Linear Regression of Y on X

Slope (K- factor) : 0.5100
 Correlation Coefficient : 0.9994
 Validity of Performance Check / Calibration Record : 26/6/2019

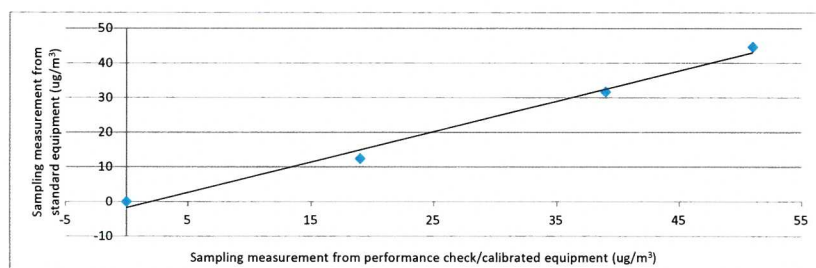
Linear Regression of Y on X

Slope (K- factor) : 0.8800
 Correlation Coefficient : 0.9945
 Validity of Performance Check / Calibration Record : 23/10/2019

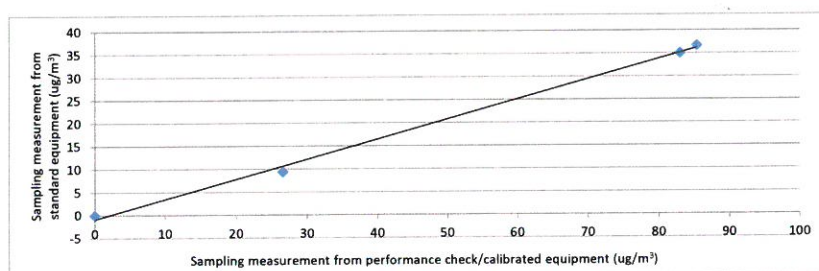
Linear Regression of Y on X

Slope (K- factor) : 0.4400
 Correlation Coefficient : 0.9988
 Validity of Performance Check / Calibration Record : 15/8/2019

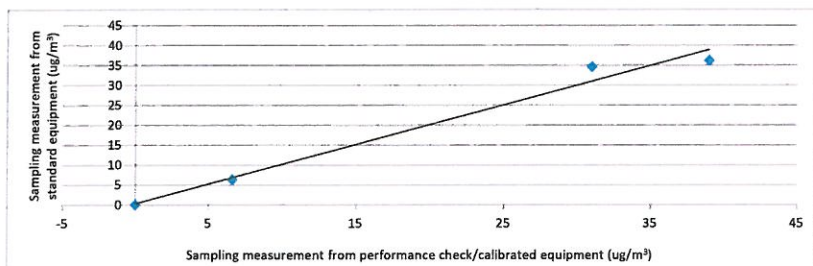
Linear Regression of Y on X

Slope (K- factor) : 1.0000
 Correlation Coefficient : 0.9901
 Validity of Performance Check / Calibration Record : 16/8/2019

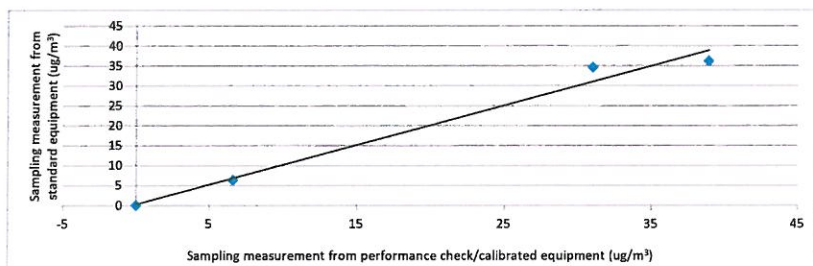
Linear Regression of Y on X

Slope (K- factor) : 1.0000
 Correlation Coefficient : 0.9904
 Validity of Performance Check / Calibration Record : 16/8/2019

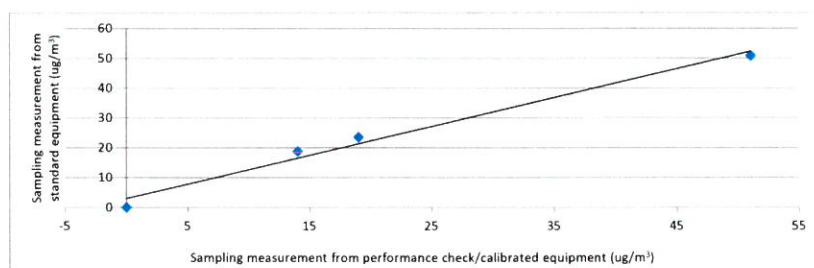
Linear Regression of Y on X

Slope (K- factor) : 1.0000
 Correlation Coefficient : 0.9921
 Validity of Performance Check / Calibration Record : 17/8/2019

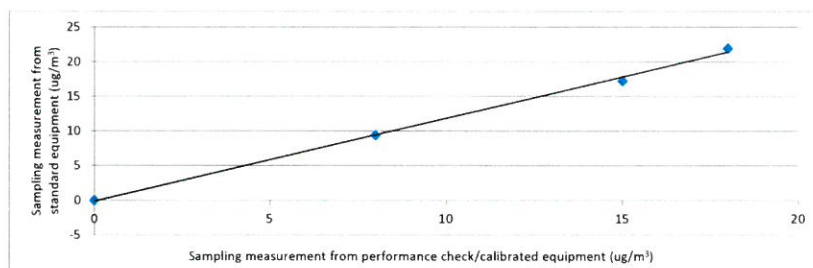
Linear Regression of Y on X

Slope (K- factor) : 1.2000
 Correlation Coefficient : 0.9988
 Validity of Performance Check / Calibration Record : 17/8/2019

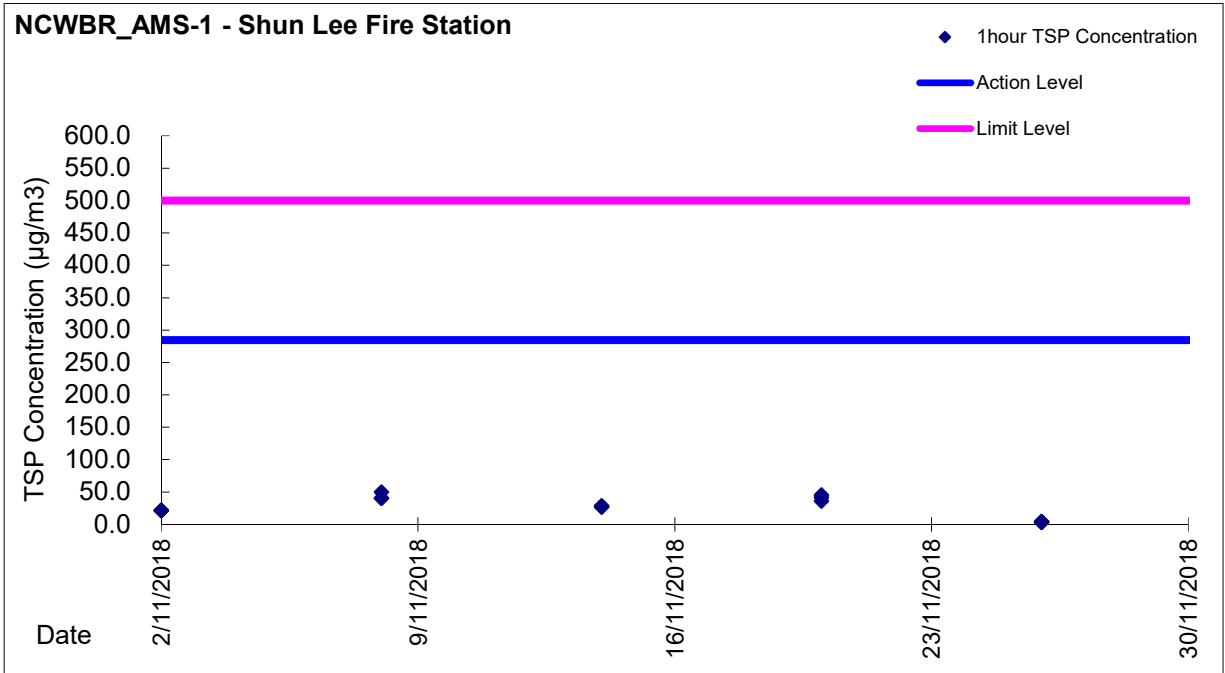
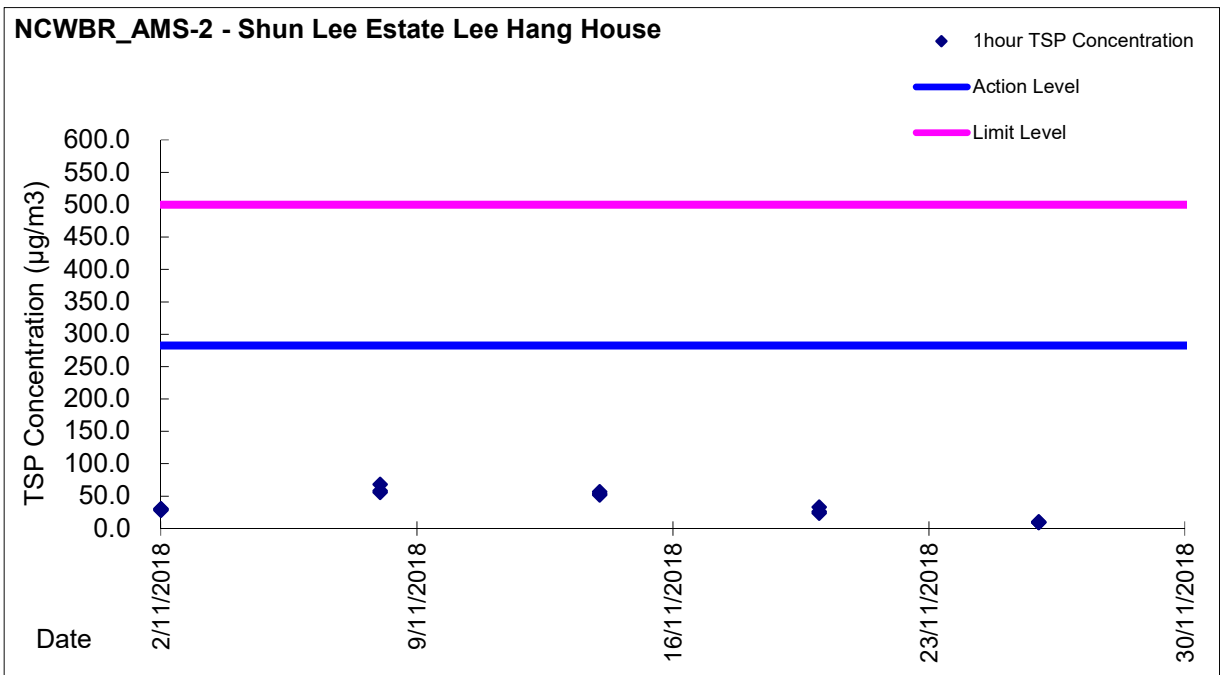
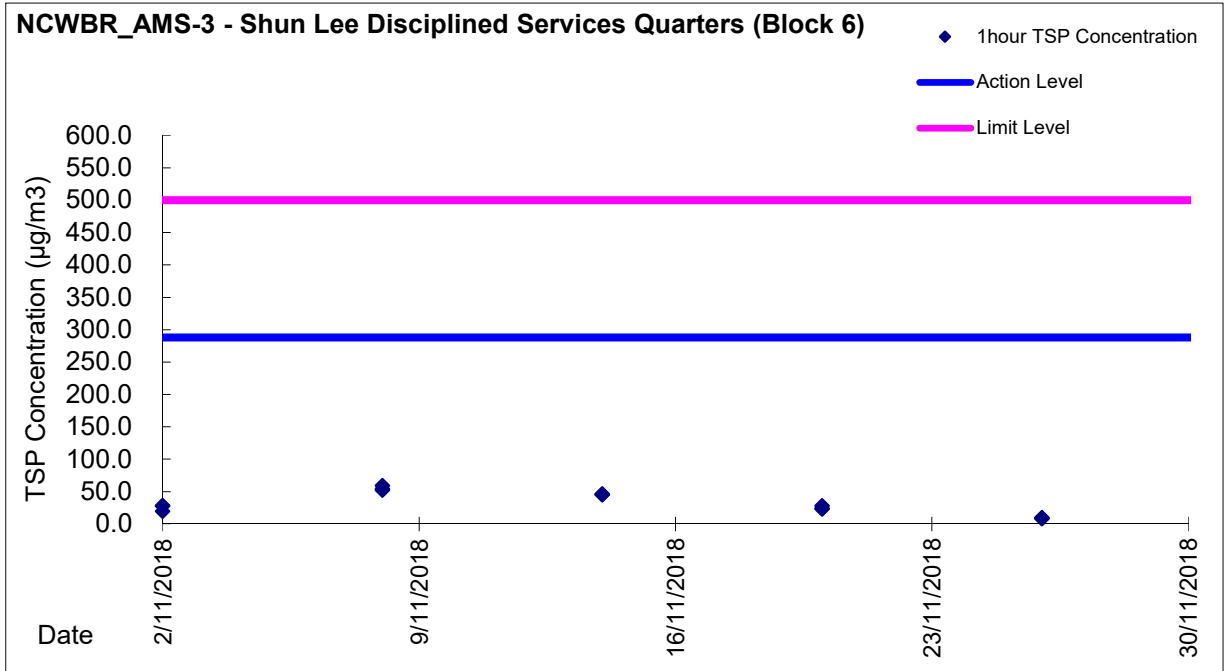
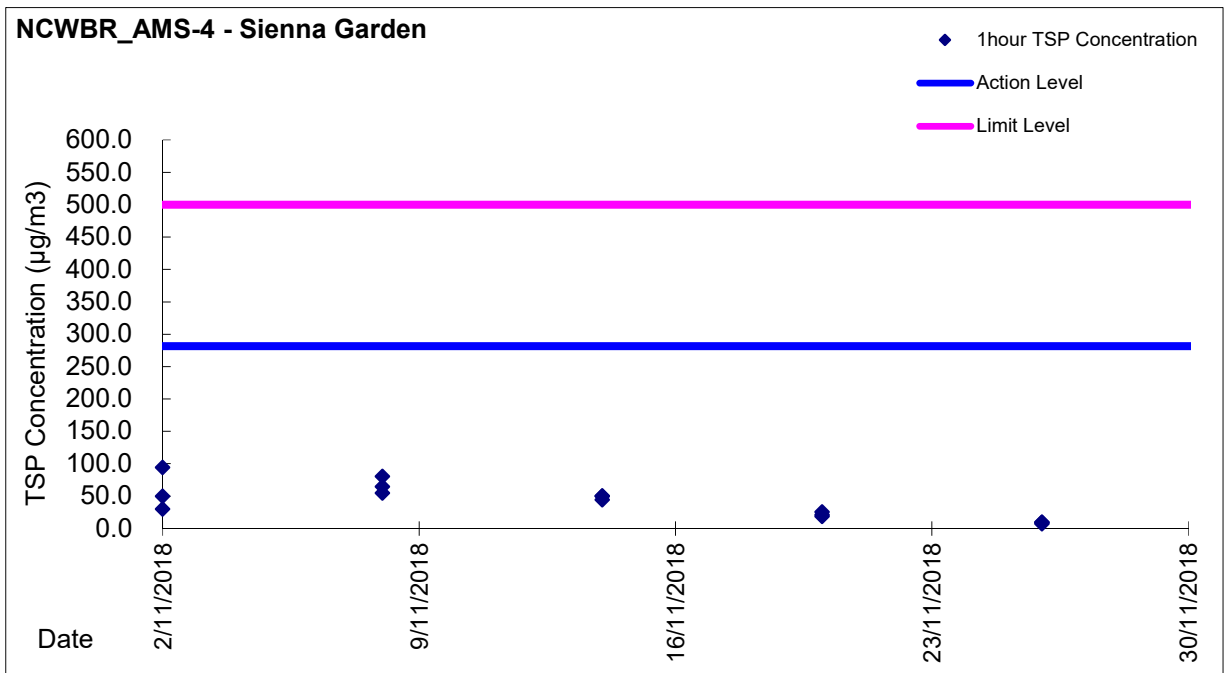
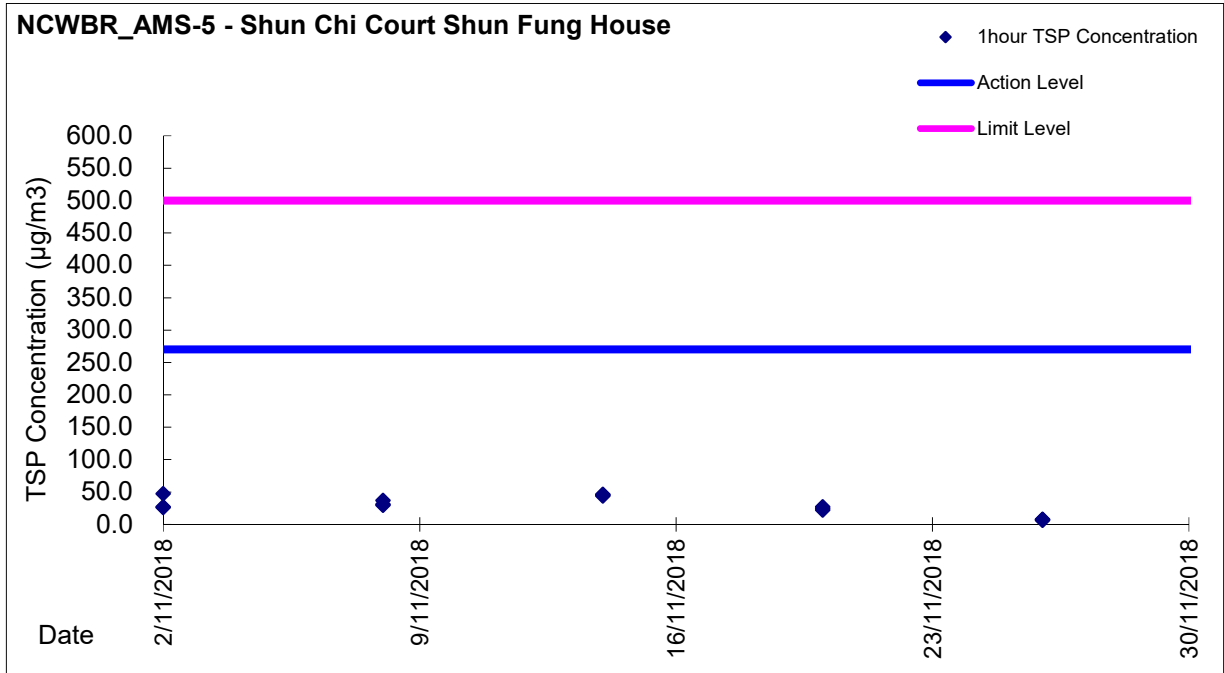
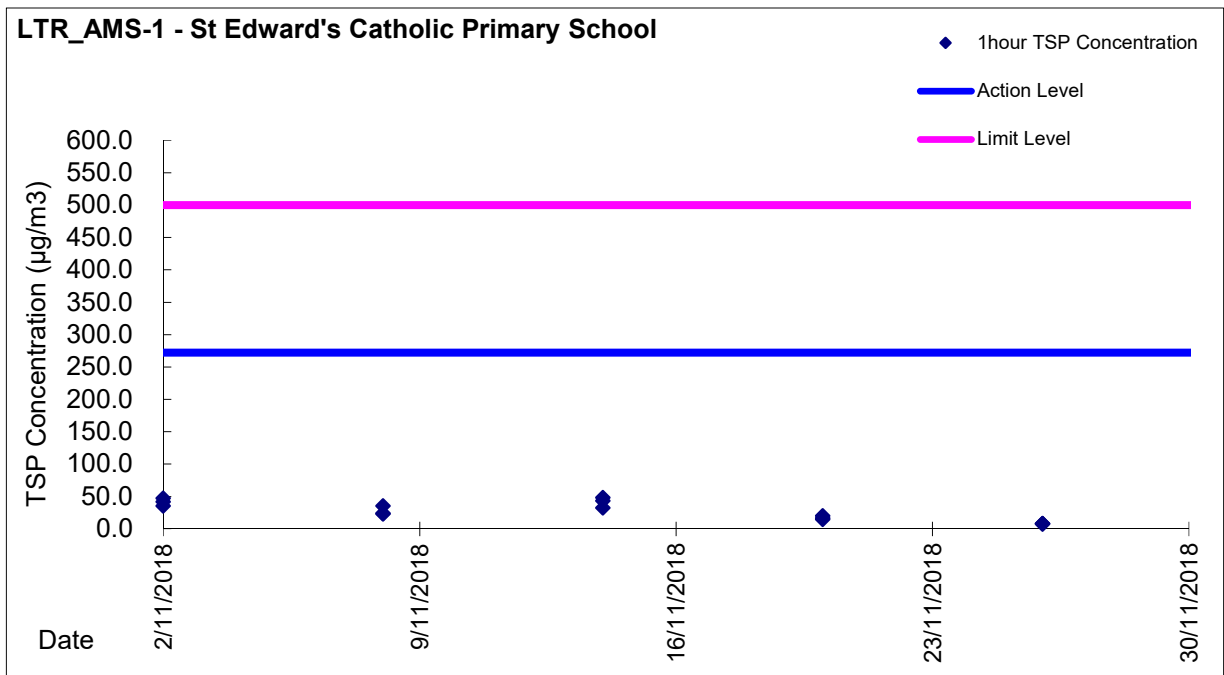
Graphic Presentation of TSP Result
