Service Contract No: EDO/01/2017
Environmental Team for
Development of Anderson Road Quarry Site
Road Improvement Works
Monthly EM&A Report (November 2018)

**ENVIRONMENTAL TEAM FOR
DEVELOPMENT OF
ANDERSON ROAD QUARRY SITE -
ROAD IMPROVEMENT WORKS**

UNDER ENVIRONMENTAL PERMIT NO. EP-513/2016

MONTHLY ENVIRONMENTAL MONITORING & AUDIT REPORT

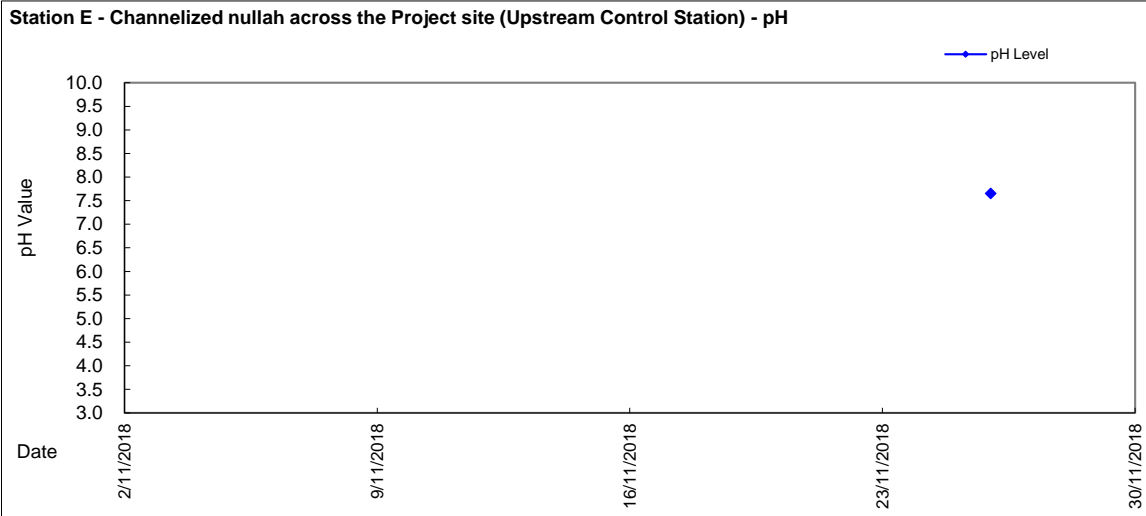
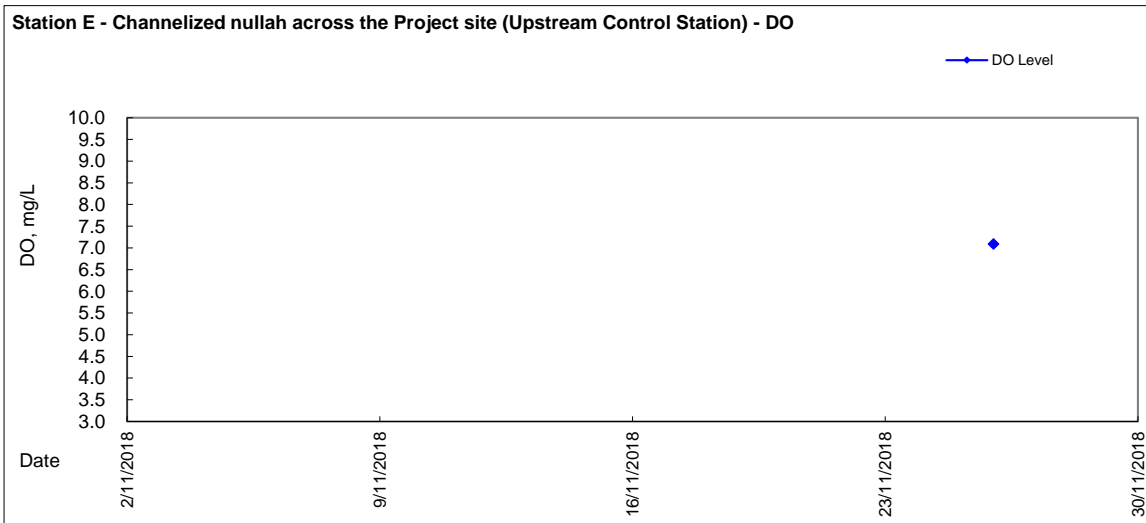
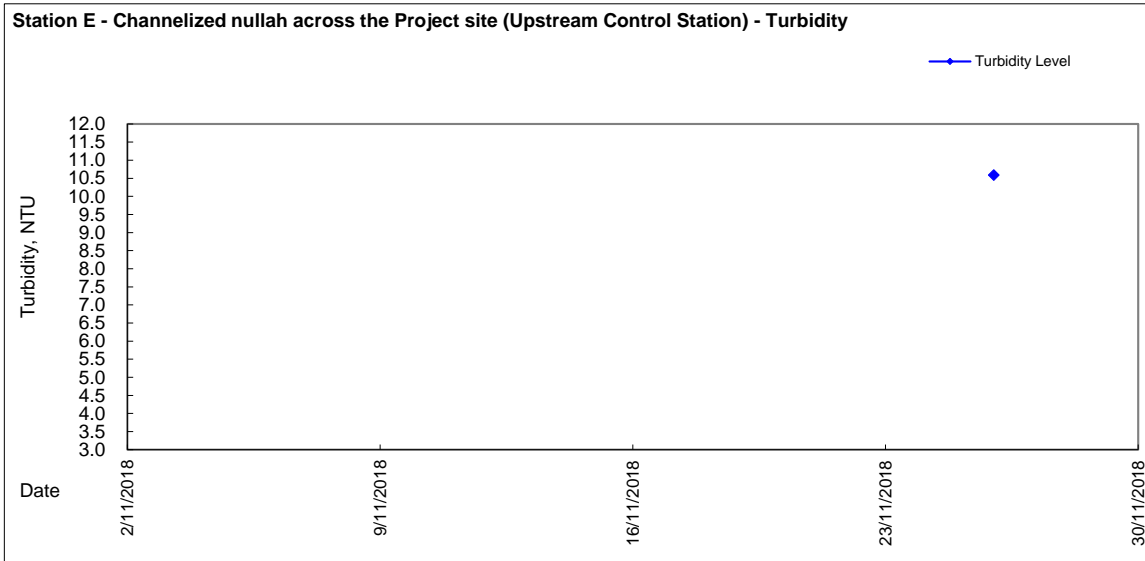
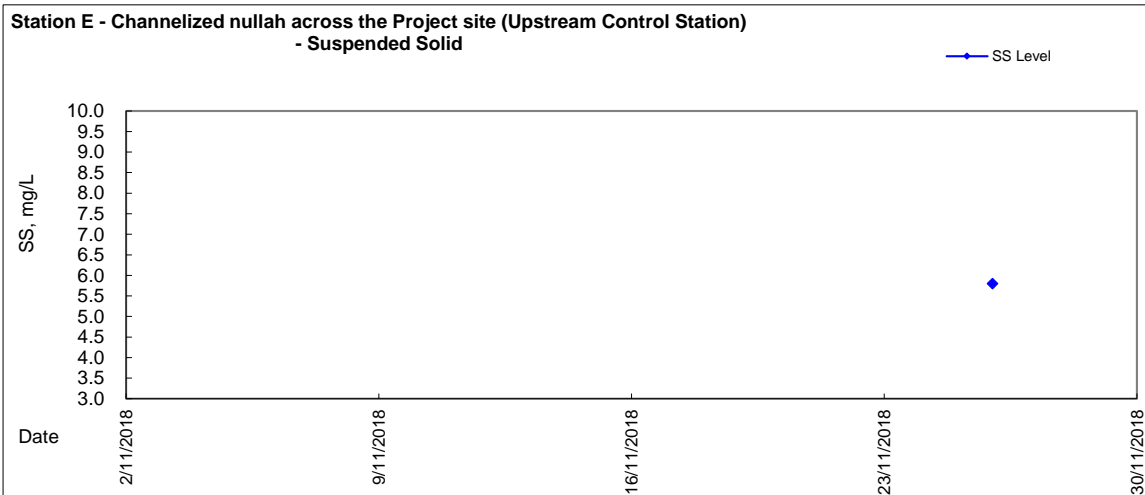
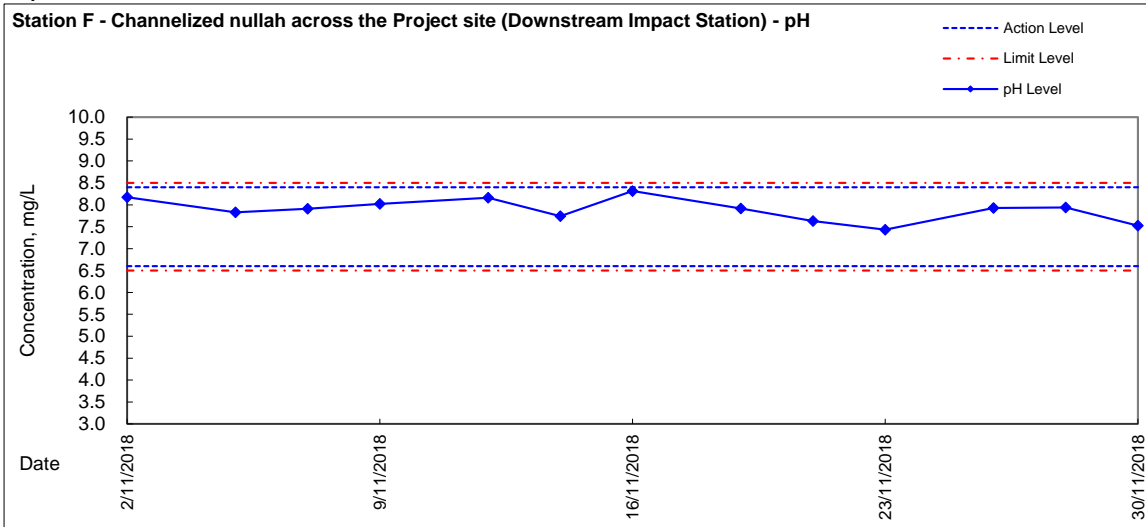
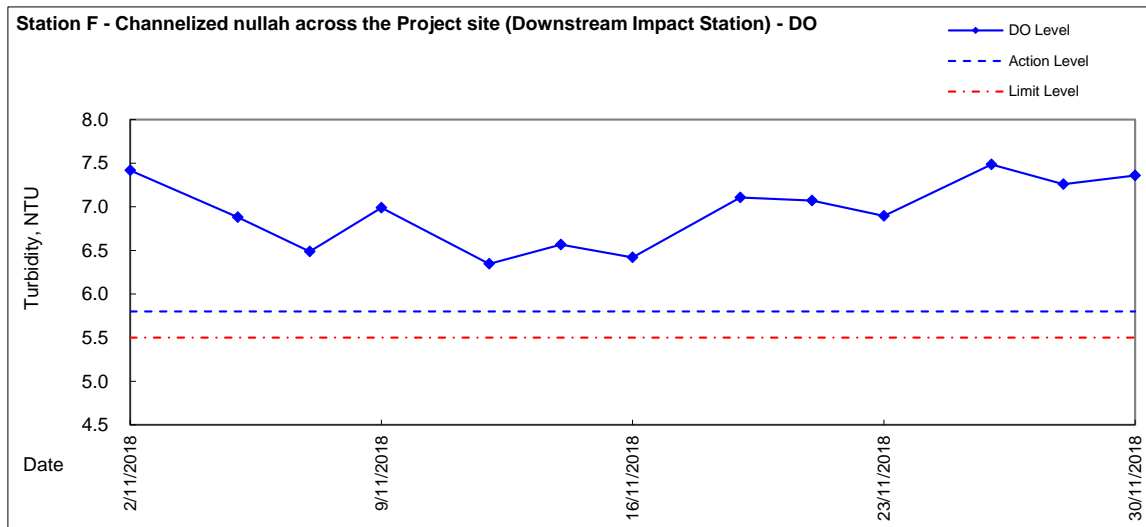
Graphic Presentation of WQM Result
