**ENVIRONMENTAL TEAM FOR
DEVELOPMENT OF
ANDERSON ROAD QUARRY SITE -
ROAD IMPROVEMENT WORKS**

UNDER ENVIRONMENTAL PERMIT NO. EP-513/2016

MONTHLY ENVIRONMENTAL MONITORING & AUDIT REPORT

NOVEMBER 2022

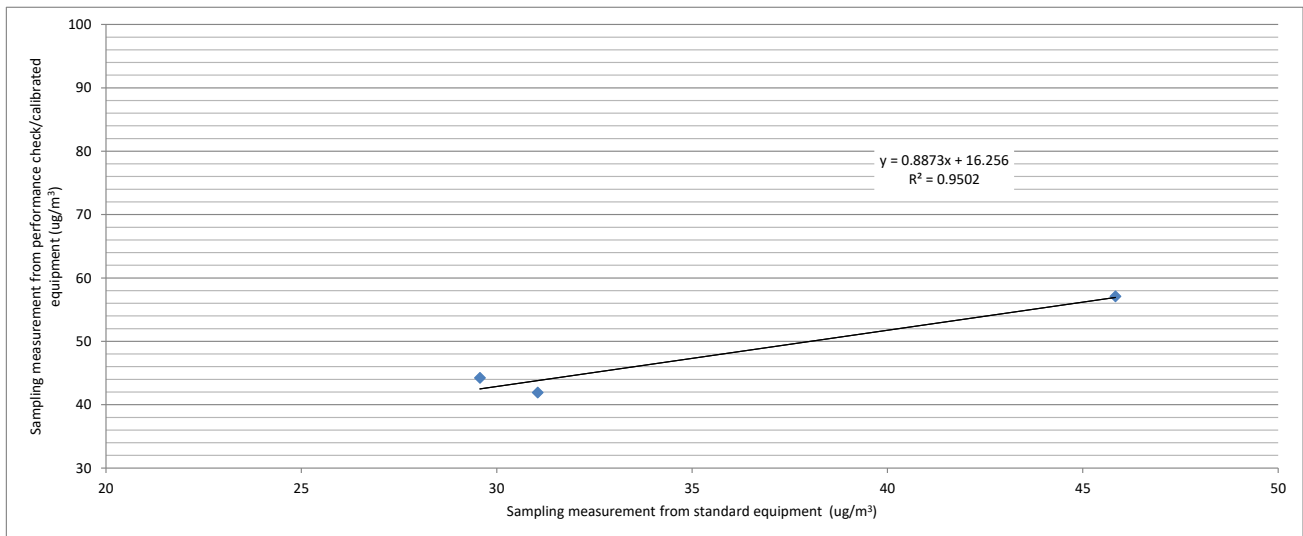
Linear Regression of Y on X

Slope (K- factor) : 1.1000
Correlation Coefficient : 0.9748
Validity of Performance Check / Calibration Record : 17/5/2023

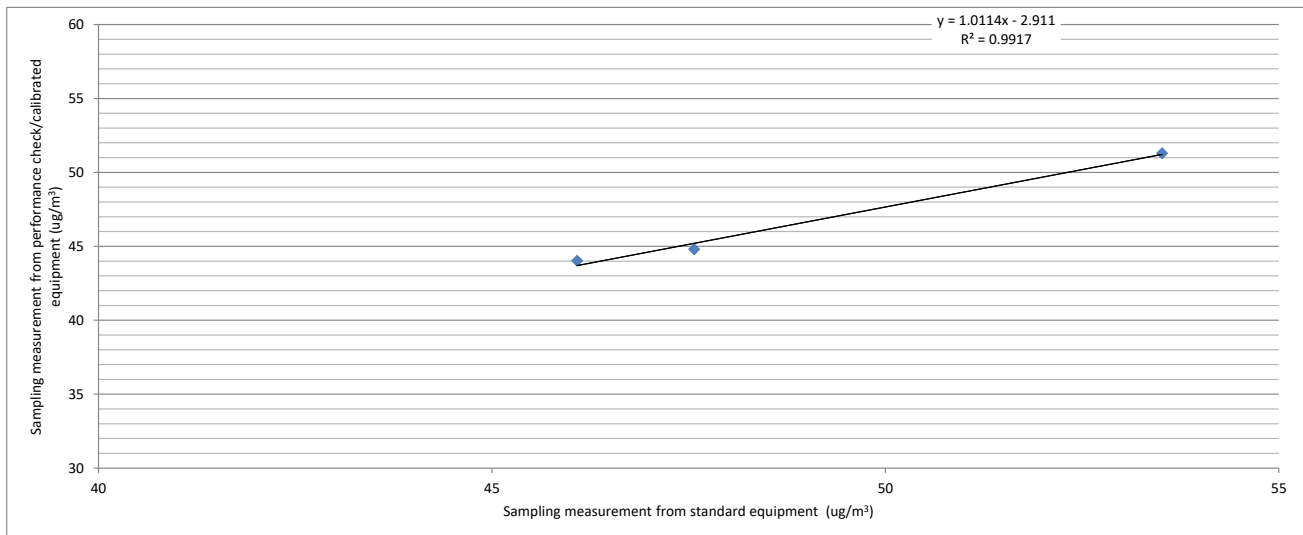
Linear Regression of Y on X

Slope (K- factor) : 1.0000
Correlation Coefficient : 0.9958
Validity of Performance Check / Calibration Record : 30/4/2023

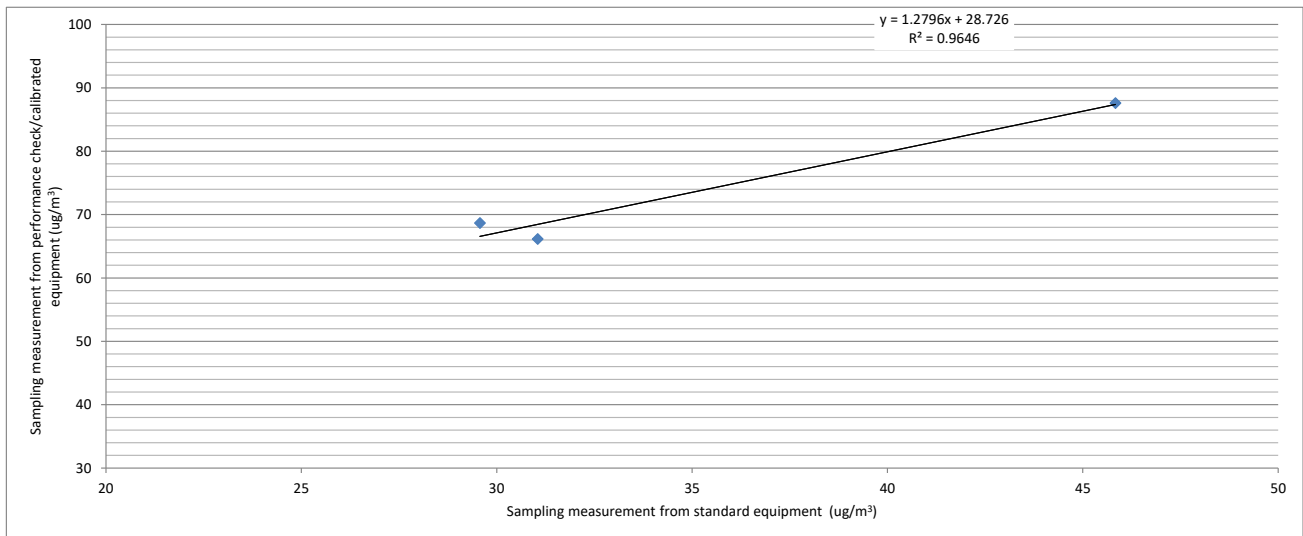
Linear Regression of Y on X

Slope (K- factor) : 0.8000
Correlation Coefficient : 0.9821
Validity of Performance Check / Calibration Record : 17/5/2023

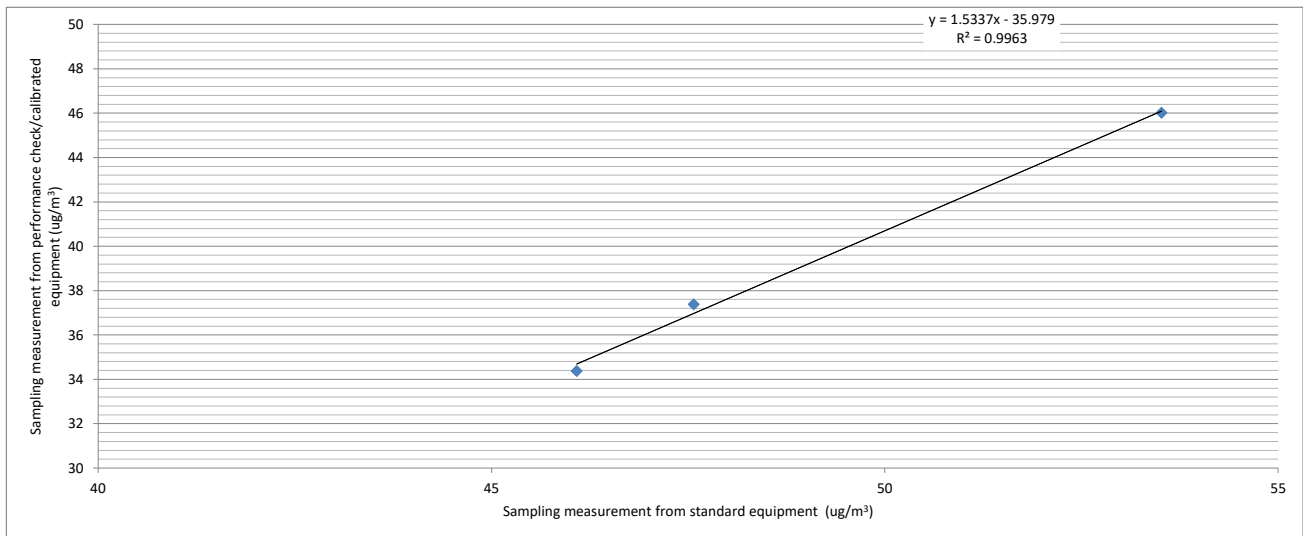
Linear Regression of Y on X

Slope (K- factor) : 0.7000
Correlation Coefficient : 0.9982
Validity of Performance Check / Calibration Record : 30/4/2023

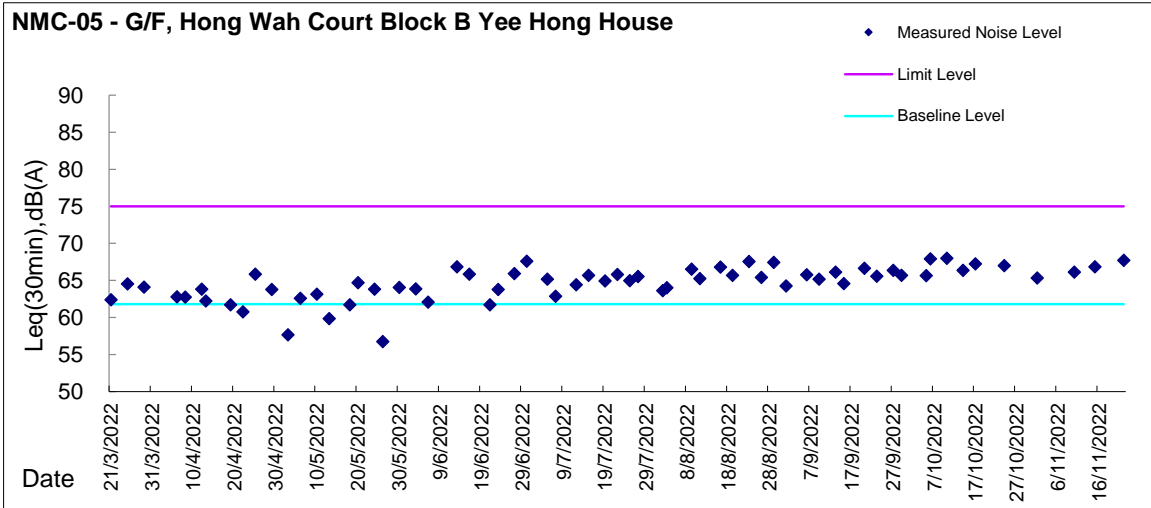
Graphic Presentation of Noise Monitoring Result

NMC-05 - G/F, Hong Wah Court Block B Yee Hong House

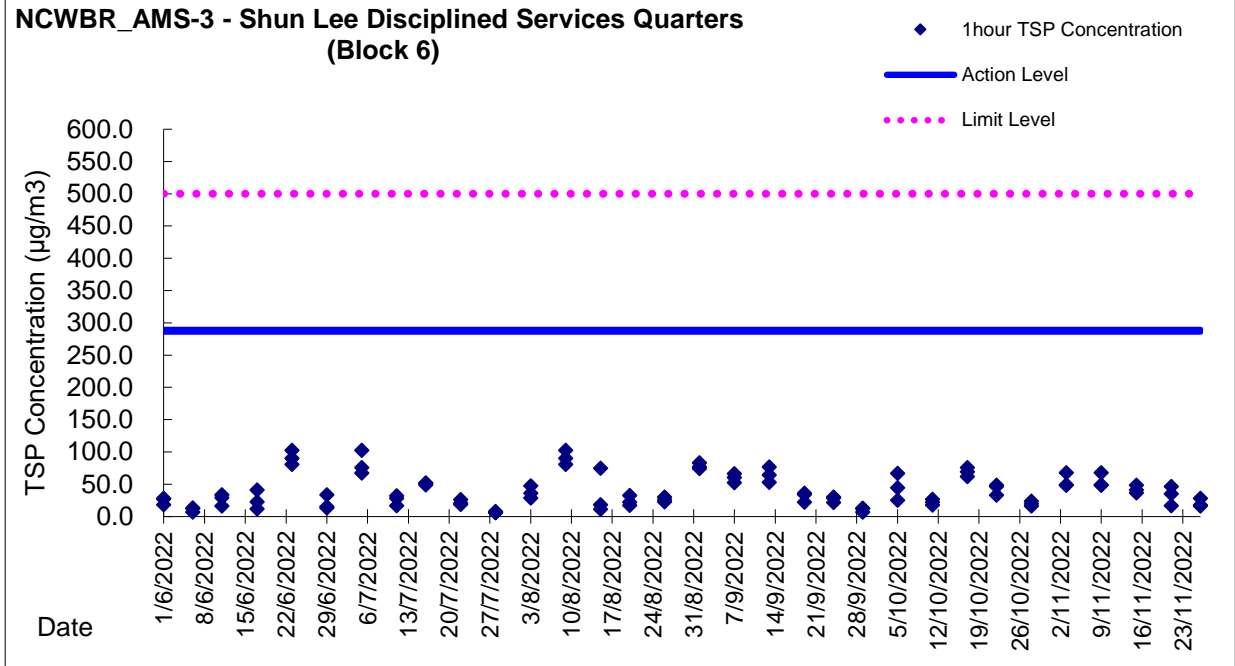
NCWBR_AMS-3 - Shun Lee Disciplined Services Quarters (Block 6)

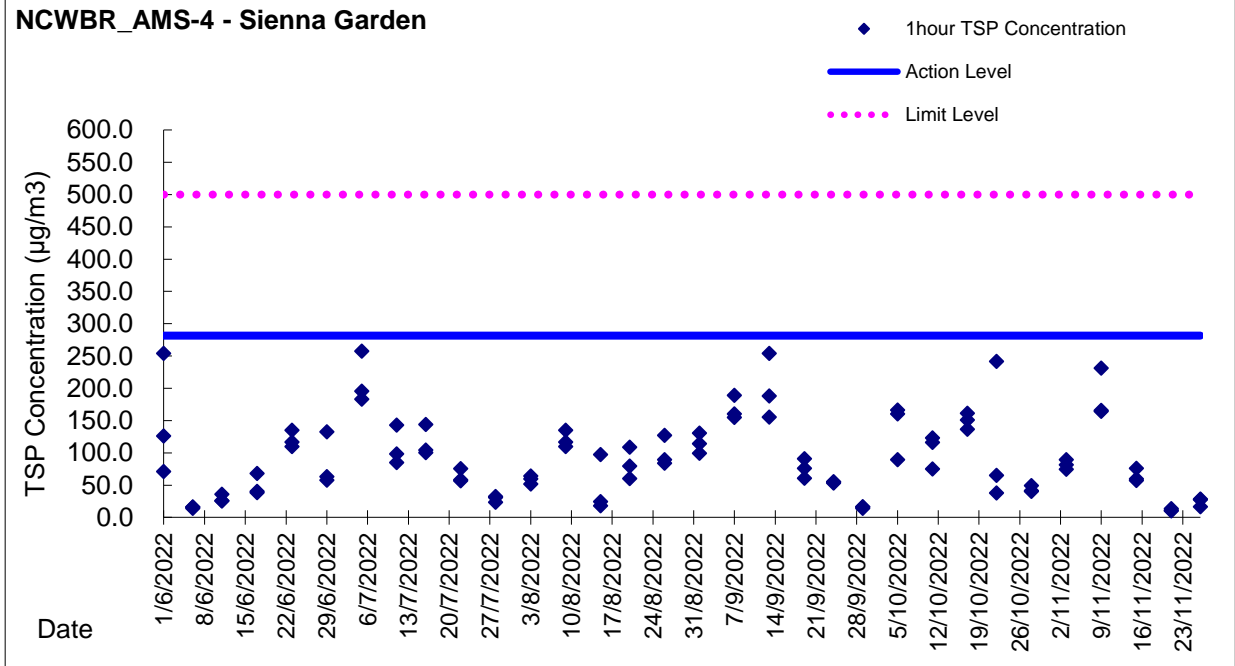
NCWBR_AMS-4 - Sienna Garden

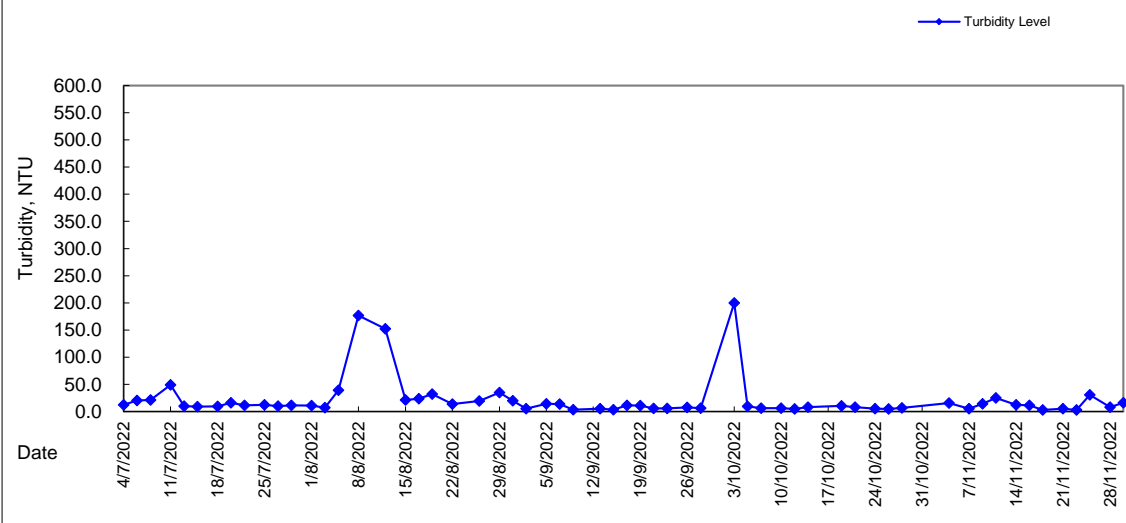
Station H - Ma Yau Tong Stream (Upstream Control Station) - Turbidity

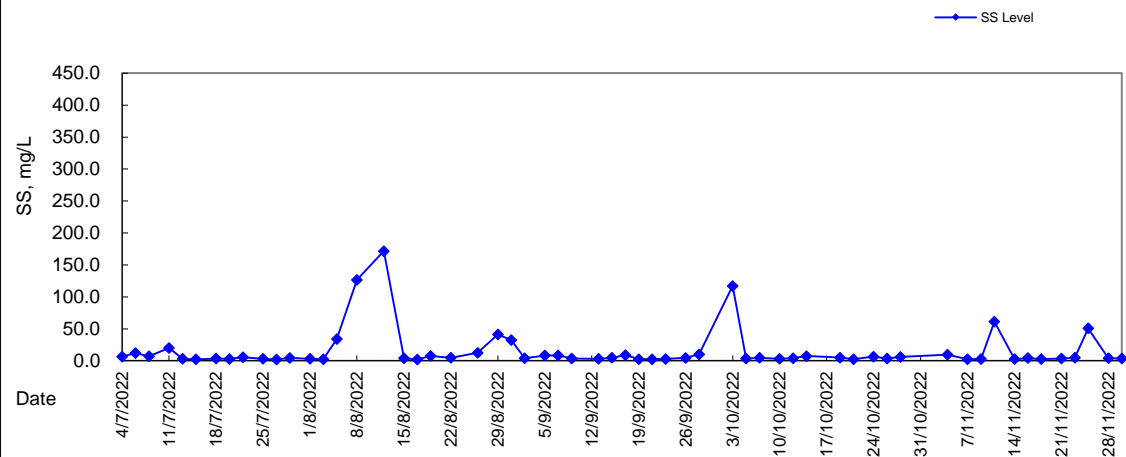
Station H - Ma Yau Tong Stream (Upstream Control Station) - Suspended Solid
