**ENVIRONMENTAL TEAM FOR  
DEVELOPMENT OF  
ANDERSON ROAD QUARRY SITE -  
ROAD IMPROVEMENT WORKS**

**UNDER ENVIRONMENTAL PERMIT NO. EP-513/2016**

**MONTHLY ENVIRONMENTAL MONITORING & AUDIT REPORT**

**DECEMBER 2020**

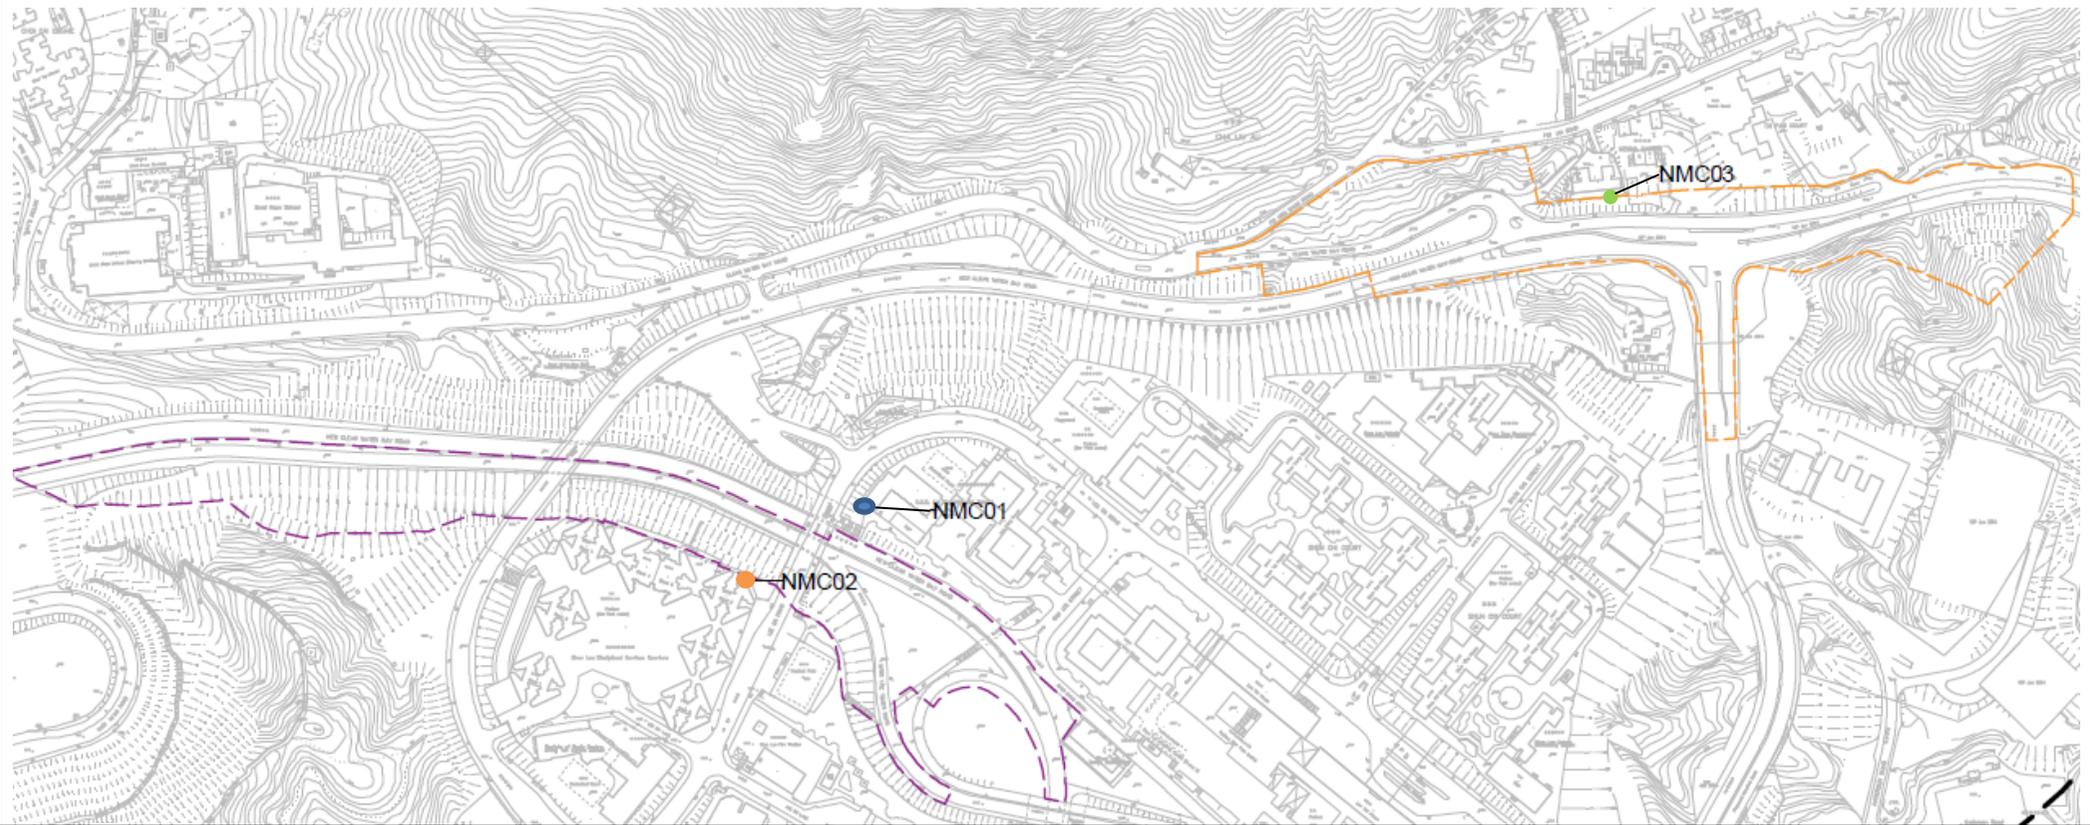
Figure 4.1  
 Location of Noise Monitoring Station  
 (Construction Phase)  
 (for Road Improvement Work 1 & 2)

Monitoring Location ID	Description
<i>Noise Monitoring Station (Construction Phase)</i>	
NMC01	Kei Shun Special School
NMC02	Shun Lee Disciplined Services Quarters Block 6
NMC03	Sienna Garden Block 6

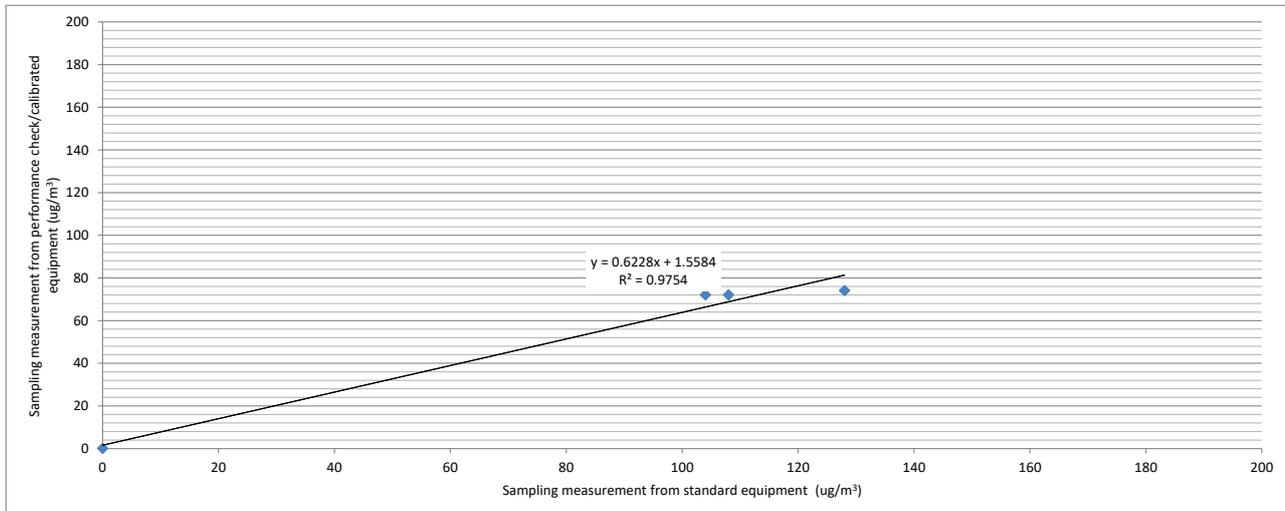
**Linear Regression of Y on X**

Slope (K- factor) : 1.6000  
 Correlation Coefficient : 0.9876  
 Validity of Performance Check / Calibration Record : 17/3/2021

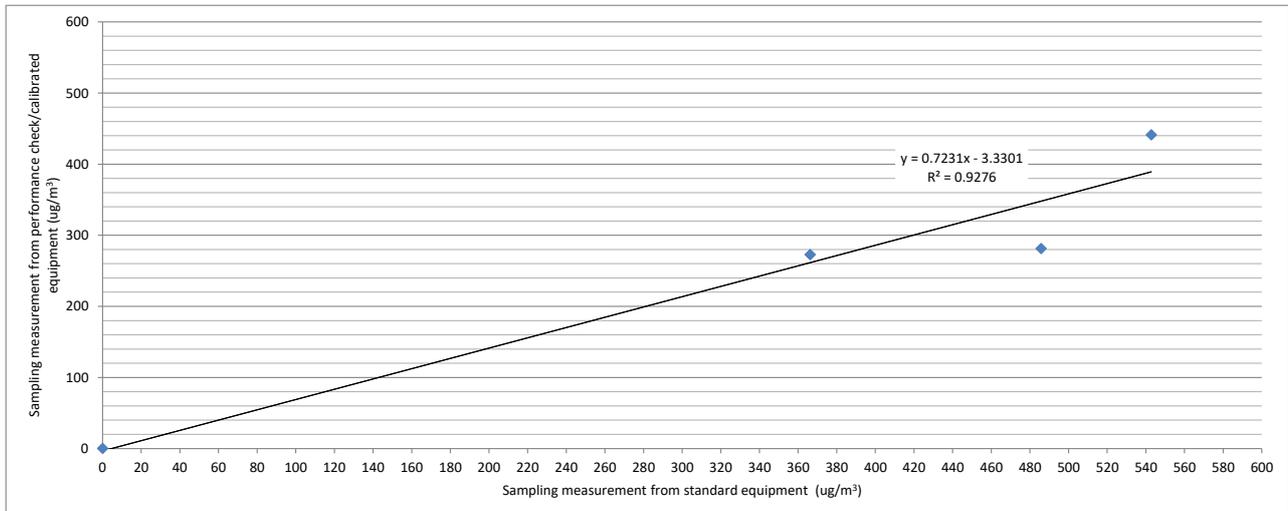
Linear Regression of Y on X

Slope (K- factor) : 1.3000
Correlation Coefficient : 0.9631
Validity of Performance Check / Calibration Record : 16/9/2021

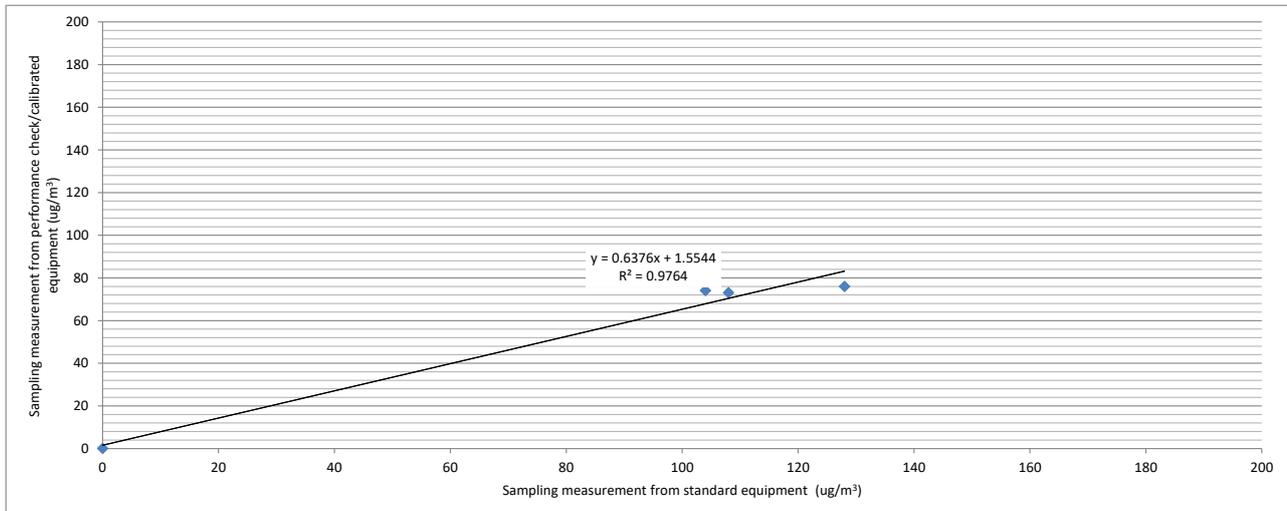
**Linear Regression of Y on X**

Slope (K- factor) : 1.6000  
 Correlation Coefficient : 0.9881  
 Validity of Performance Check / Calibration Record : 17/3/2021

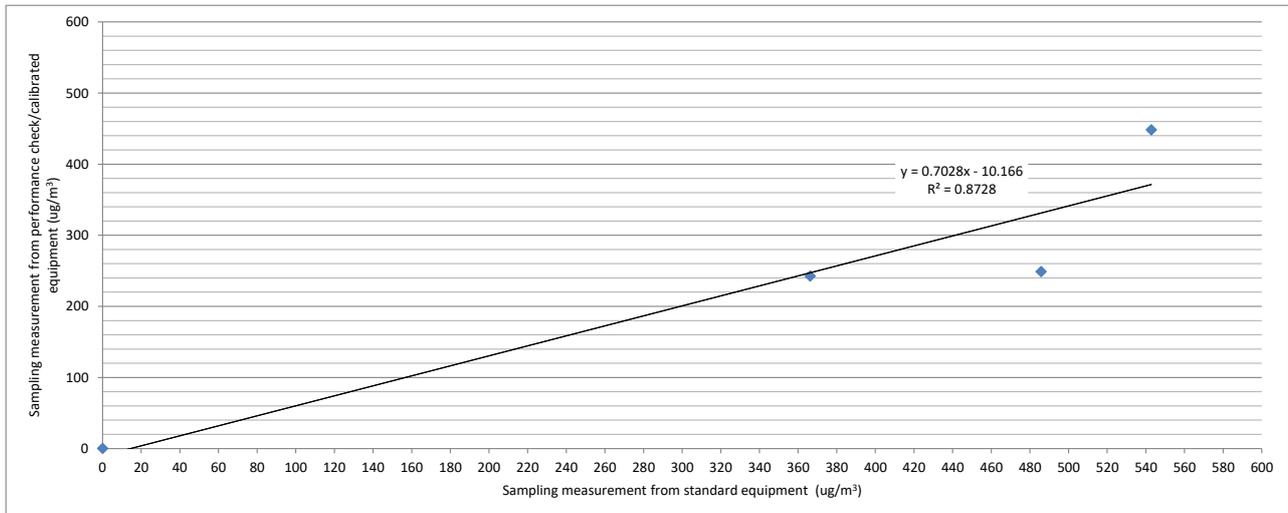
Linear Regression of Y on X

Slope (K- factor) : 1.3000
Correlation Coefficient : 0.9342
Validity of Performance Check / Calibration Record : 16/9/2021

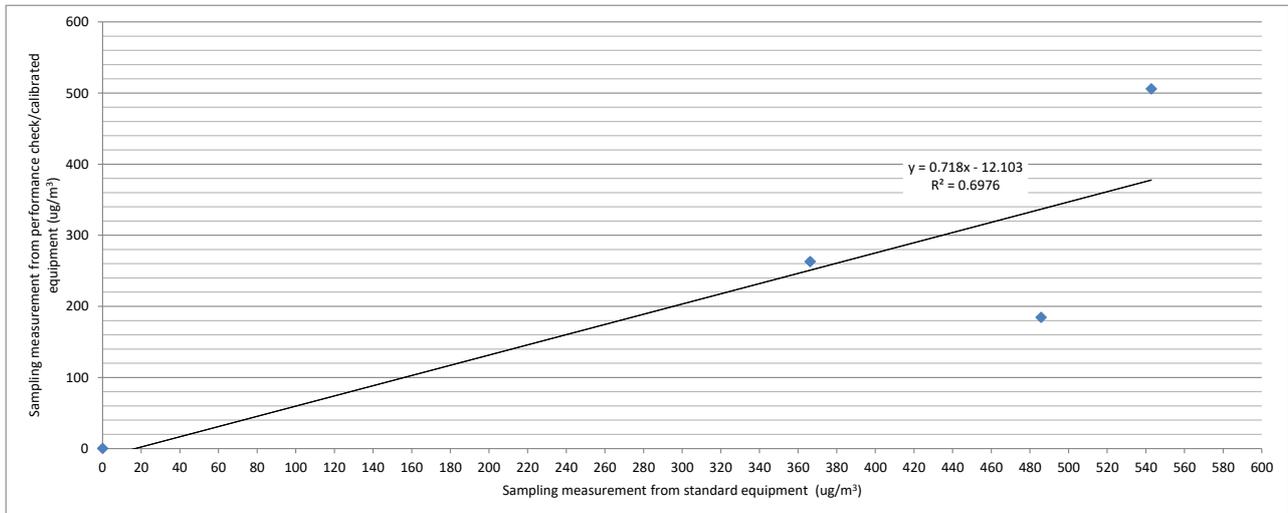
Linear Regression of Y on X

Slope (K- factor) : 1.0000
Correlation Coefficient : 0.8352
Validity of Performance Check / Calibration Record : 16/9/2021

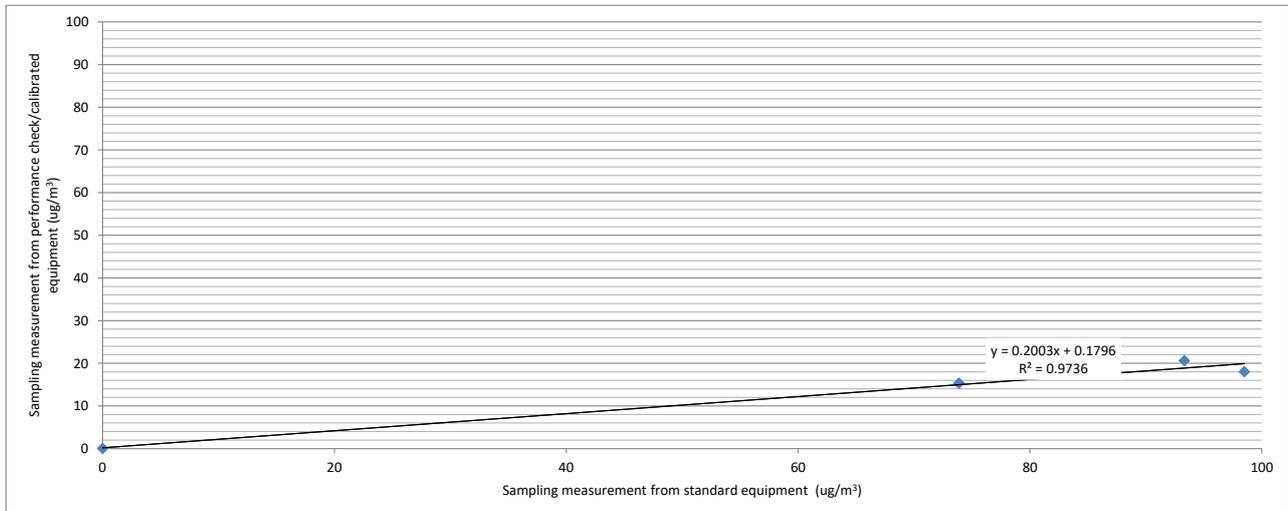
Linear Regression of Y on X

Slope (K- factor) : 4.9000
Correlation Coefficient : 0.9867
Validity of Performance Check / Calibration Record : 27/4/2021

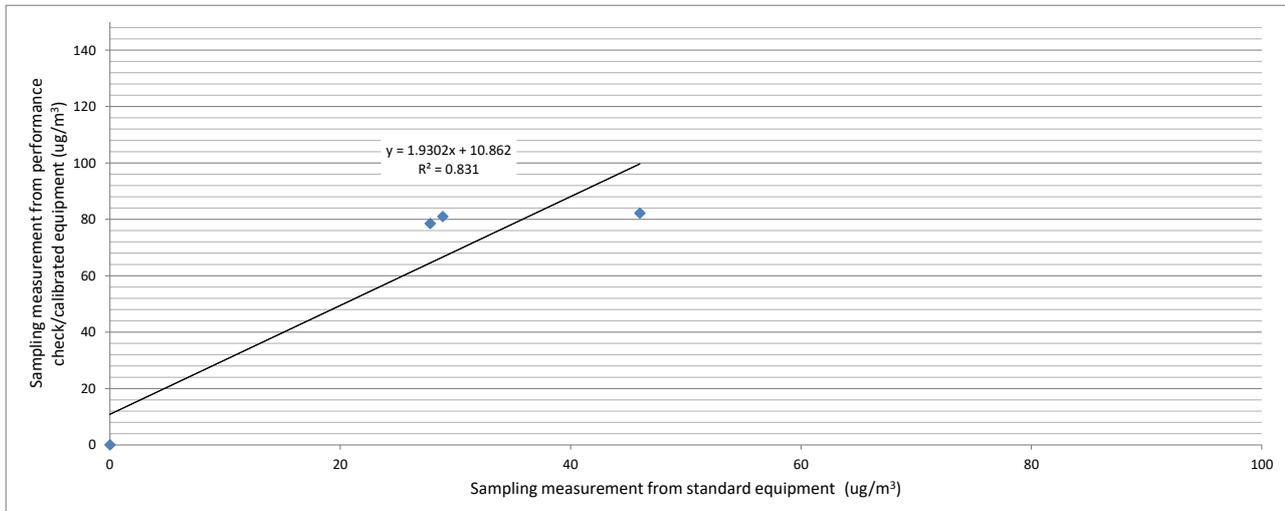
**Linear Regression of Y on X**

Slope (K- factor) : 0.5000  
 Correlation Coefficient : 0.9116  
 Validity of Performance Check / Calibration Record : 3/11/2021

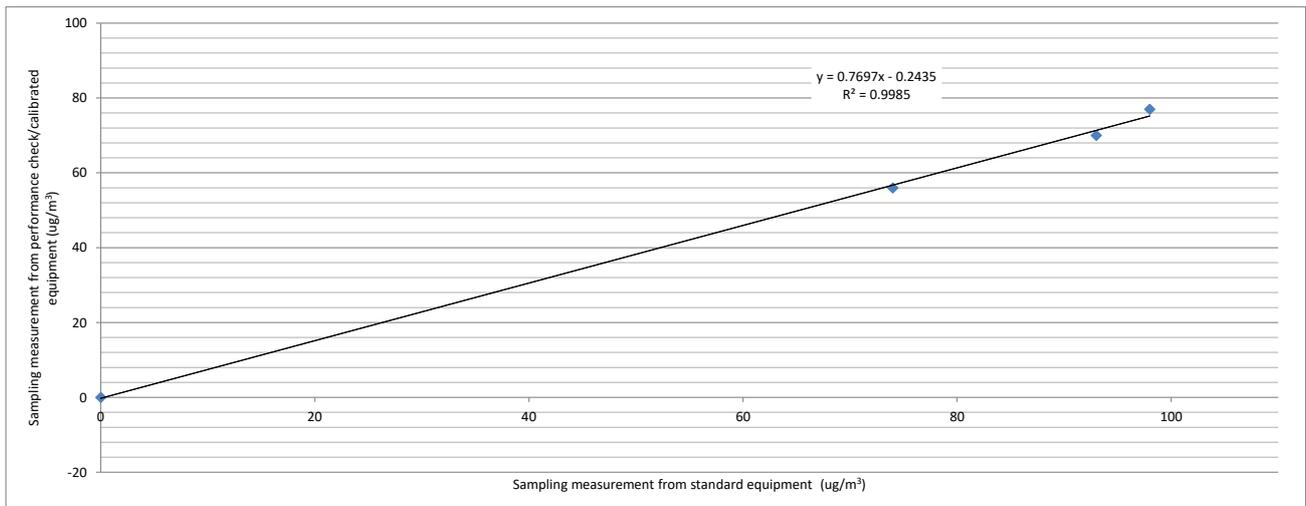
Linear Regression of Y on X

Slope (K- factor) : 1.3000
Correlation Coefficient : 0.9992
Validity of Performance Check / Calibration Record : 2/5/2021

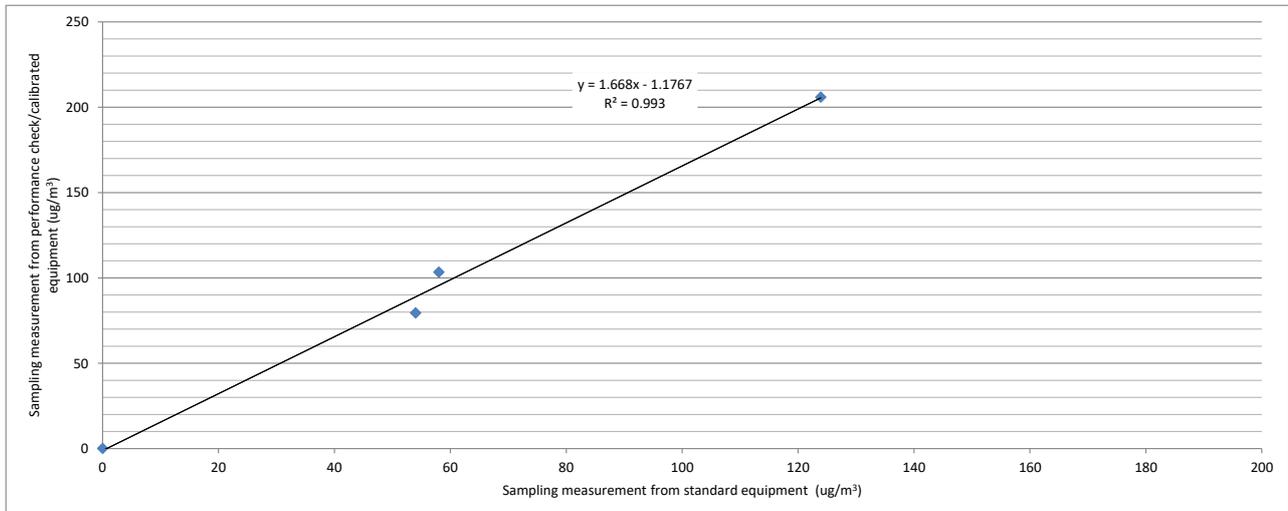
Linear Regression of Y on X

Slope (K- factor) : 0.6000
Correlation Coefficient : 0.9965
Validity of Performance Check / Calibration Record : 27/8/2021

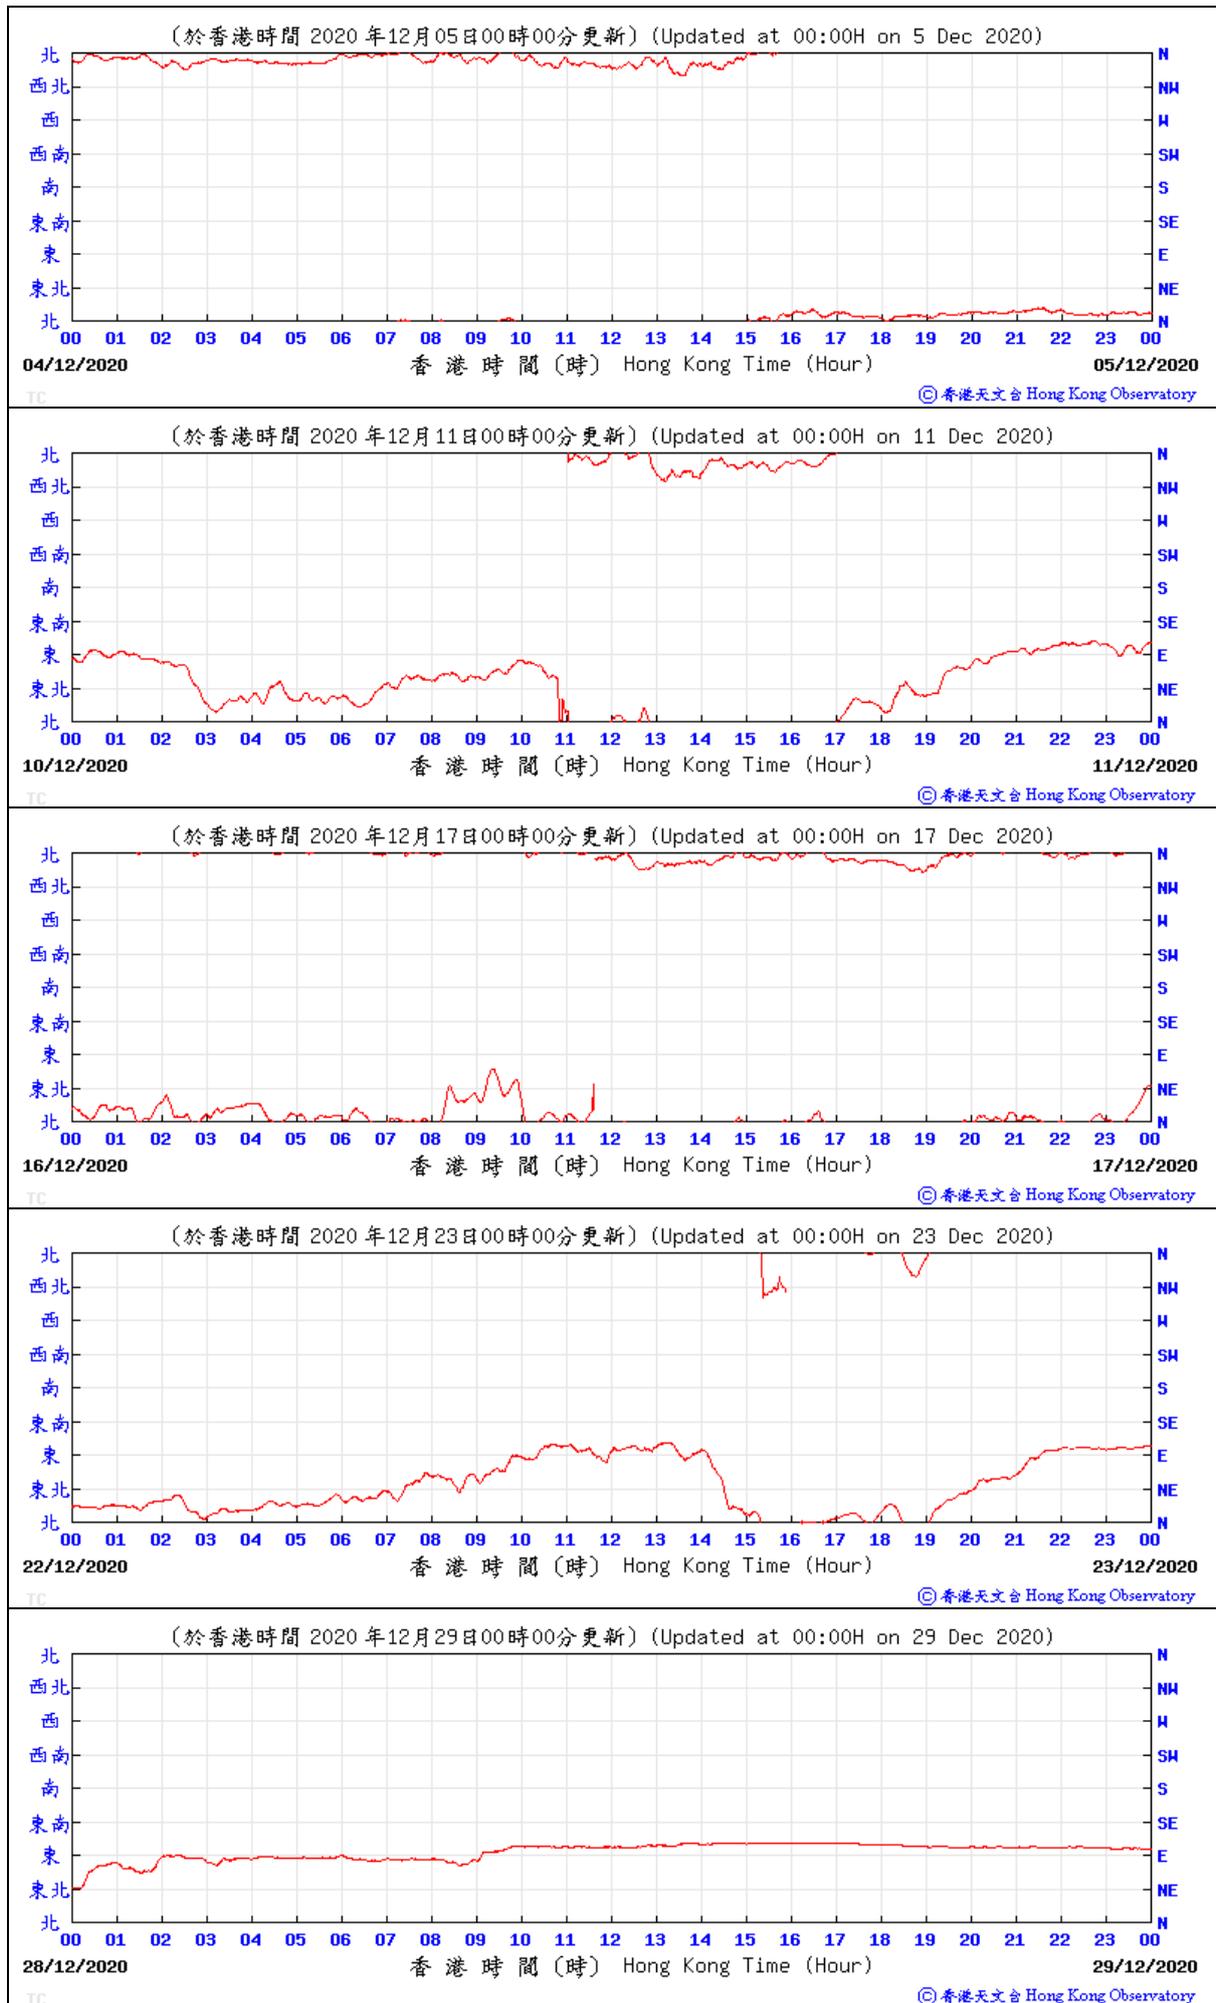
# A. Wind Direction extracted from Tate's Cairn HKO Automatic Weather Station

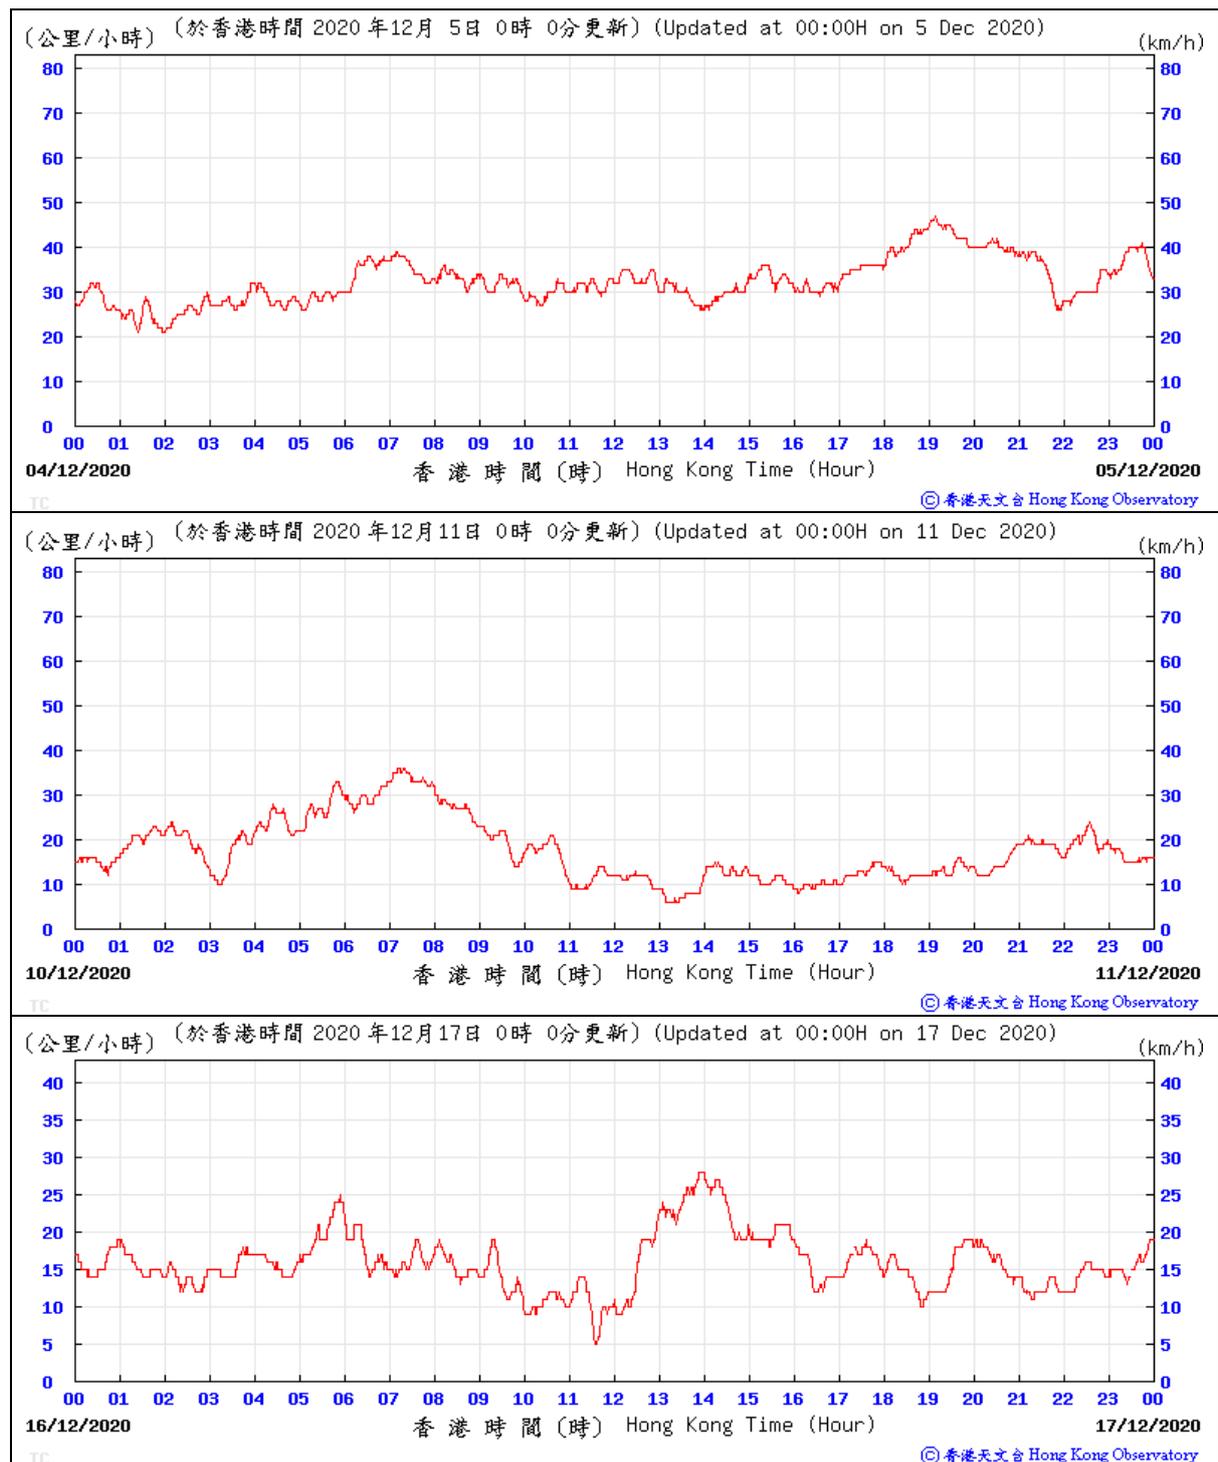
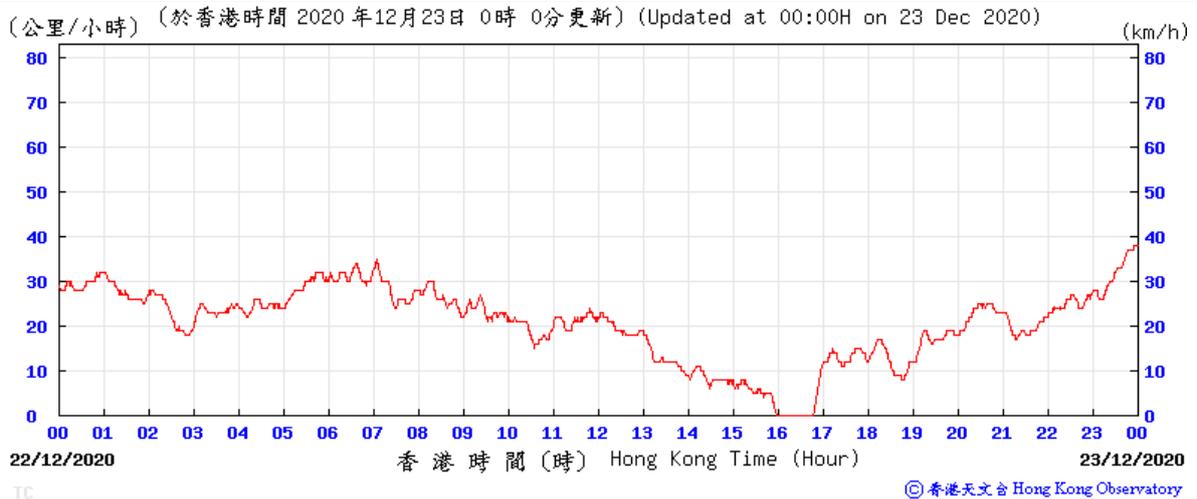
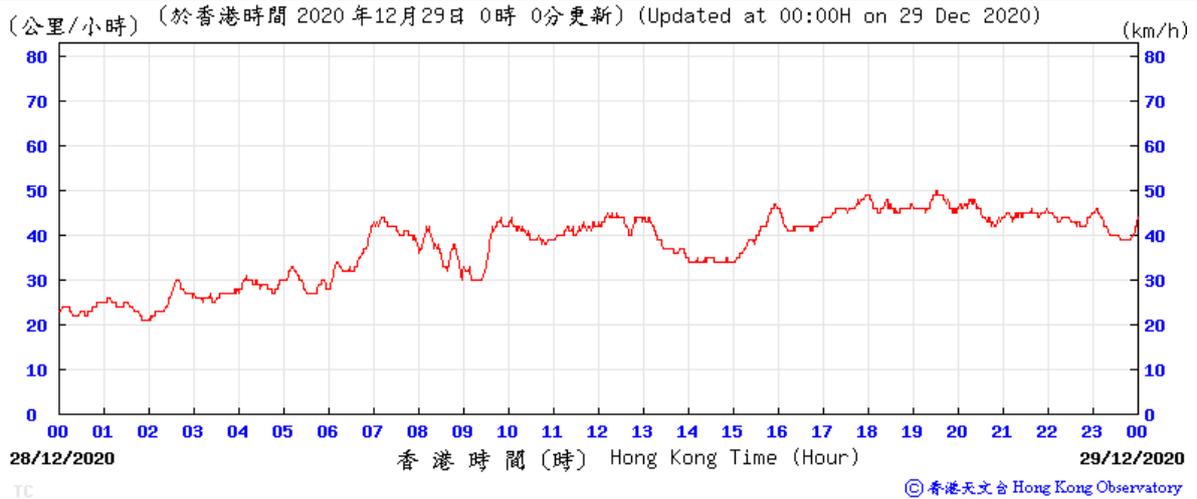
## B. Wind Speed extracted from Tate's Cairn HKO Automatic Weather Station

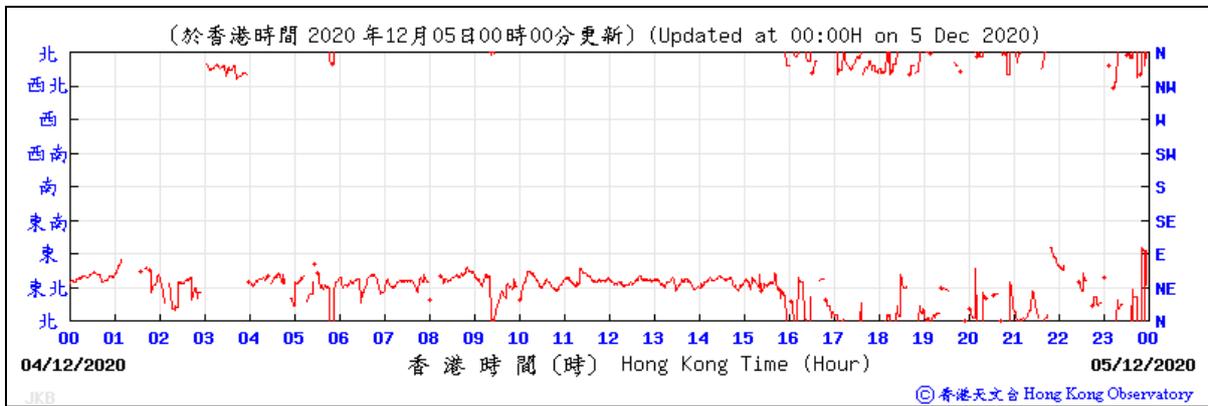
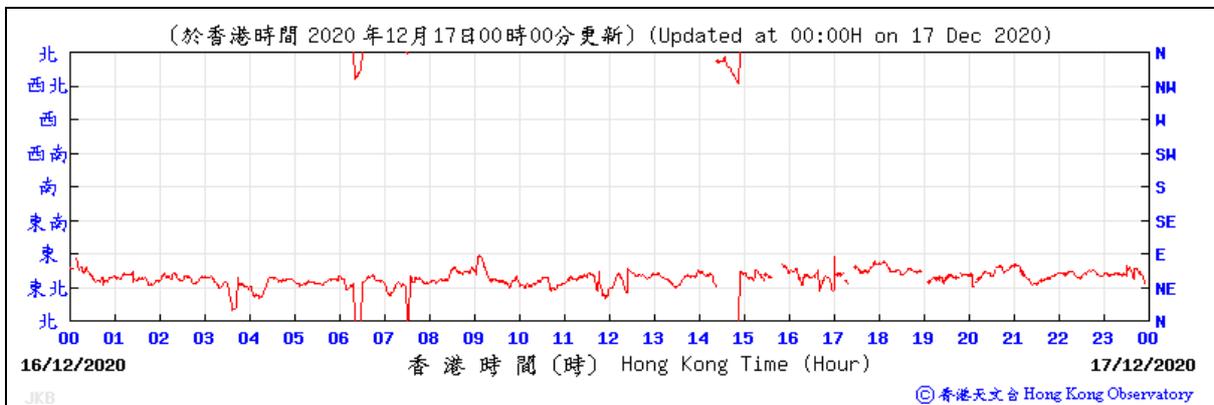
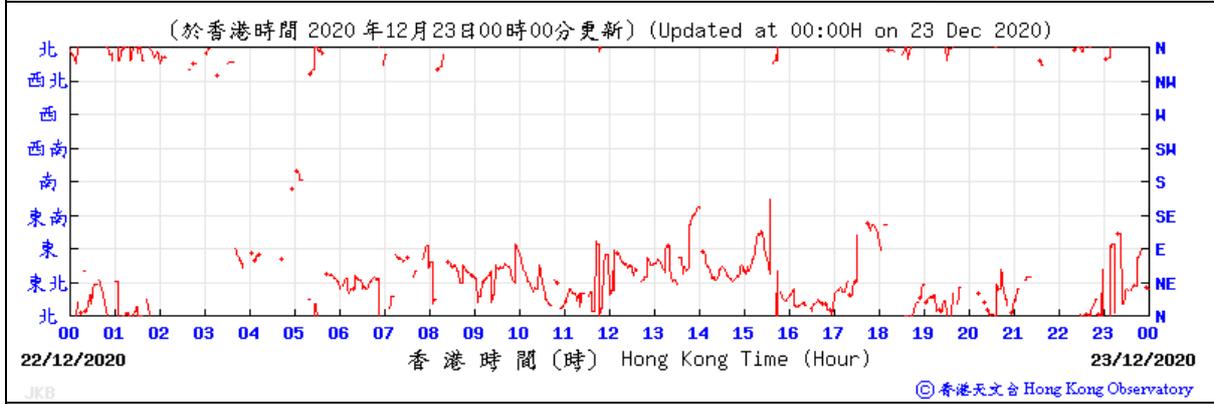
### C. Wind Direction extracted from Tseung Kwan O HKO Automatic Weather Station

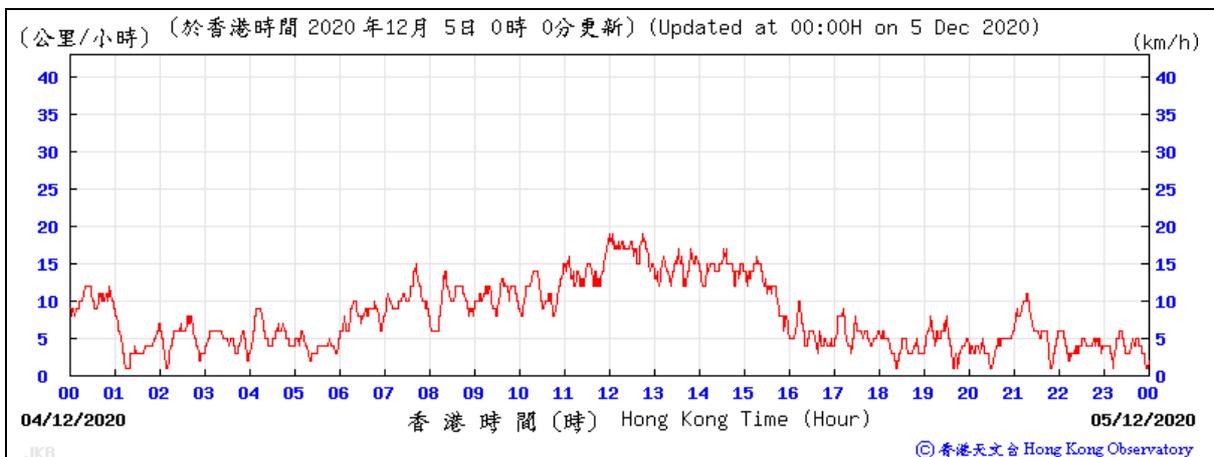
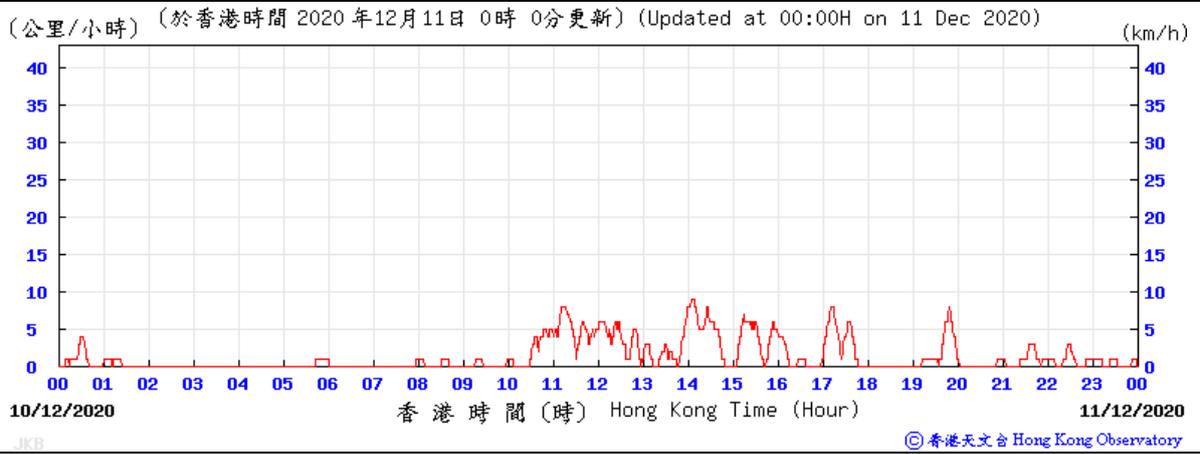
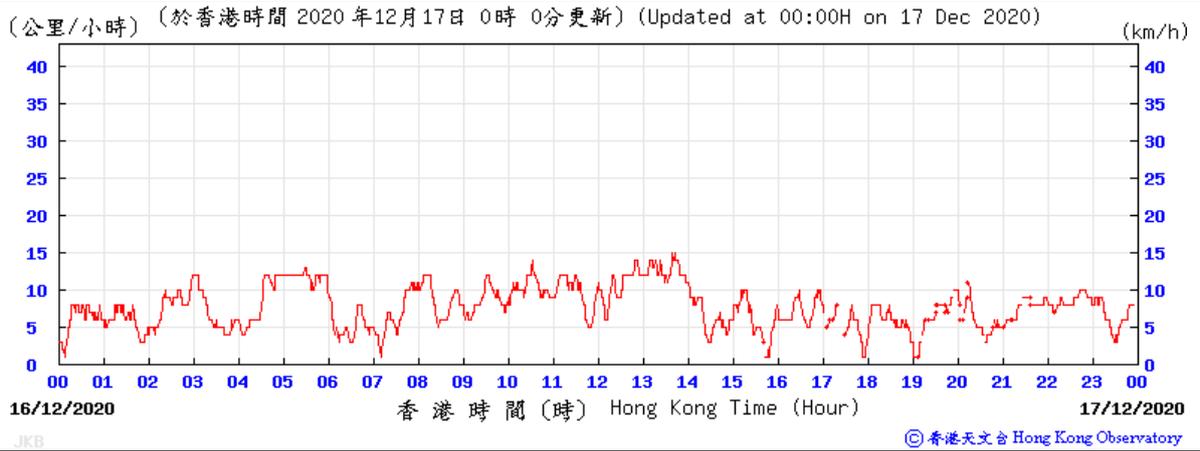
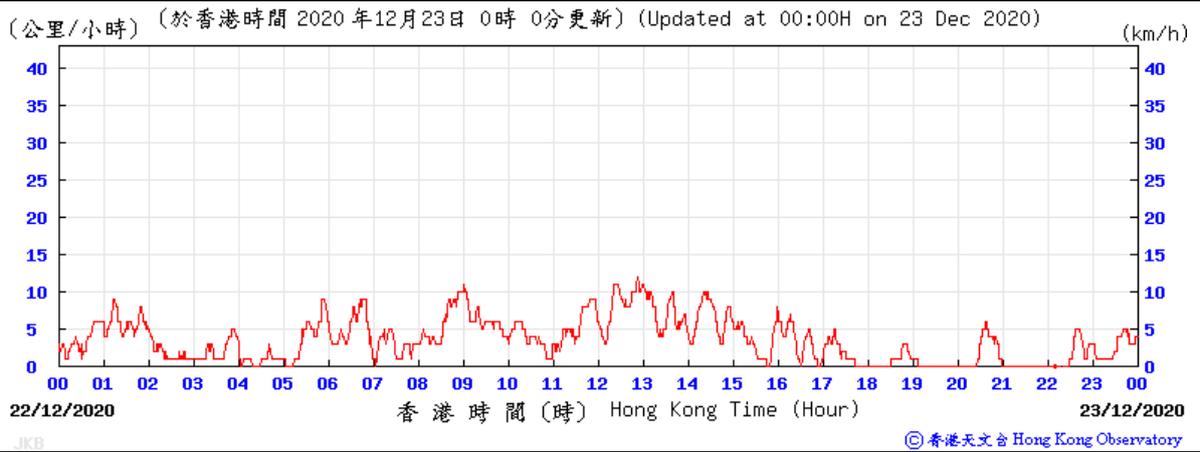
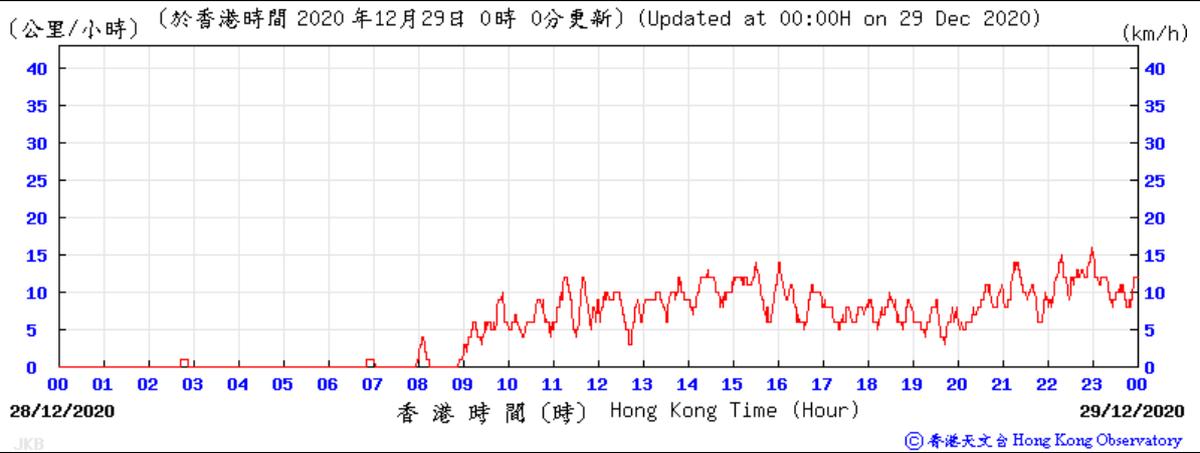
#### D. Wind Speed extracted from Tseung Kwan O HKO Automatic Weather Station

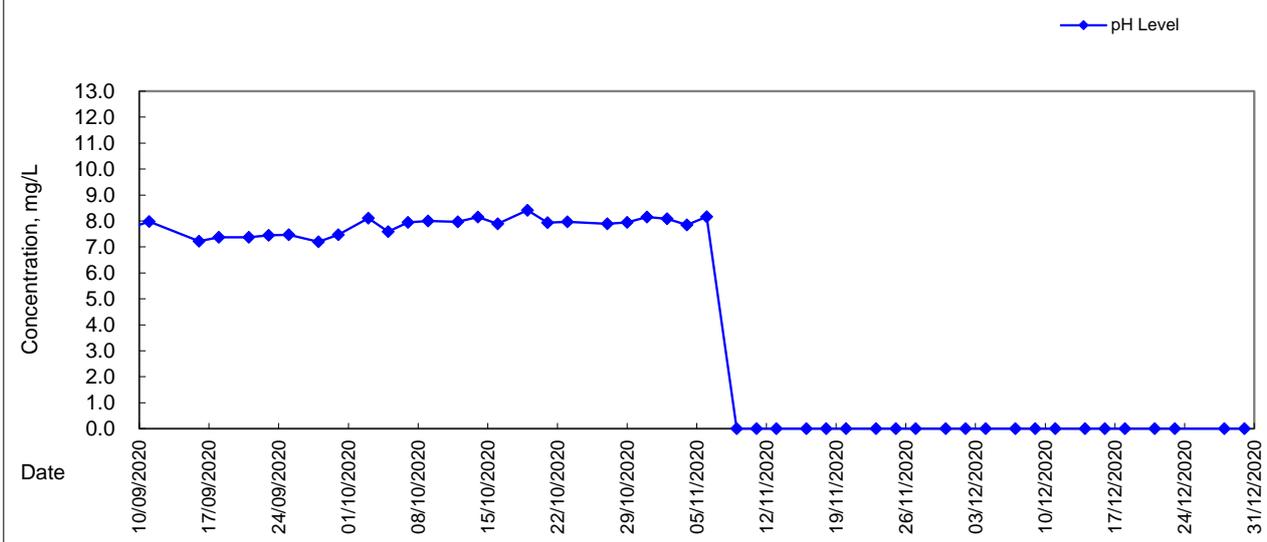
Station AC2 - Upstream reference station - pH

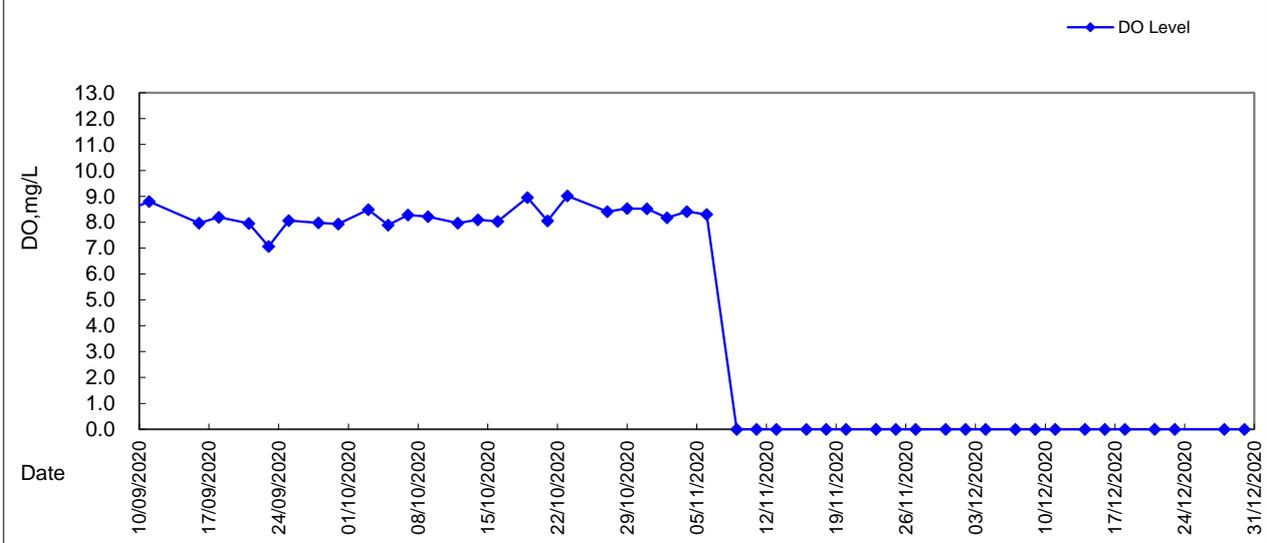
Station AC2 - Upstream reference station - DO

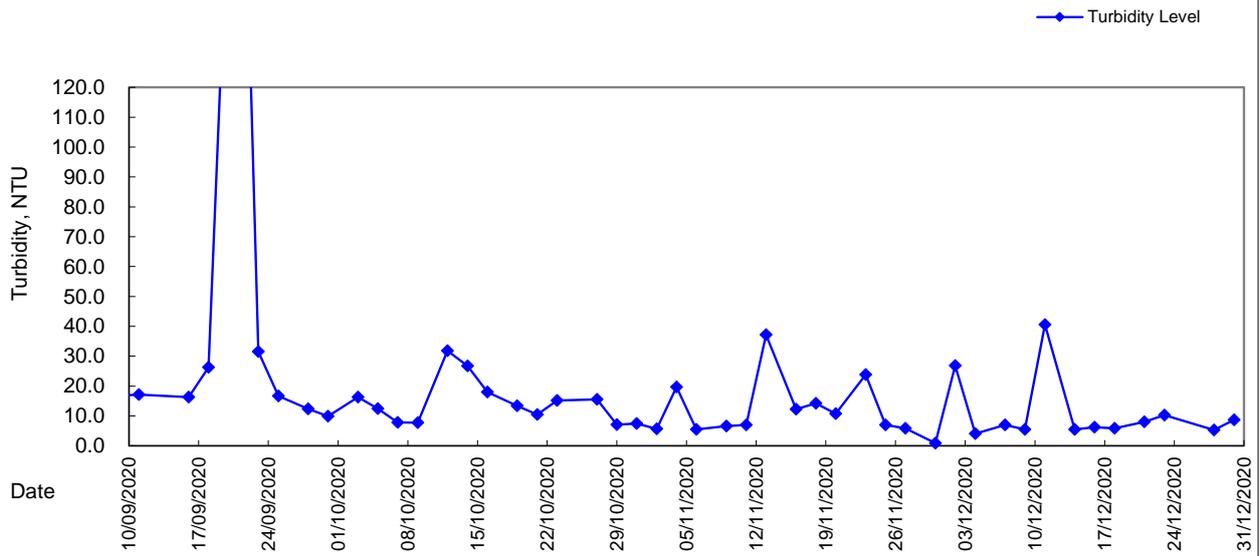
Station AC3 - Upstream reference station - Turbidity

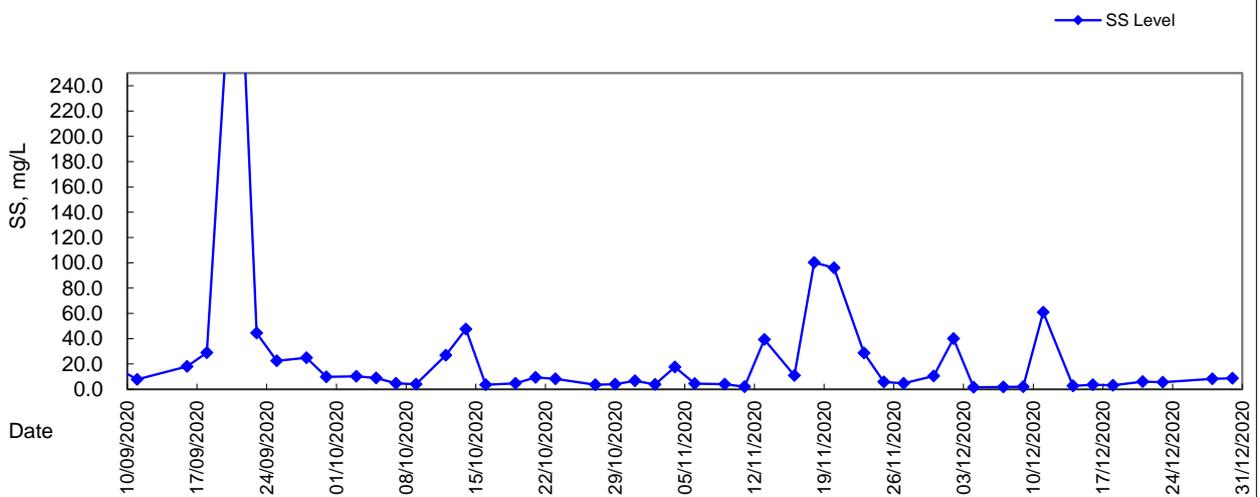
Station AC3 - Upstream reference station - Suspended Solid
